BUNBURY PORT AUTHORITY

BUNBURY PORT AUTHORITY
BERTH 1 & 2 REMEDIATION
PROJECT

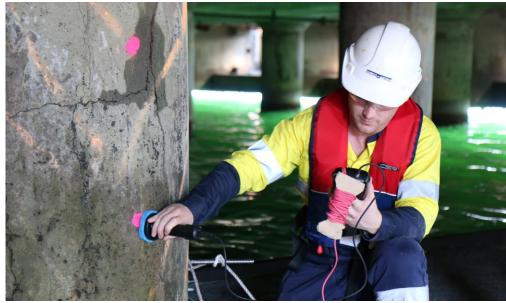
Corromap analysis was performed to determine the likelihood and potential of corrosion.
