RIO TINTO YANDI CORROSION REPAIRS

MAINTENANCE - BLAST AND PAINT

Rio Tinto Yandicoogina Corrosion Repairs

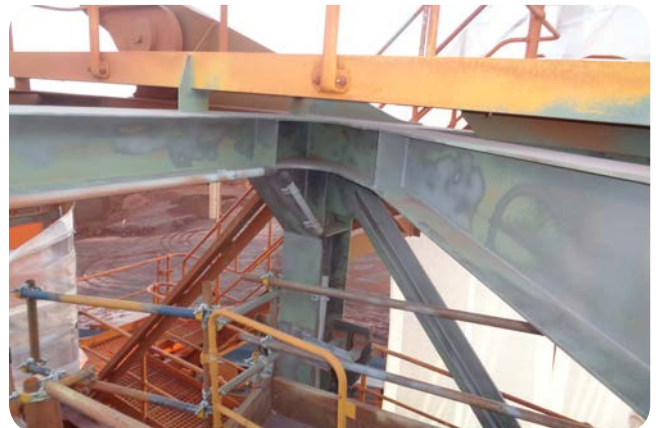
- ▮ Overview of reclaimer with encapsulation.
- ▮ Structural steel abrasive blasted.
- ▮ Completed coatings.

- ▮ High pressure water blast of structure to remove iron ore from steel surface.
- ▮ Abrasive blast of structural steel on head end primary structure of reclaimer, areas of slew drive and bracing connections.
- ▮ Liaised with Rio Tinto engineer to determine which areas required immediate structural strengthening.
- ▮ Carried out parent metal repairs on designated areas.
- ▮ Striped in initial coat of surface tolerant epoxy
- ▮ Spray applied initial coat of surface tolerant epoxy at 250 DFT and allowed to cure.
- ▮ Spray applied second and final coat of surface tolerant epoxy to a total DFT of 500 µm.
