## Healthy Home Standard Report

17 Jun 2026 / 73C Pulham road, Warkworth, Auckland / Ashish Haridas / HHSR001358

HHSR001358

73C Pulham road, Warkworth,  
Auckland

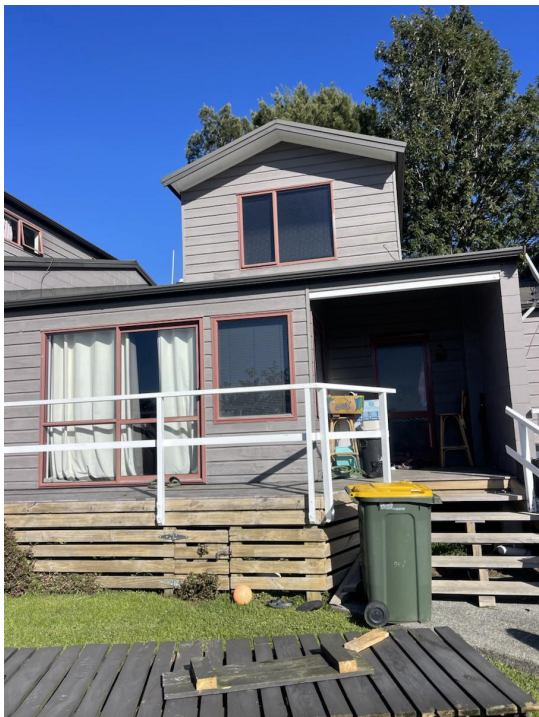
Photo 2

Is the roof structure rafter (skillion) type?

Yes

Please provide photos of the skillion roof.

Compliant

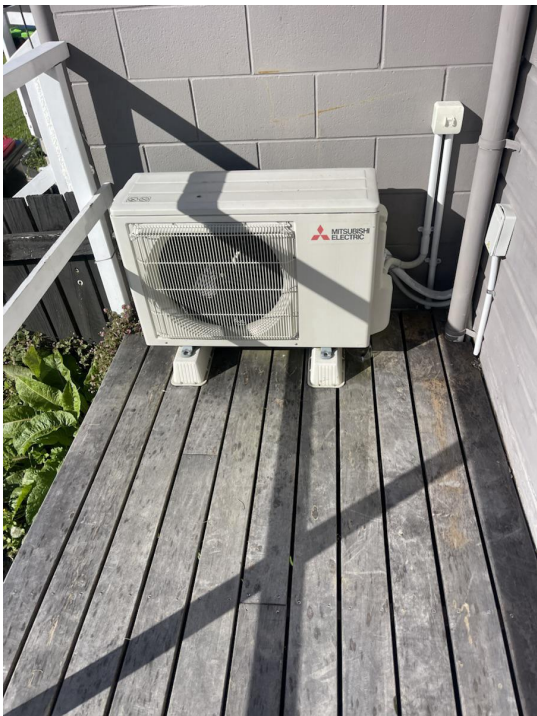
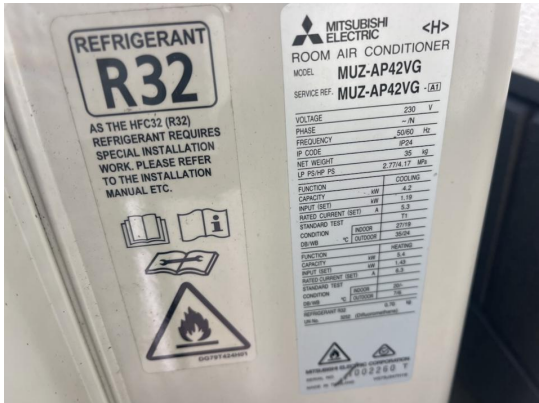
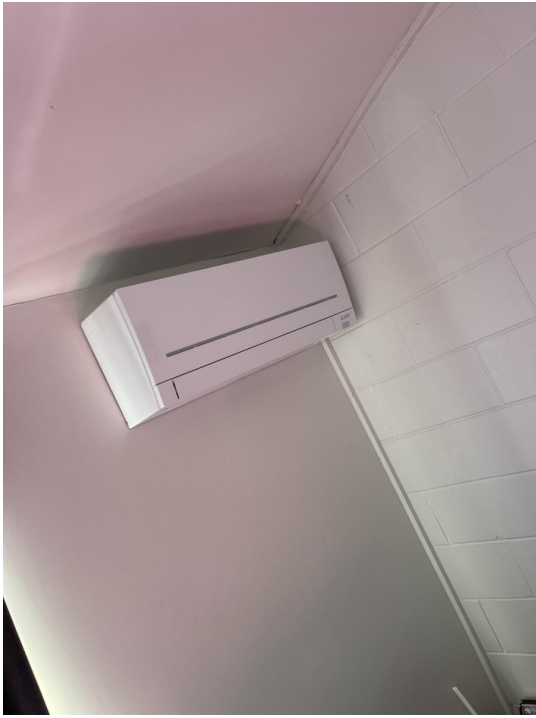
| What are the sources of the heating capacity and it's output. | Heat pump- 5.4kW |

Provide photo evidence of the heating source.

Existing heat pump achieves at least 80% of the required heating capacity to heat up living area as per HHS- Hence Compliant

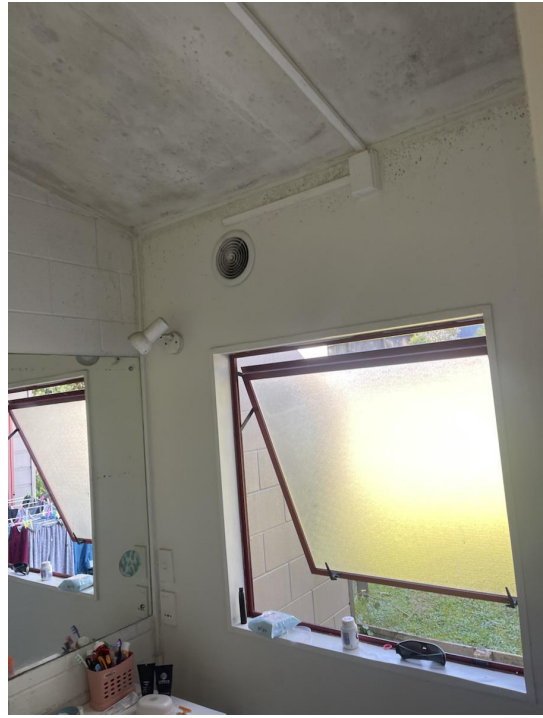
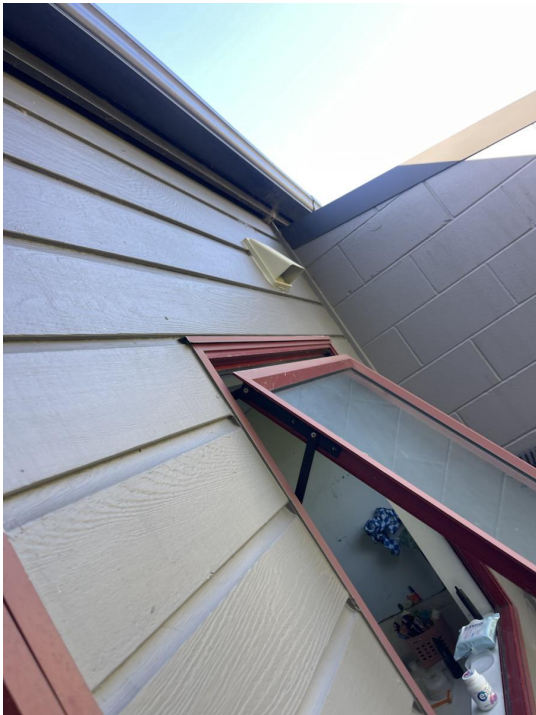
Is the extractor fan functional and ducted outside?

Yes

Please provide the photos of functional extractor.

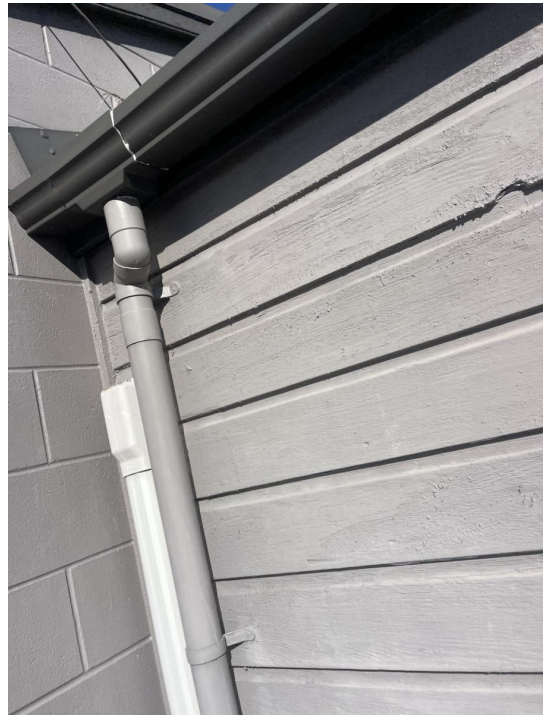
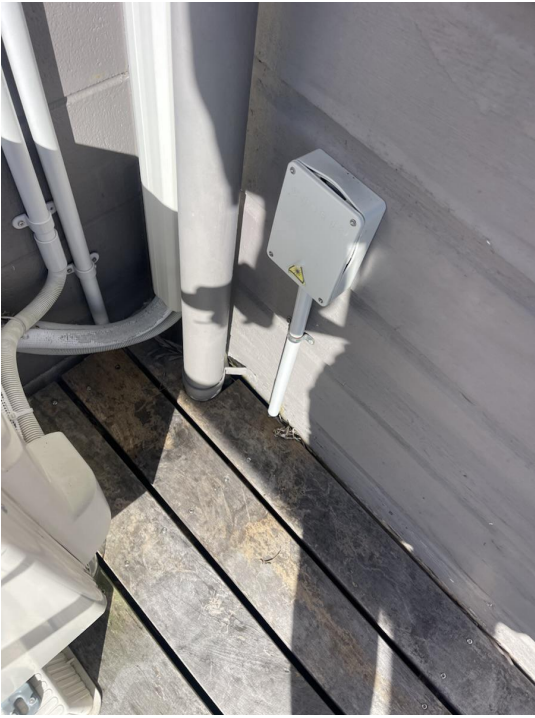
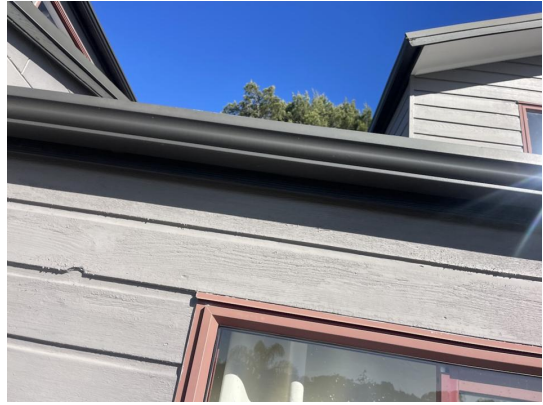
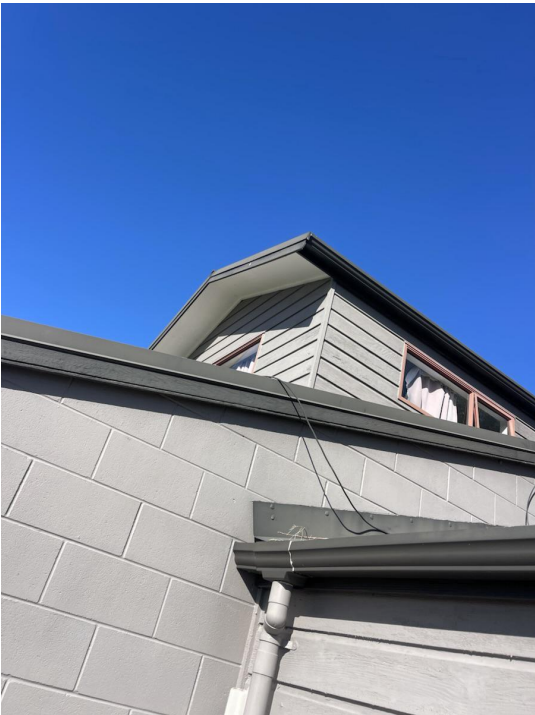
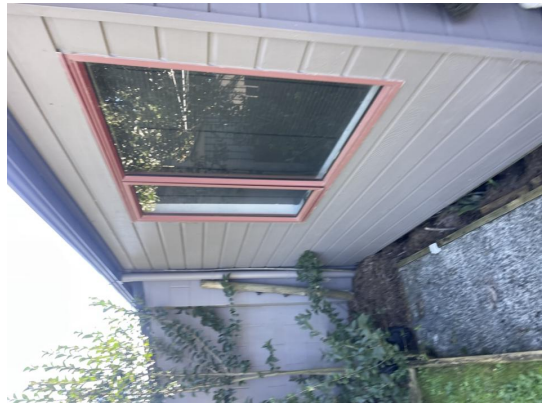
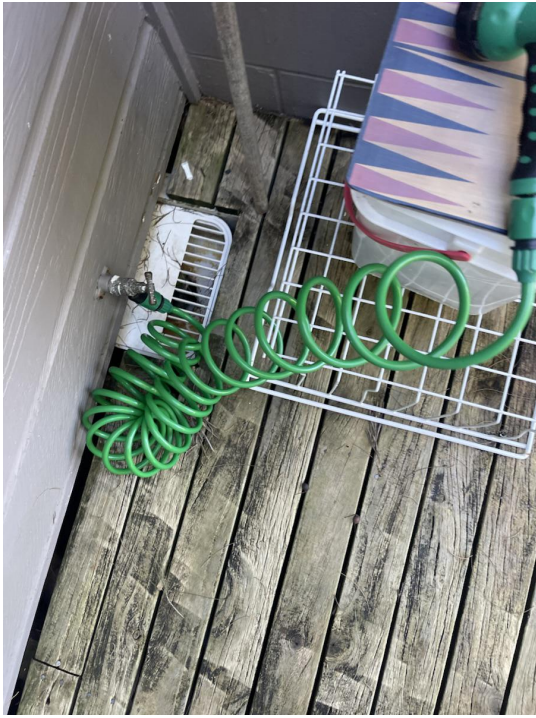
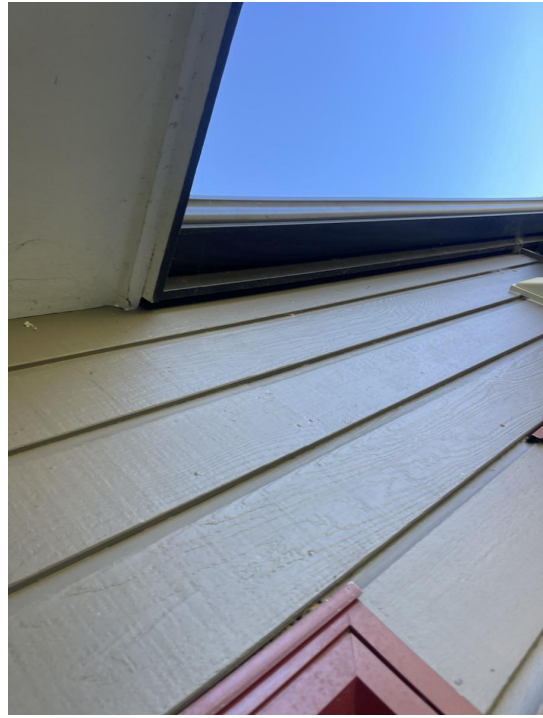
**Is the drainage system in good working order, free of visible blockage or vegetation growth and the securely connected to drains.**

Yes

Please provide photo shots of the drainage system, including gutters, down pipes and drain.

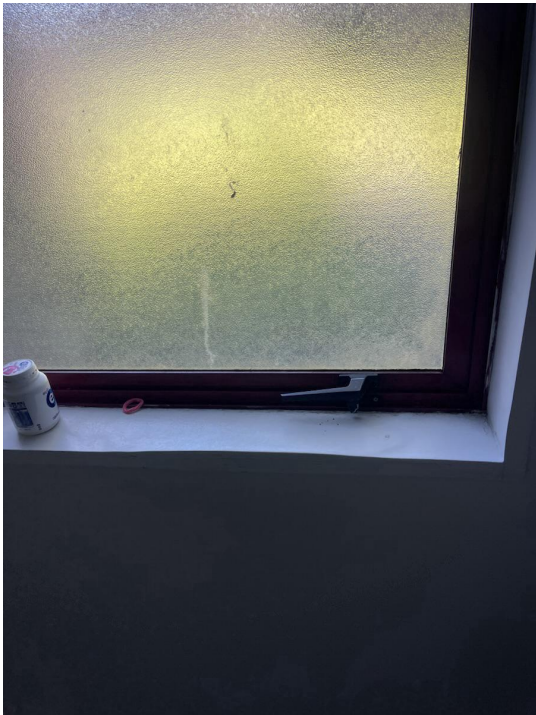
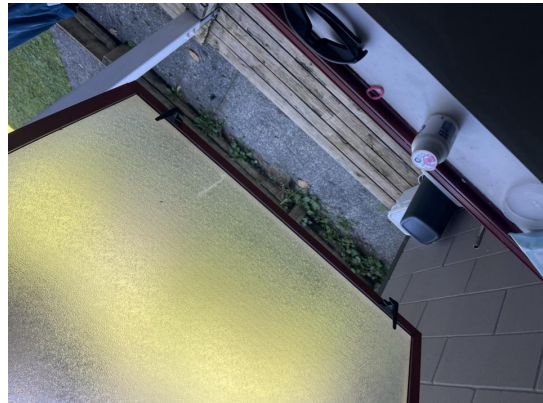
| Is the property free from any unreasonable gaps (more than 3mm) or holes that allows draughts into or out of the premise? | Yes |

Please upload photo evidence.
