**Mastergroup Lot 11 Trust**

**Site Audit Report & Site Audit Statement**

**Richards Road, Riverstone, NSW Lot 11,  
DP816720,**

**20 December 2013**

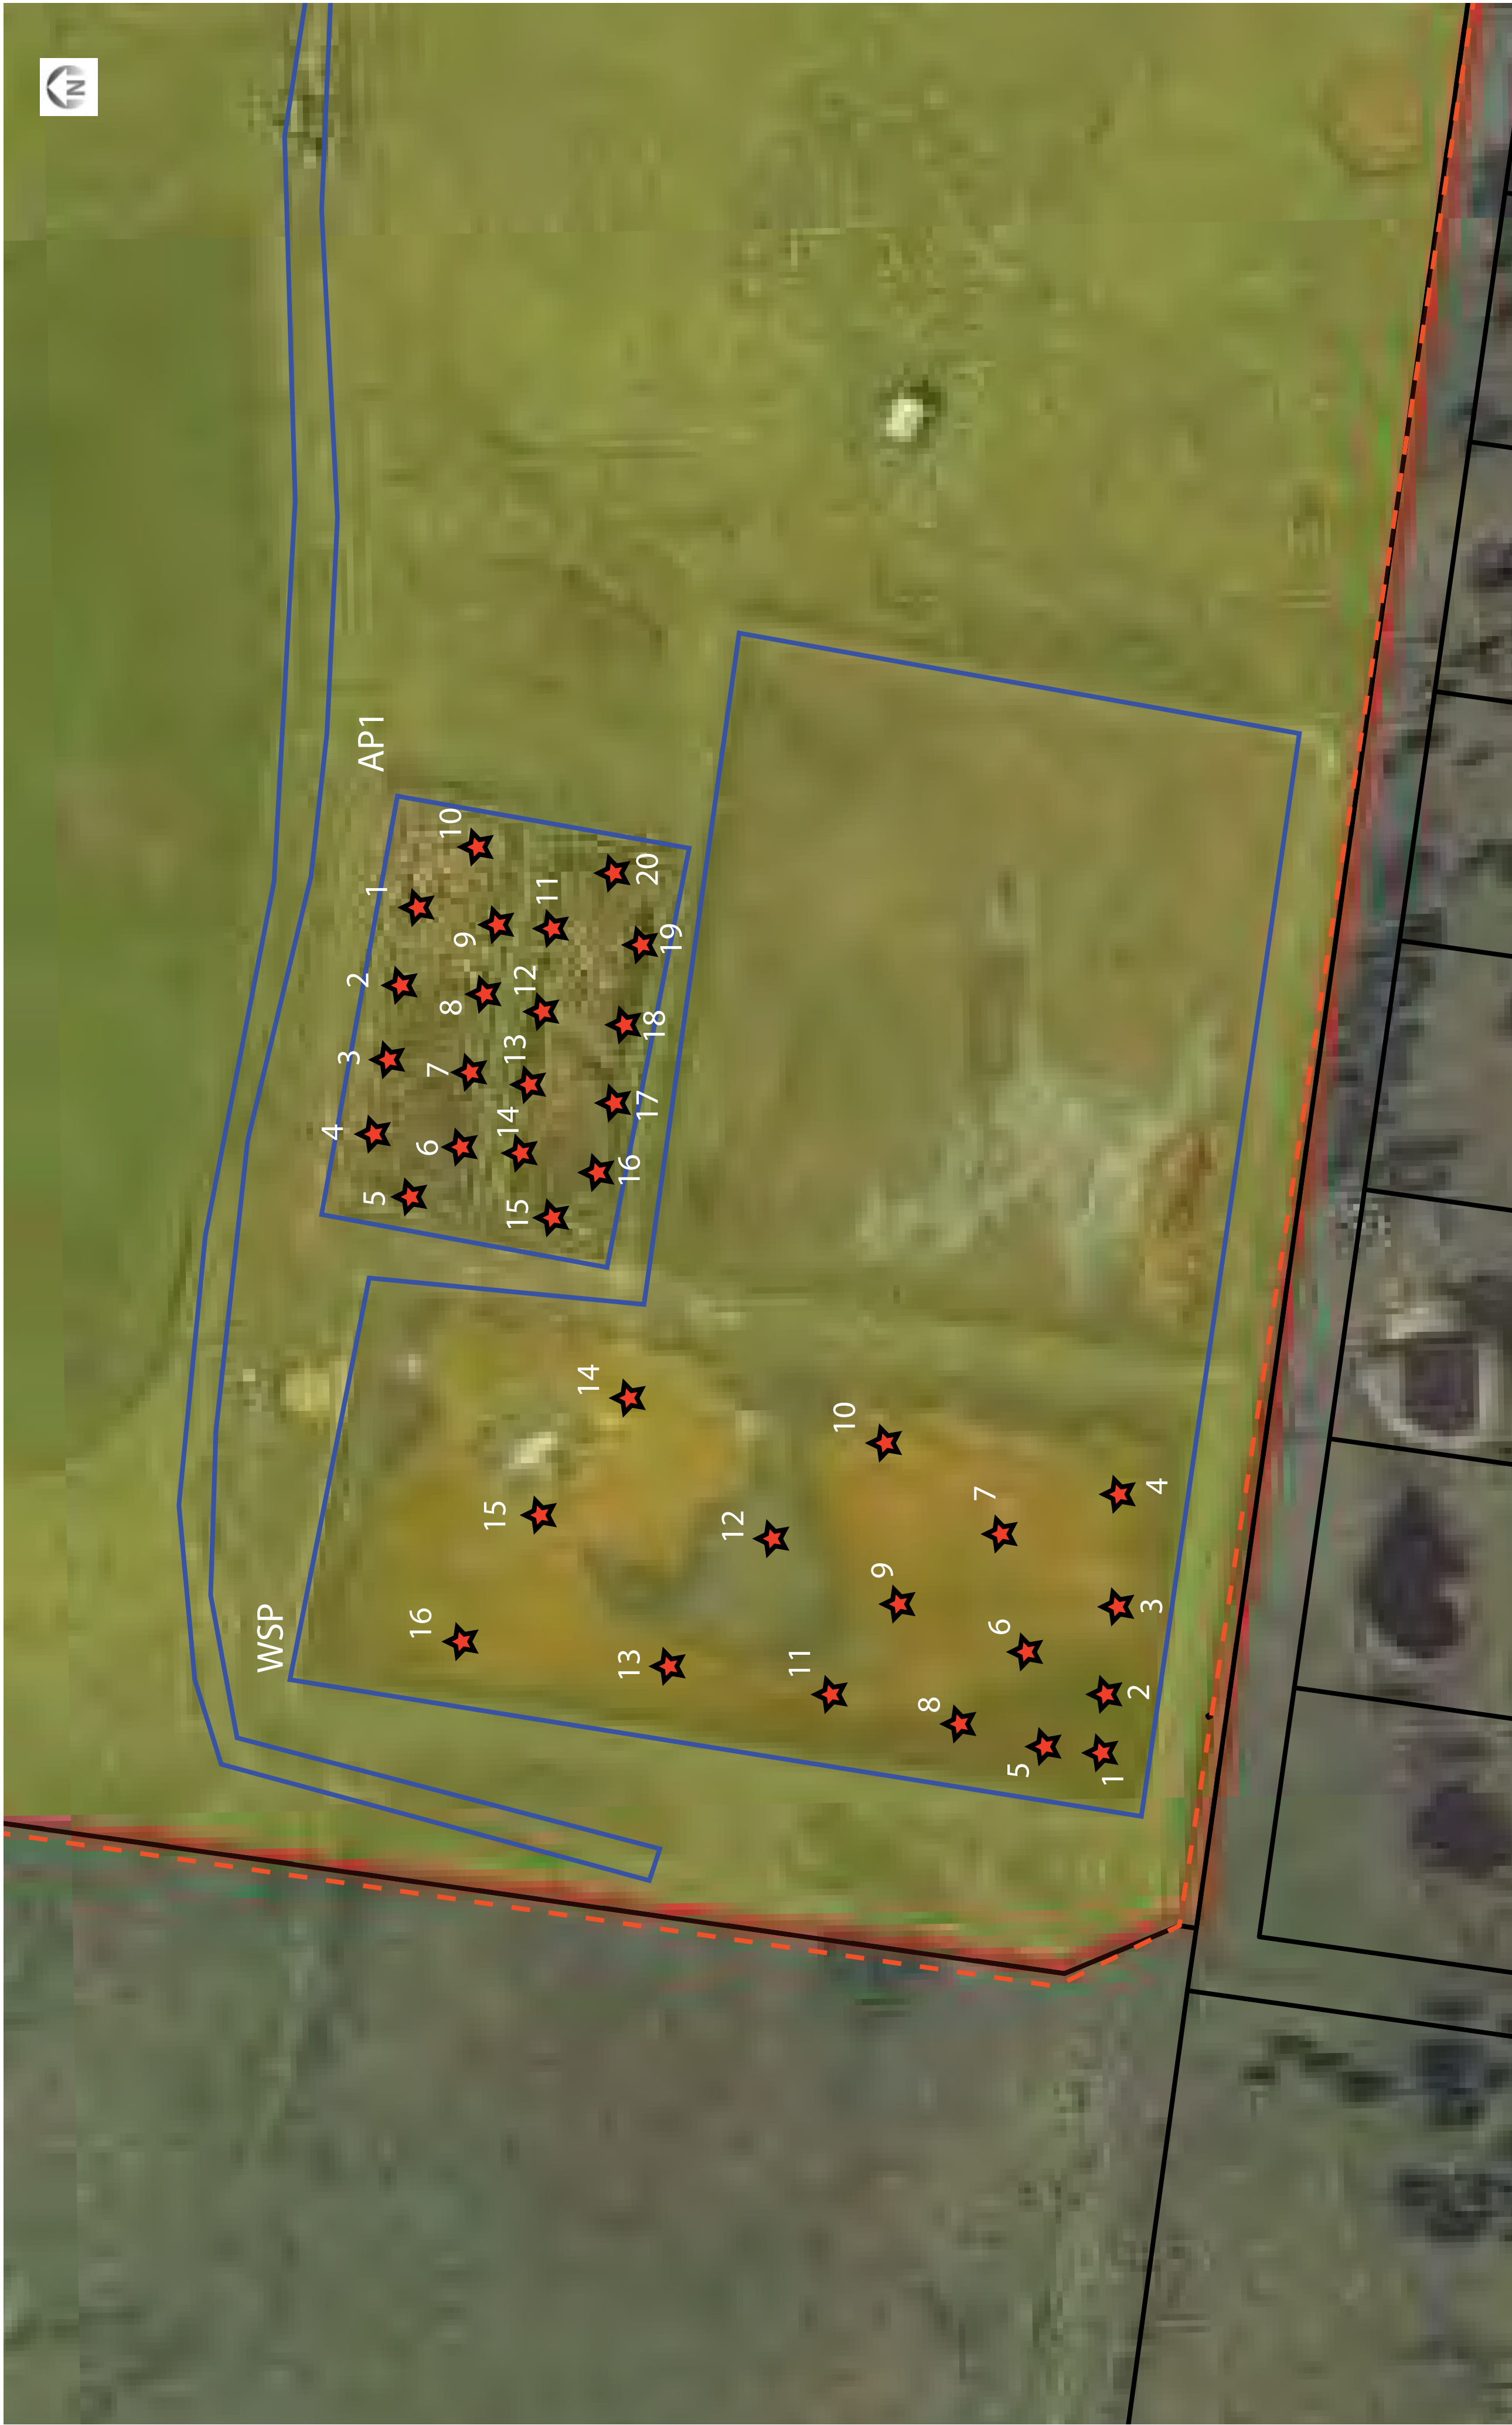
**Title: Map 4 - AEC1 and AEC2: Settling Ponds and Anaerobic Ponds**  
Report: Riverstone Detailed Site Investigation  
Address: Lot 11, Richards Road, Riverstone  
Legend: ★ Approximate Sampling Location

The Auditor accepts that the condition of soils in the settling ponds (AEC 1) and anaerobic ponds (AEC 2) do not warrant further investigation or remediation. The current form of the settling ponds will almost certainly be altered substantially by bulk earthworks during future development of the site so that nutrients and salts will be mixed with other soils which will reduce likelihood of mobilisation into storm runoff..

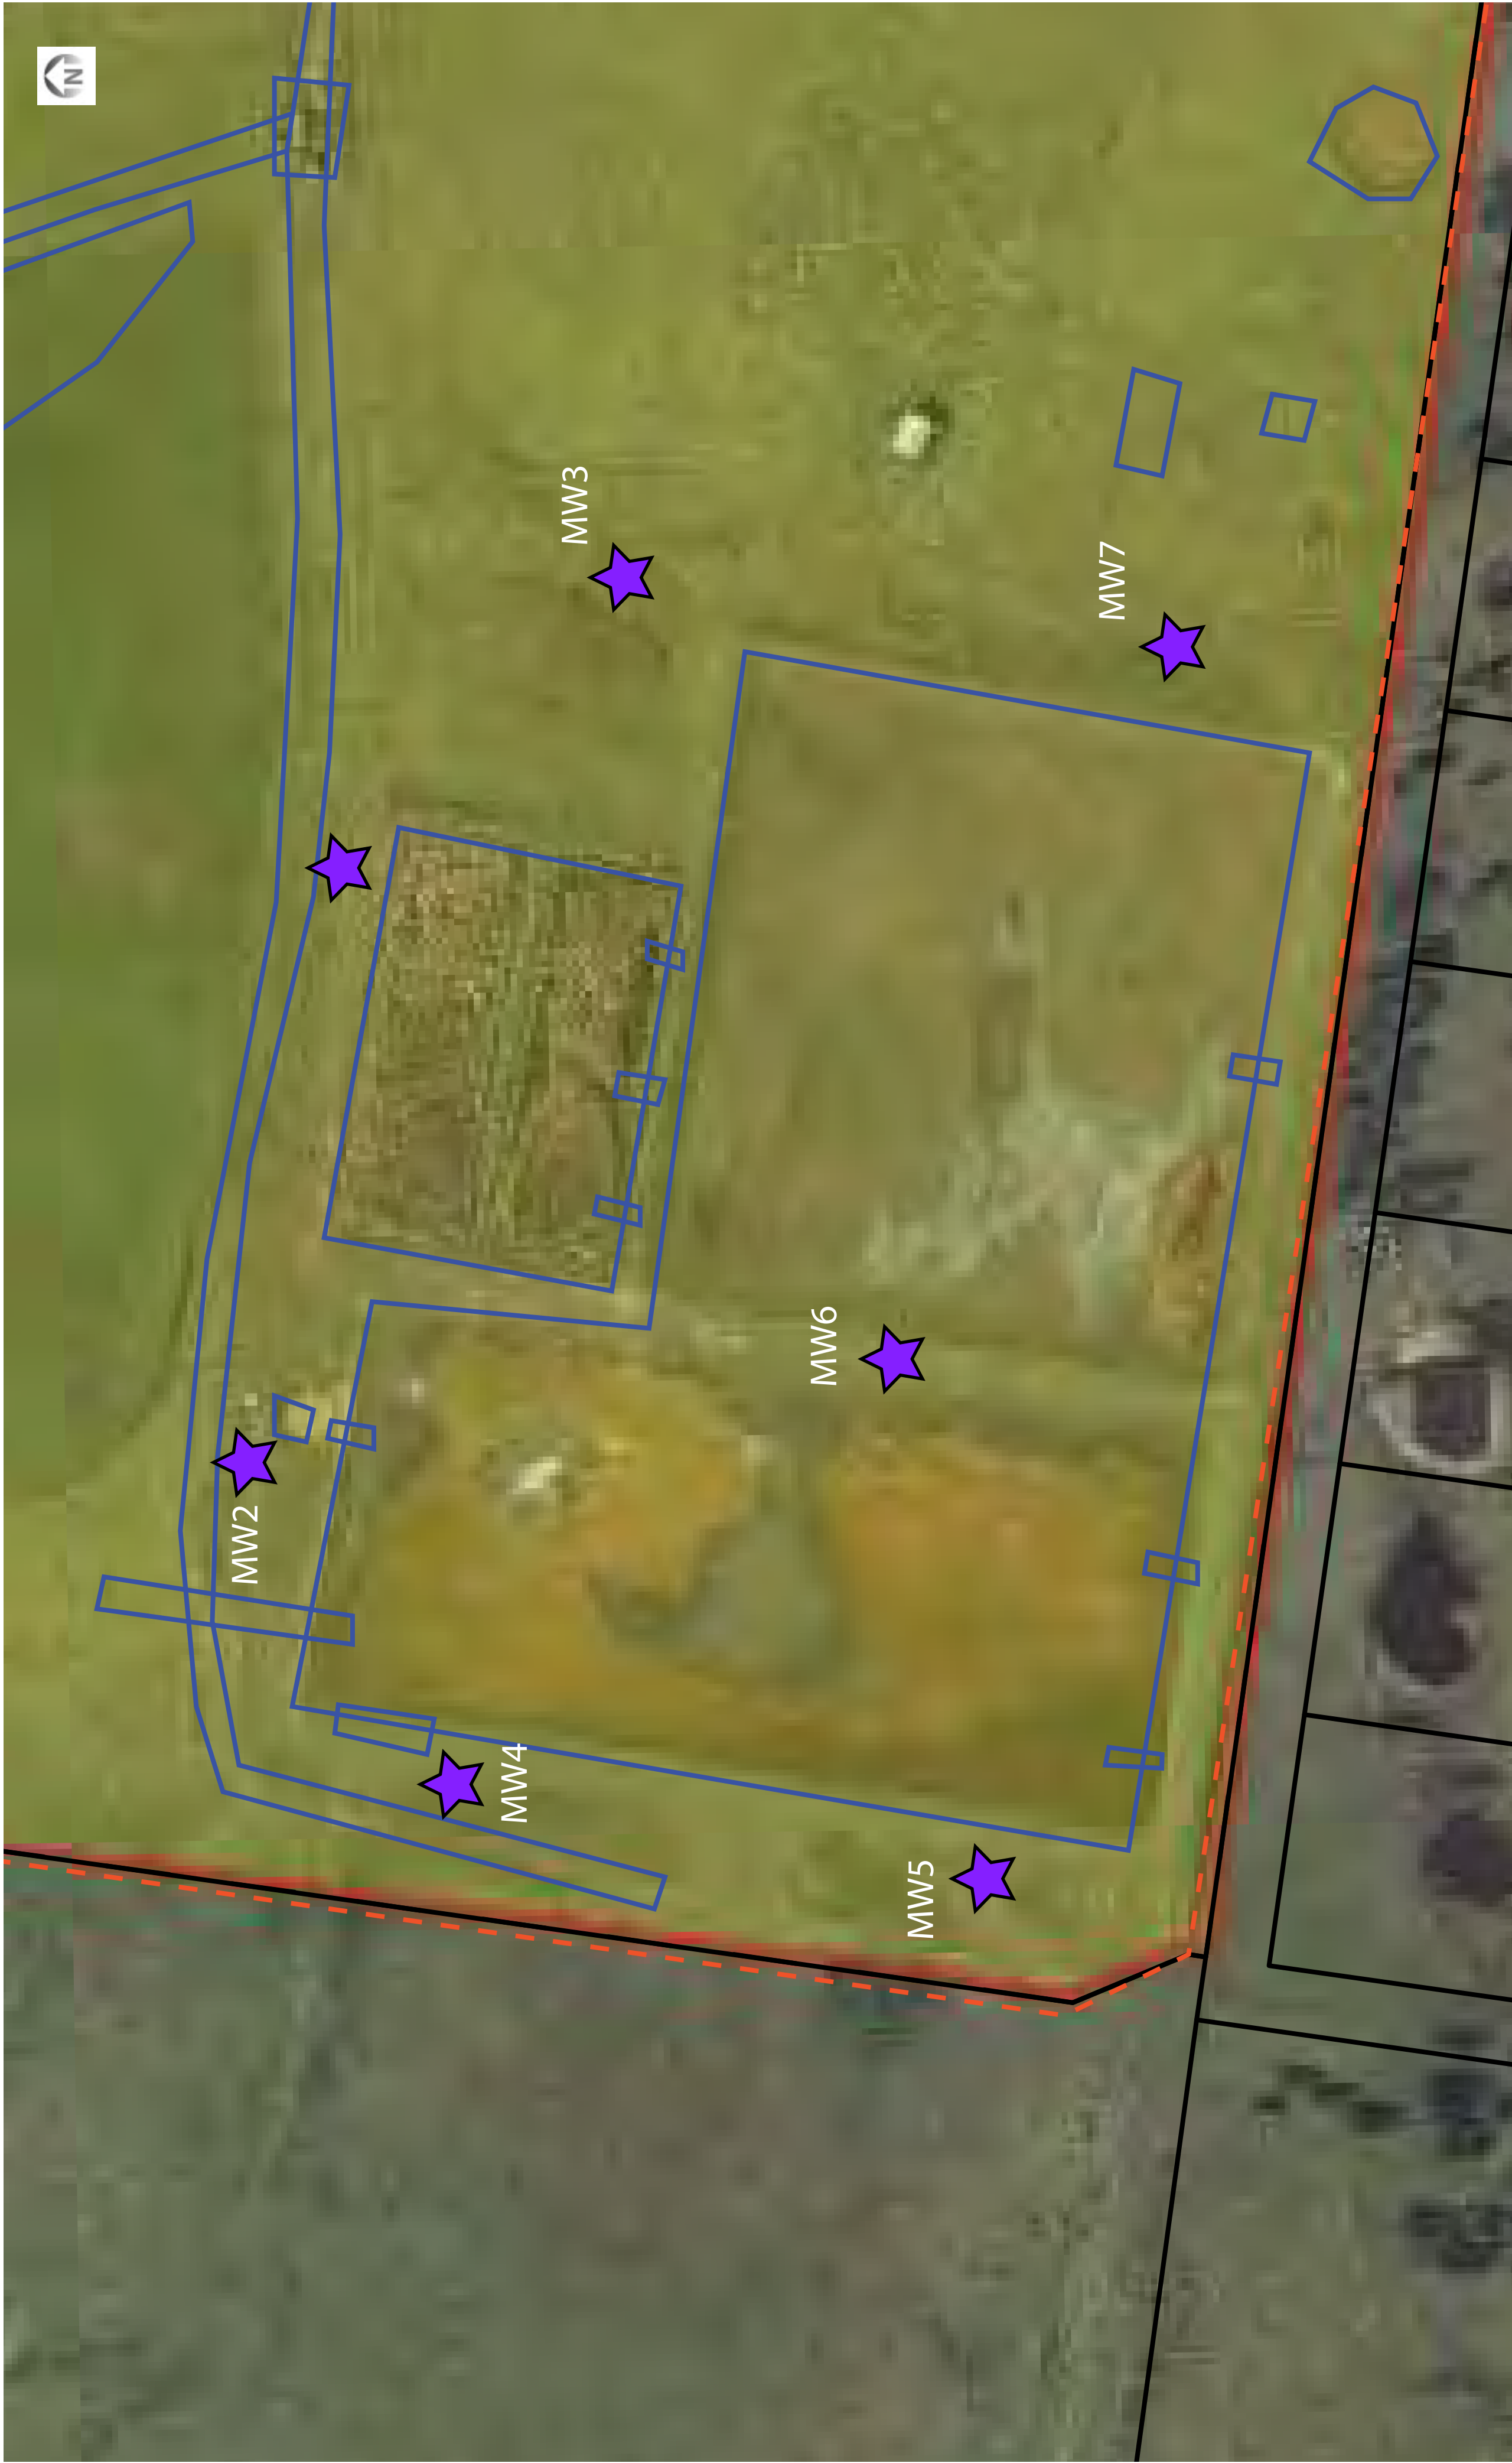
**Title: Map 14 - AEC 13: Groundwater Monitoring Wells**

The Auditor considers that infiltration from the ponds appears to have created a local mound in the groundwater table, but that the quality of groundwater shows no apparent impact. Thus, no further groundwater investigation appears warranted. The Auditor agrees with SESL that no groundwater remediation works will be required for the site.
