Report on
Preliminary Site Investigation

Land Capability Study
Lowes Creek Maryland Precinct, Bringelly, NSW

Project 76742.00
September 2018

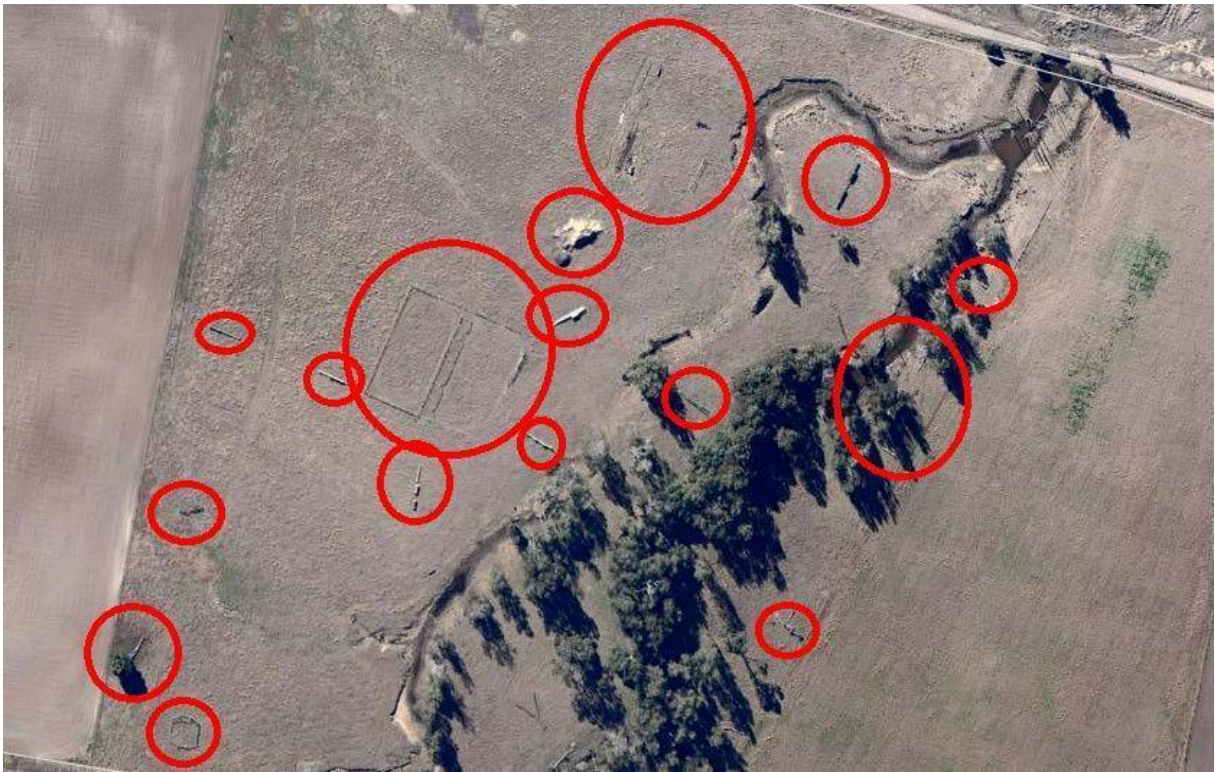
Figure C1: Lot 13 south of easternmost dam – Several elongate features (including possible fence lines) and stockpiles (September 2010)

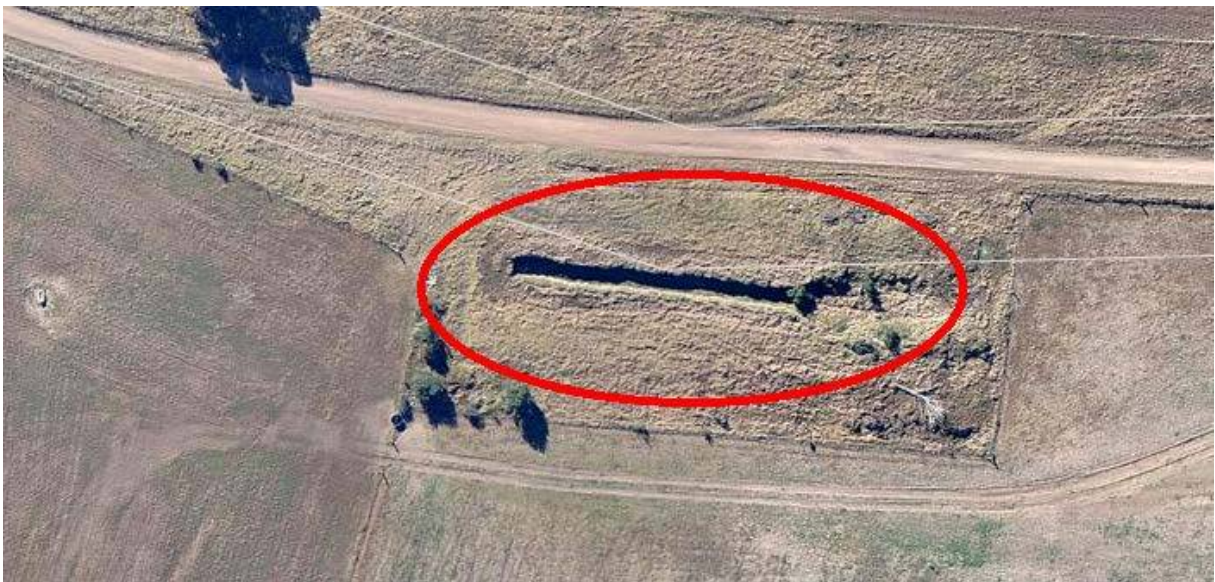
Figure C2: Lot 13 south side of access road to Lot 1 (July 2010) – Linear trench in the ground and based on later aerial photographs and observations made during the Walkover this feature appears to have been filled in based on later aerial photographs

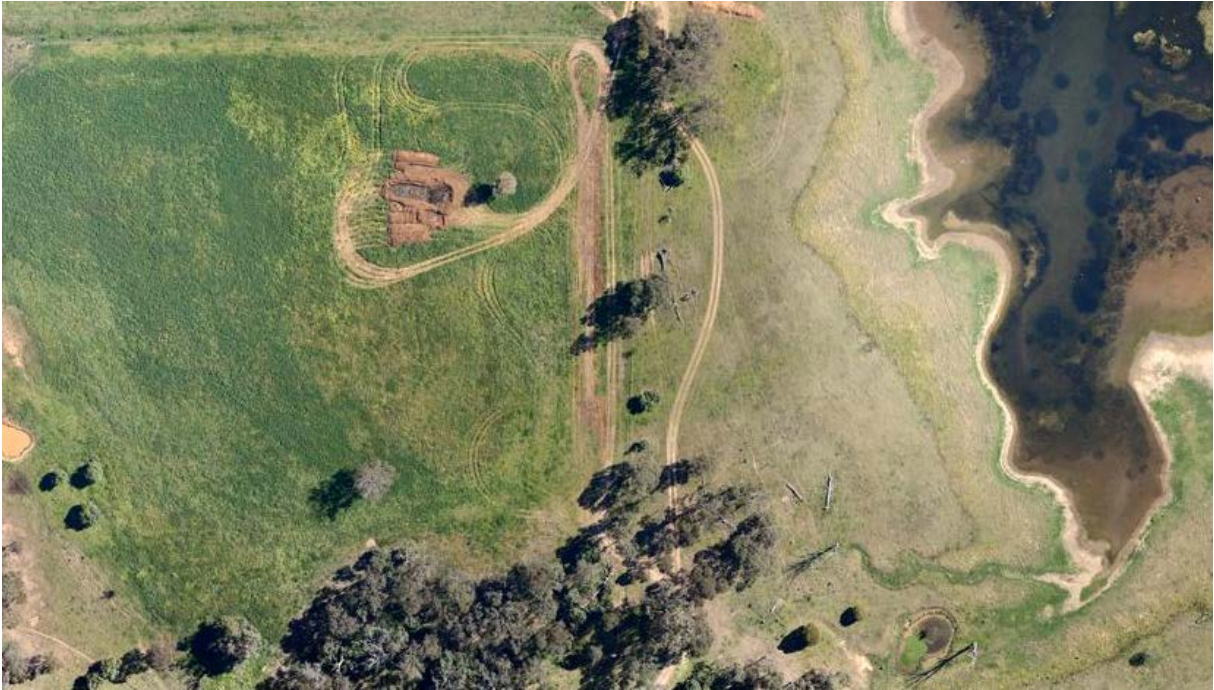
Figure C3: Lot 13 west side of westernmost dam – Stockpiles (September 2010)

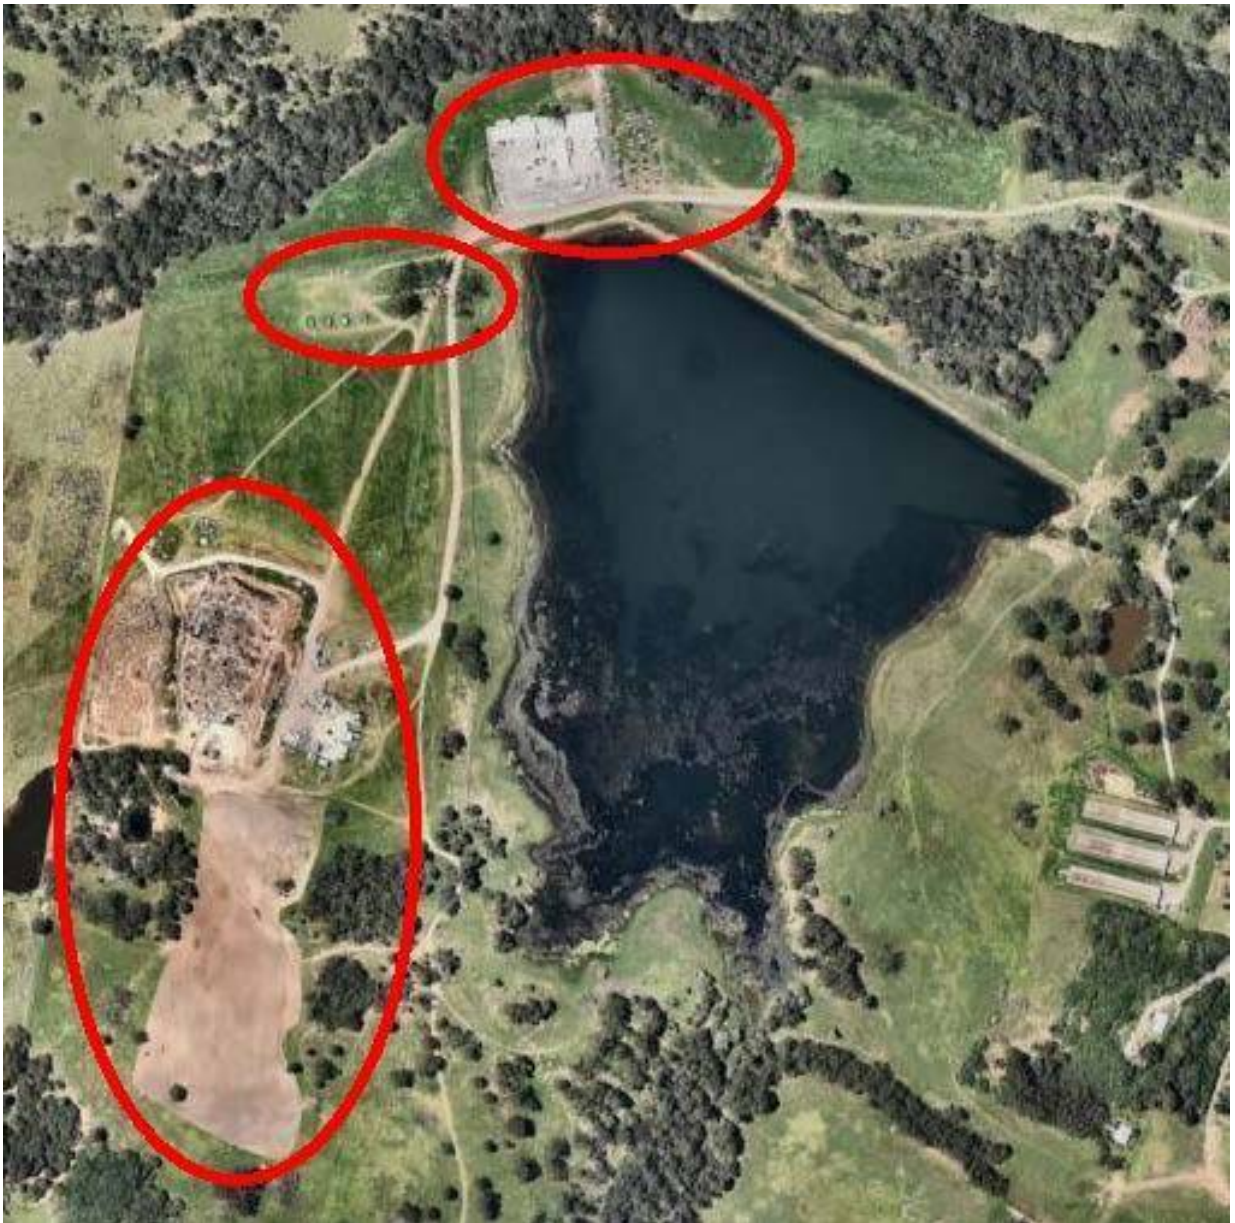
Figure C4: Lot 13 – Land clearance and material storage associated with film set (confirmed by MD to be located at the site during this time) is present at the site (November 2016)

Stockpiles of shale and limestone materials are located near the north western corner of the western dam in Lot 13 (Photograph C14) that may be remaining from a film set that was recently located near here (refer to Section 4.7; Figure C4). No construction and demolition type materials or suspected ACM were visible on the surfaces of the stockpiles. The road continued around the western dam and toward the southern part of the lot, where construction and demolition type materials were visible in parts of the road. A stockpile of organic material was observed near to the southern extent of the western dam.

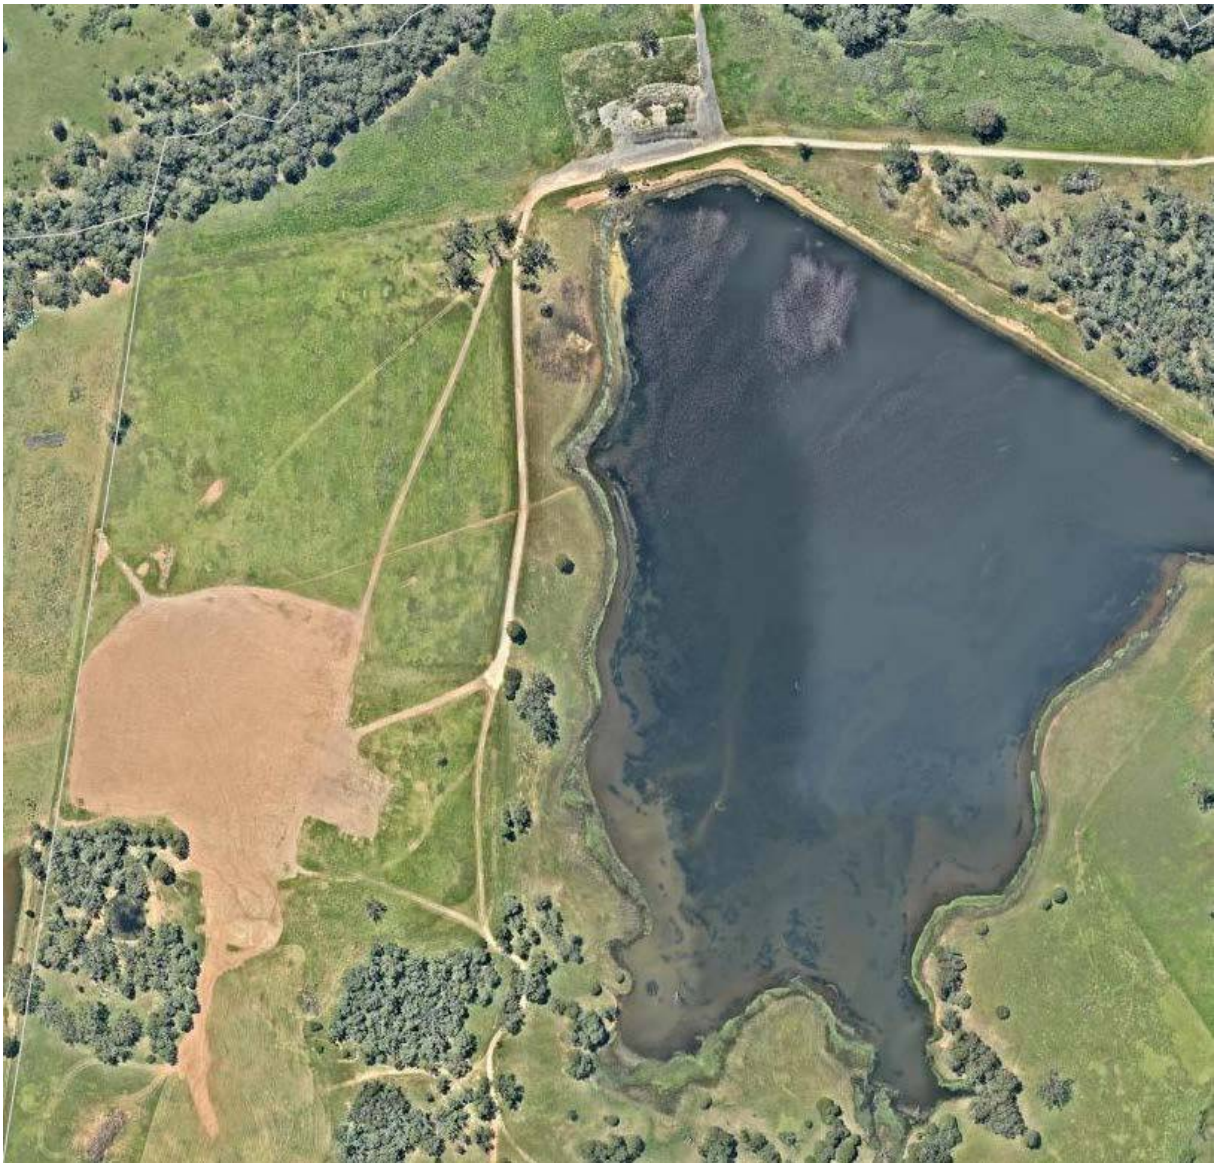
Figure C5: Lot 13 – Film set has been cleared, however stockpiles remain north of the westernmost dam and some land scarring is evident (January 2016)

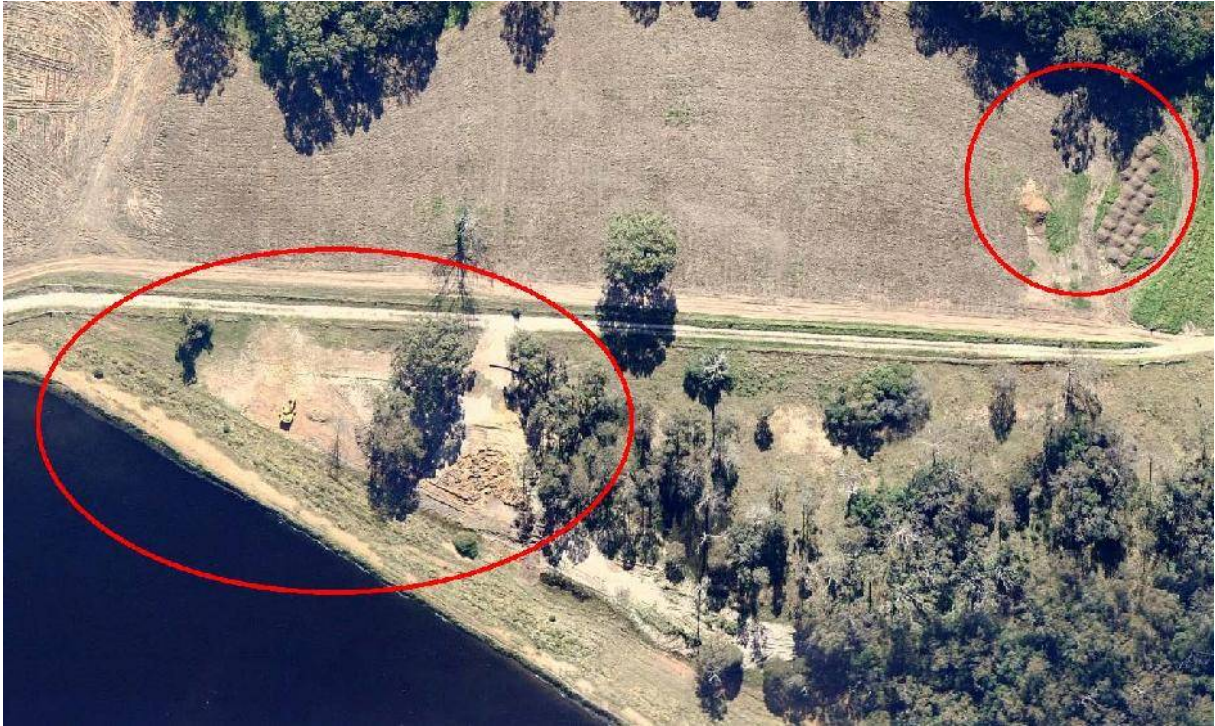
Figure C6: Lot 13 – Land clearing and stockpiling north of westernmost dam (May 2012)

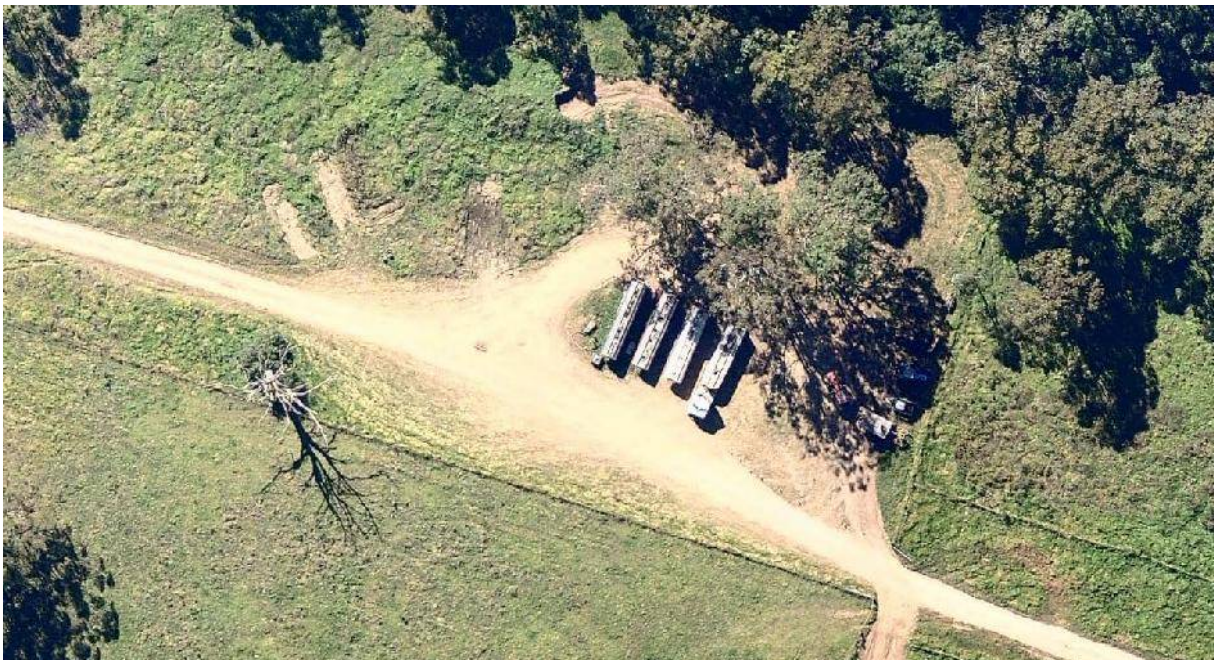
Figure C7: Lot 13 – Current stockpiling area located north of westernmost dam and north of laydown yard appears to have been utilised as a laydown yard and parking of large vehicles (possibly trucks) or shipping containers (2012)

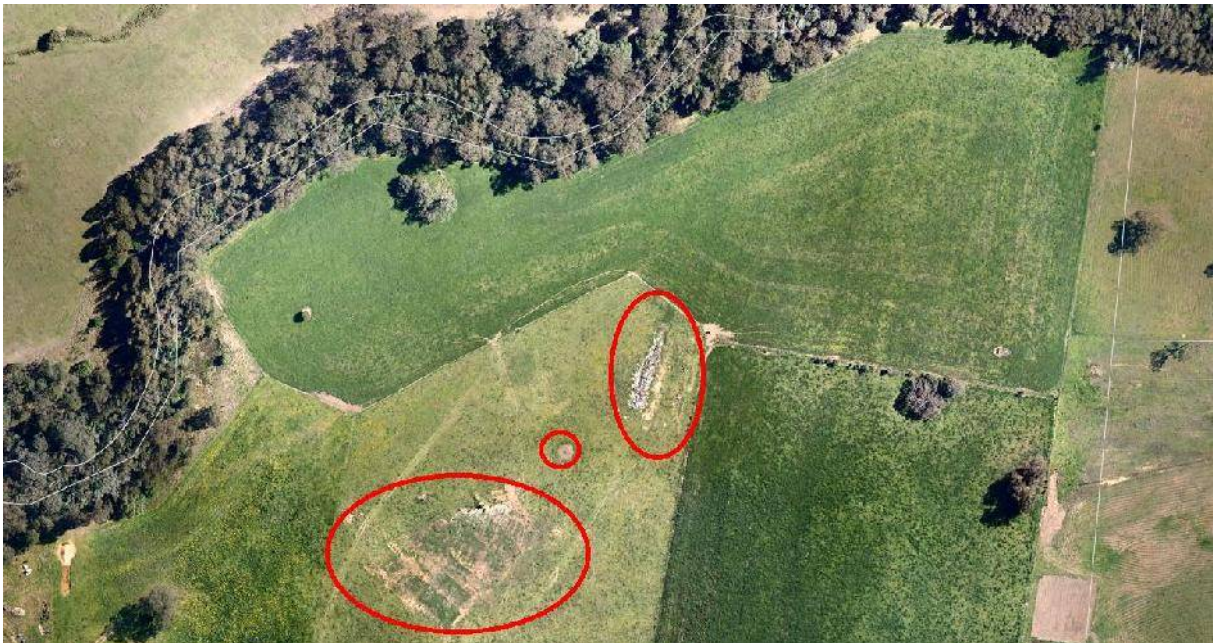
Figure C8: Lot 13 – Land scarring and stockpiling in the north eastern part of the lot (2012)

Lot	PAEC #	AEC #	Description	Associated COPC	Risk Rating	Recommended Further Investigation
13	54	15F	Land scarring and stockpiling in north eastern part of the lot	Metals, petroleum hydrocarbons, pesticides, PAHs, phenols and asbestos	Medium	Targeted soil sampling and analysis.
9 (separate ownership lots)	35	15G	Stockpiles	Metals, petroleum hydrocarbons, pesticides, PAHs, phenols and asbestos	Low	Site walkover. Targeted soil sampling and analysis, if required.
11 (separate ownership lots)	66	15H	Stockpiles	Metals, petroleum hydrocarbons, pesticides, PAHs, phenols and asbestos	Low	Stockpile soil sampling and analysis.

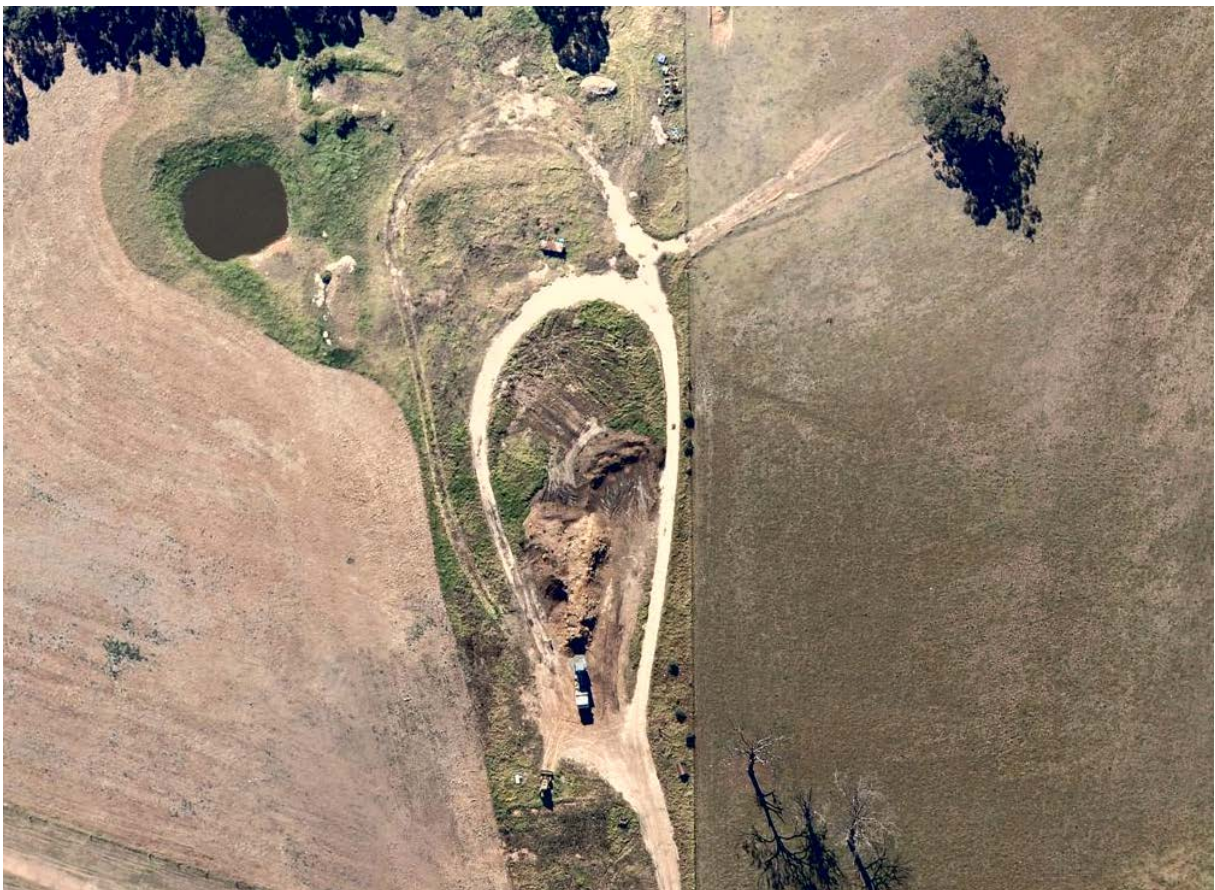
Figure C9: Lot 13 – Stockpiling and possible filling in the north eastern part of the lot (2012)

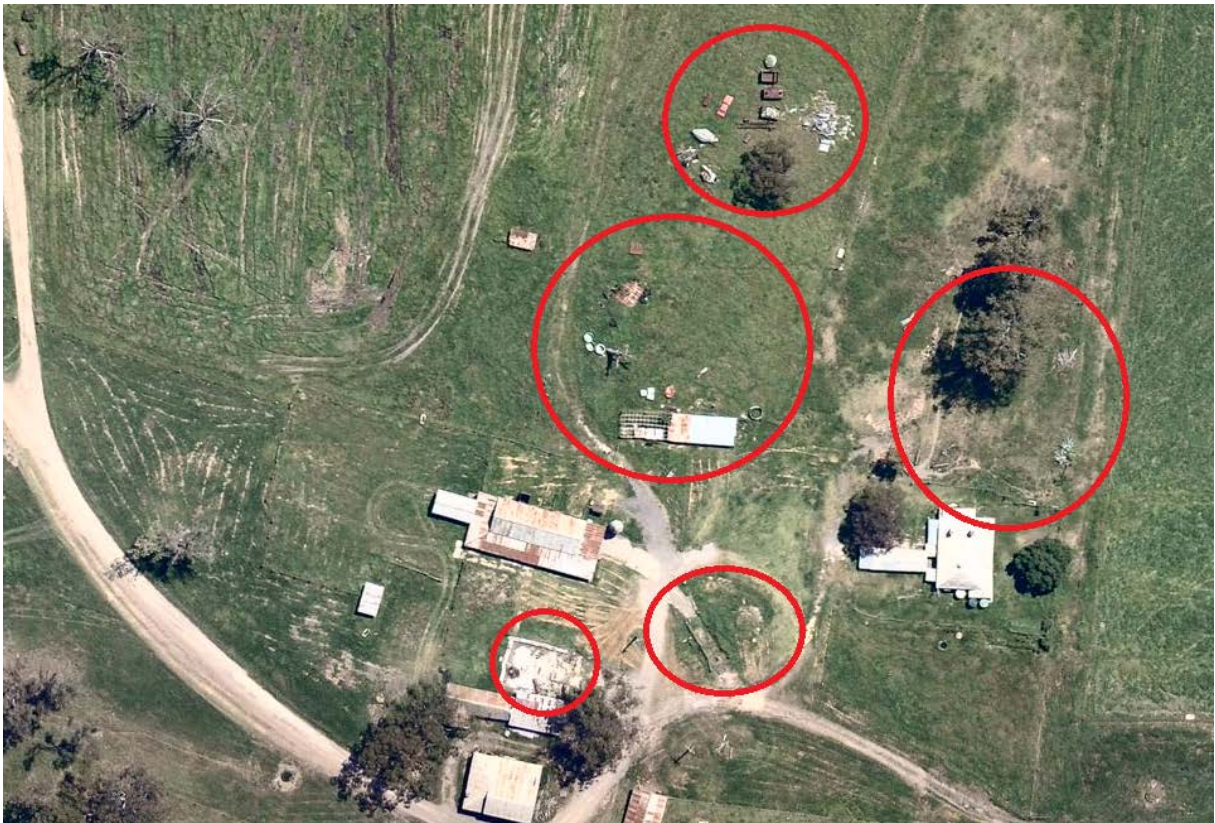
Figure C10: Lot 13 – Stockpiles and material laydown areas north of the farmstead area (present in aerials until 2012)

Lot	PAEC #	AEC #	Description	Associated COPC	Risk Rating	Recommended Further Investigation
13	47	21	Ground disturbance, laydown areas and stockpiles north of the farmstead	Metals, petroleum hydrocarbons, pesticides, PAHs, phenols and asbestos	Medium	Targeted soil sampling and analysis.
13	59	22	historical timber power lines are located throughout site	Metals, pesticides, petroleum hydrocarbons, PAHs, creosote and ammonia	Low	Targeted soil sampling and analysis.
Part 101	65	23	Barb wire stockpiles	Heavy metals	Low	Targeted soil sampling and analysis.

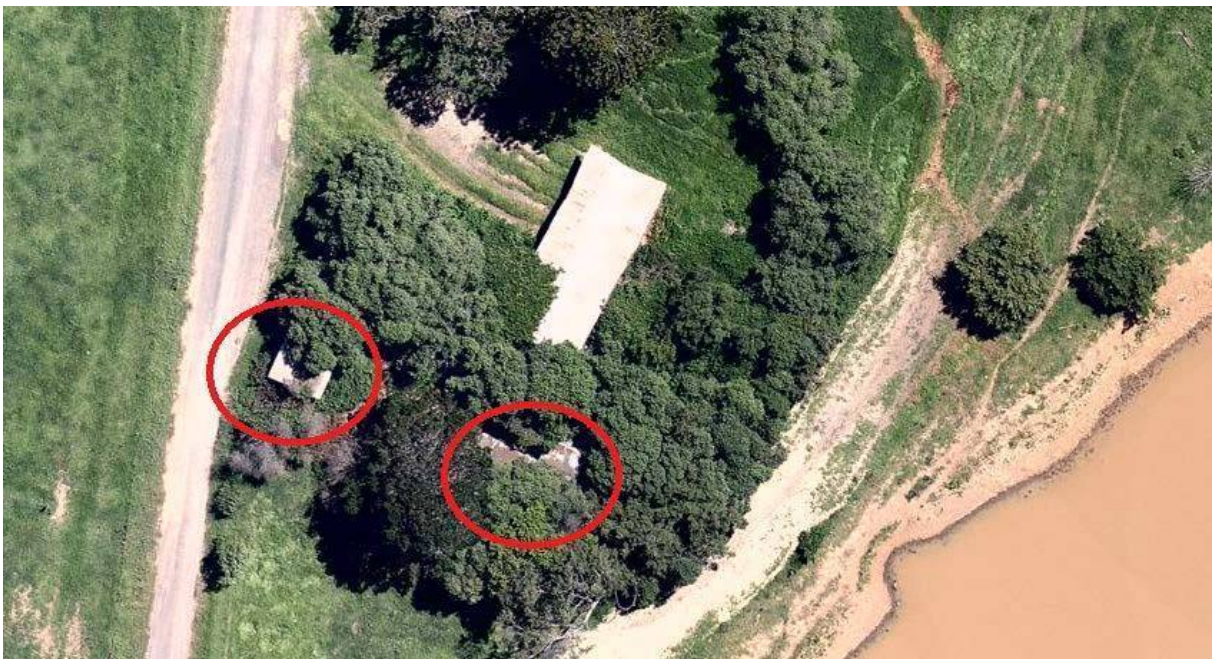
Figure C11: Small dam east of Lot 1 north, Lot 13 – Two structures (no longer present) located near the current dilapidated timber / metal shed (present until mid – late 2013)

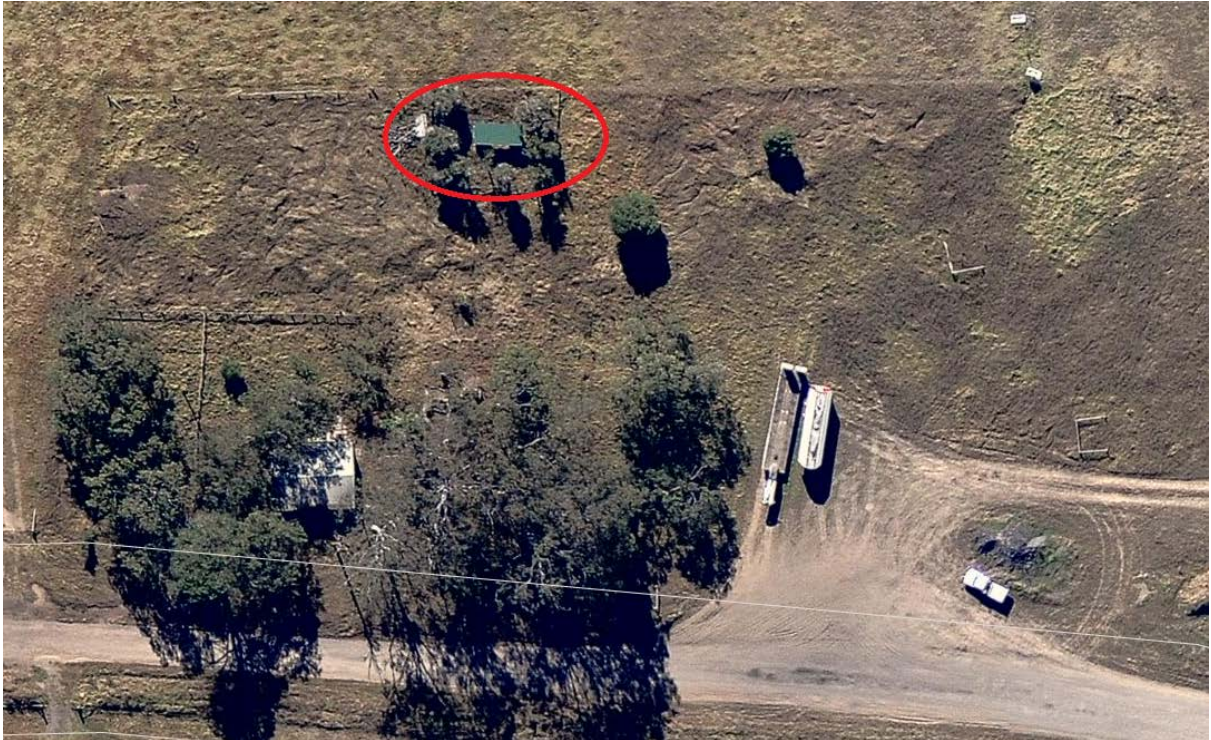
Figure C12: Access road through Lot 13 to Lot 1 north structure near former residential cottage – (present until 2010)

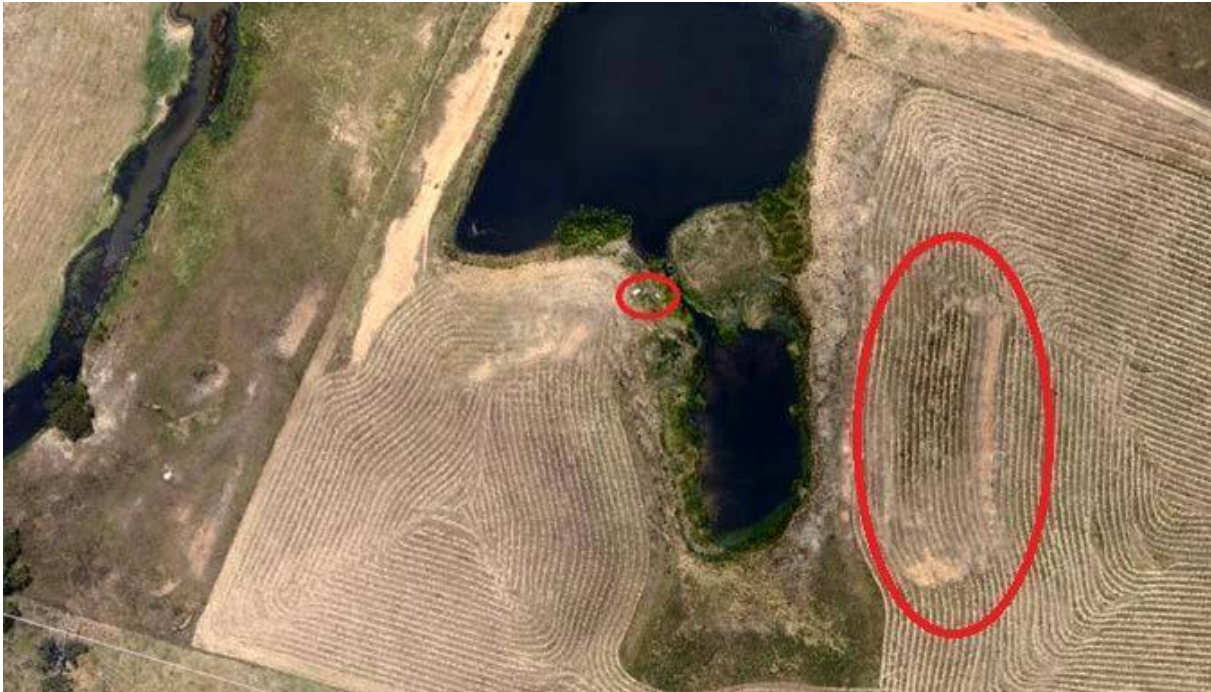
Figure C13: Lot 10 – Land scarring and small structure (now under dam water) located in dam next to creek in ploughed field (February 2011)

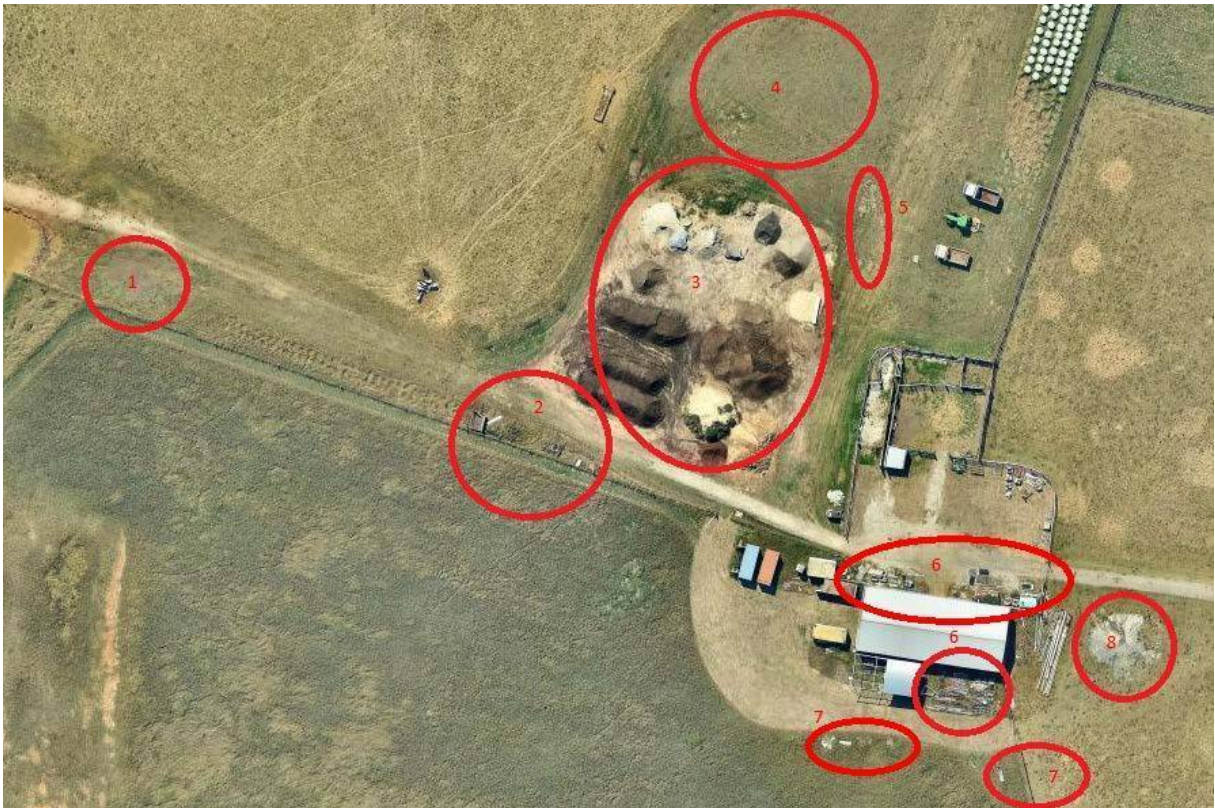
Figure C14: Lot 10 – Unknown features (#2, 4, 5 and 7), stockpiles (#3, 6 and 8) and land scarring (#1) surrounding large shed (October 2011)

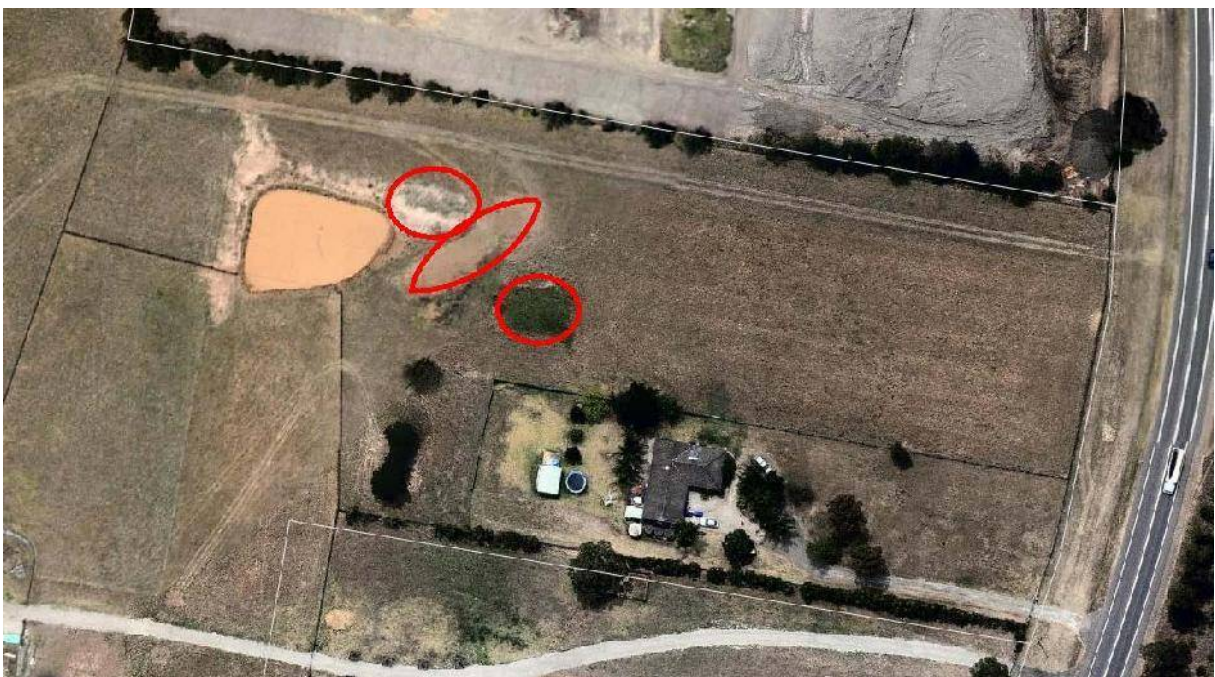
Figure C15: Lot 10 eastern part – Land scarring, stockpiles and general fill (all aerials)

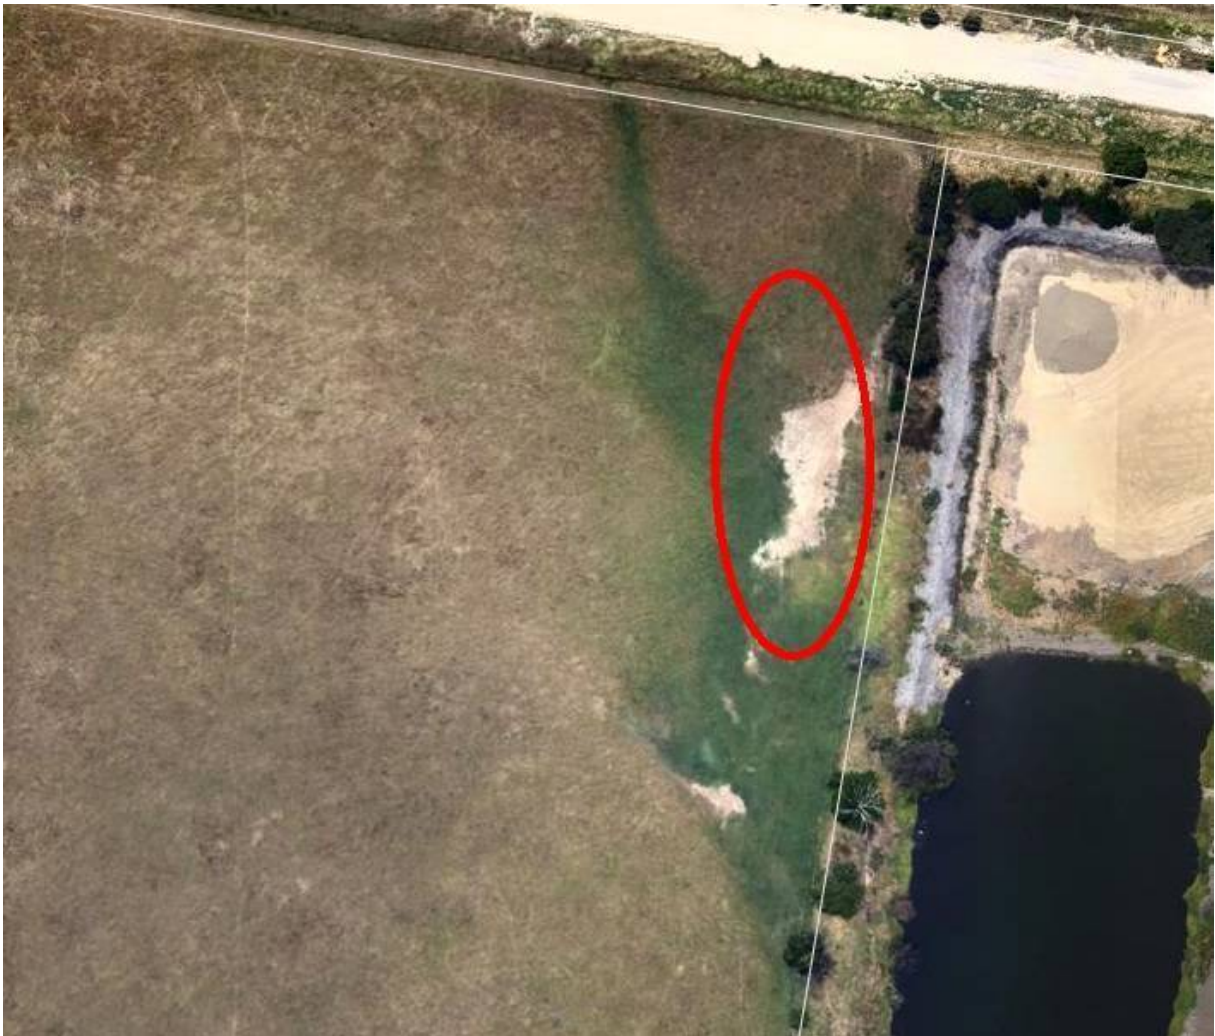
Figure C16: Lot 10 – Suspected washout / erosion of soils from near Lot 102 (February 2011)
