Our Ref: V160833GReport01.1

24 May 2016

## Review of Audit Site Former Sewerage Treatment Plant 405 Evans Road, Lyndhurst, Victoria

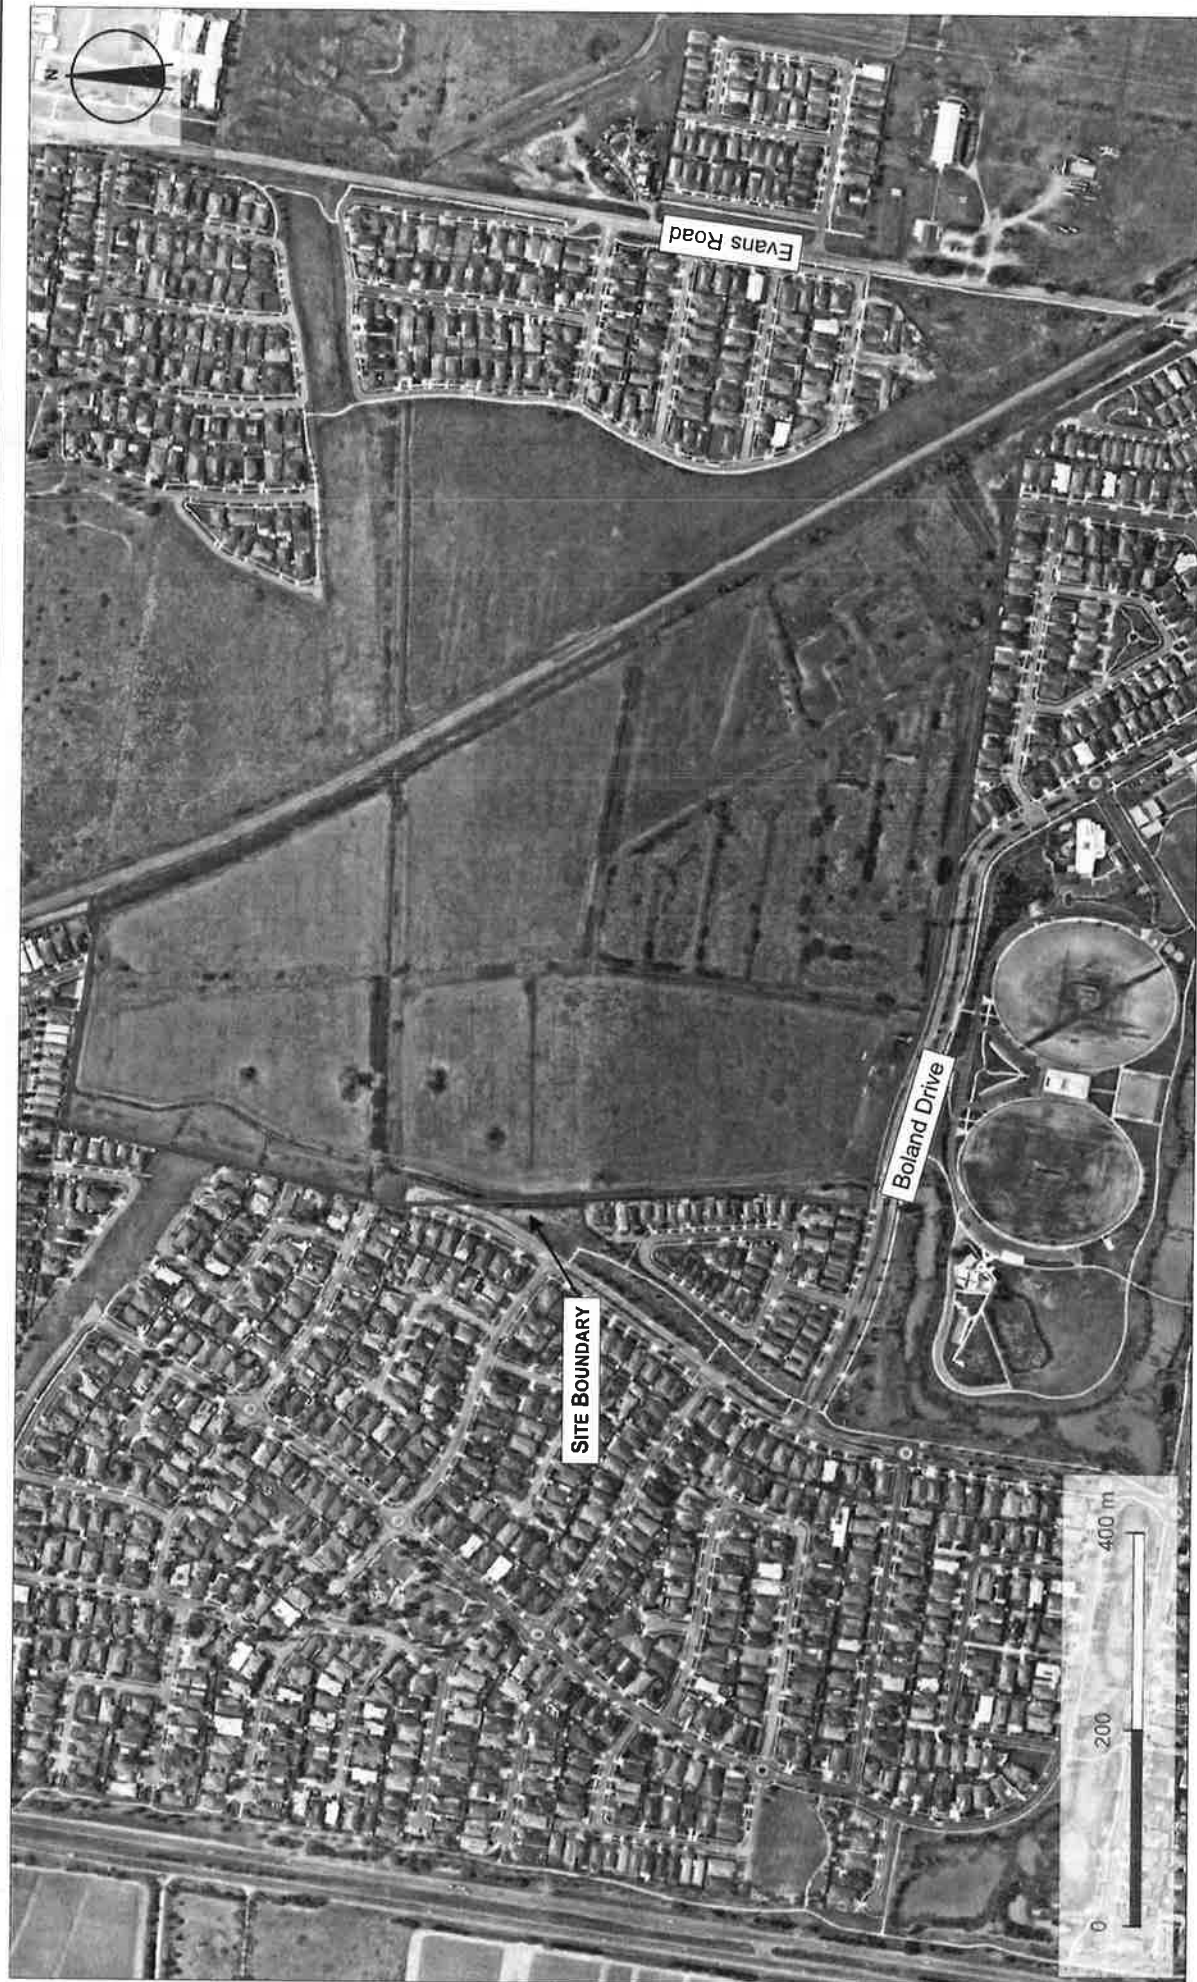
Figure 2: Site Aerial Photograph

The review indicated that there have been no significant changes to the site condition apart from the minor dumping of hard waste along the southern and south-eastern part of the site. It is also noted that there has been some development in the south-west of the site, to the immediate north of the footpath adjacent to Boland Drive. This is the probable location of temporary sales offices, and includes an area that is in the process of being levelled and 'decorated' with feature rocks.

It is noted that a large advertising board, measuring approximately 9 m x 3 m, lies face down a short distance to the north of the aforementioned site development. The board appears to have been discarded in this location since February 2010.

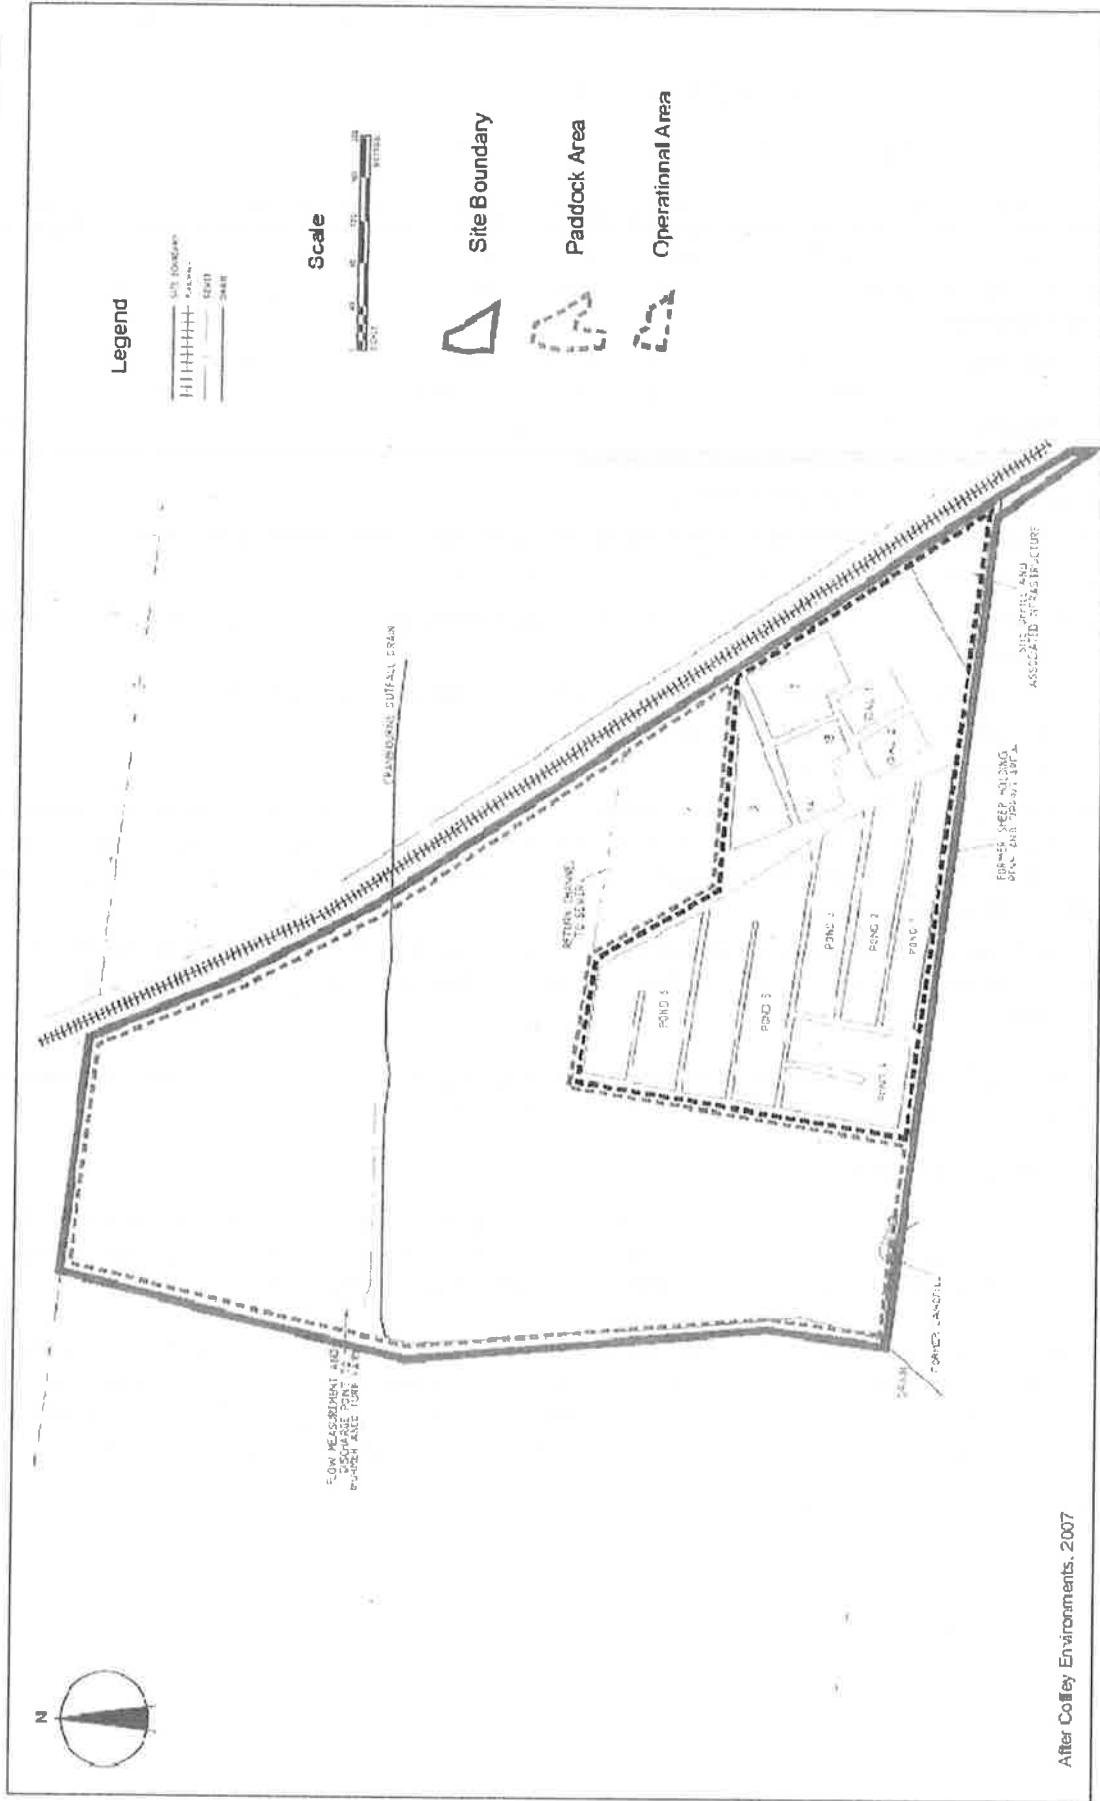
Figure A: Audit Site Plan

The site is located at the Former Cranbourne Sewage Treatment Plant, 405 Evans Road, Lyndhurst. The Audit site boundary is shown in Figure A, attached to the Executive Summary.
