DSL WASH PLANT REFURBISHMENT

DAMPIER, WA

MAINTENANCE - PROTECTIVE COATINGS

Rio Tinto Dampier Salt Limited Wash Plant Refurbishment

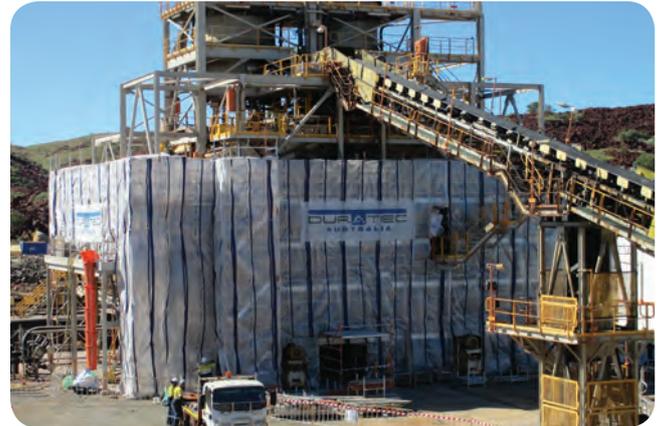
- ▶ Overview of the wash plant site with full encapsulation erected.
 - ▶ Two coats of epoxy was applied at 600 microns total dft.
 - ▶ Application of the first coat of Interzone 954 by airless spray.

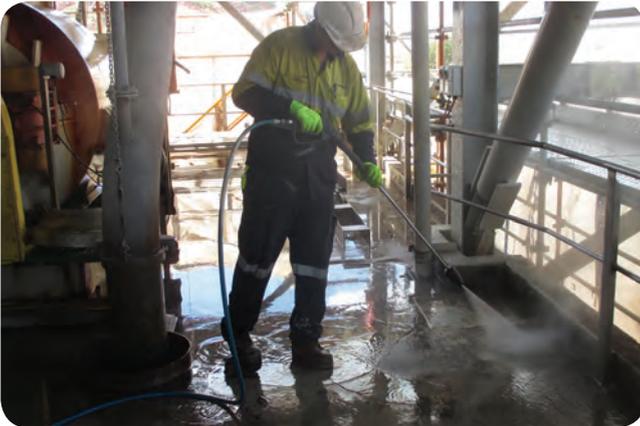
- ▶ High pressure water washing the concrete floors before repairs.
- ▶ Duratec specialists performing crack injection on one of the concrete floors of the structure.
- ▶ All nuts, bolts and difficult to access areas were first stripe coated with a brush.

The scope also included performing concrete repairs to three suspended concrete floors including crack injection, concrete repair and waterproofing.

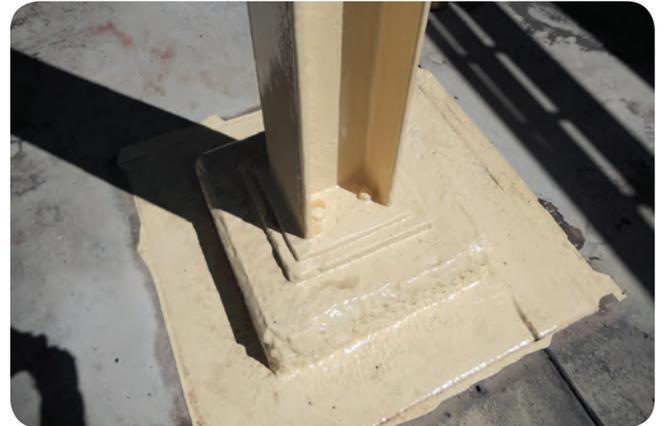
- ▶ Polibrid 705E was used to protect the footings.
- ▶ The coatings were extensively checked for the correct film thickness by Duratec's NACE 3 inspector.
- ▶ Wash Plant project at night.

- ▶ The structural column bases were protected using Polibrid 705E elastomeric urethane to completely encapsulate and protect the footings.
- ▶ The project was delivered with commendation from the client for our safety and quality performance.
- ▶ Two separate coats of different colours (assisting in uniform application) of Interzone 954 was applied.
