SEA WATER SCHEME CORROSION REPAIRS

KARRATHA, WA

MAINTENANCE - PROTECTIVE COATINGS

Water Corporation Burrup Sea Water Scheme Corrosion Repairs

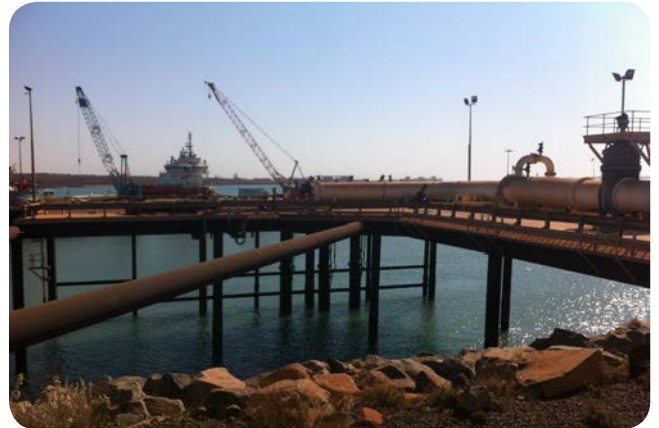
- ▶ Jetty overview.
- ▶ Corrosion beneath deck.
- ▶ Headstock damage.

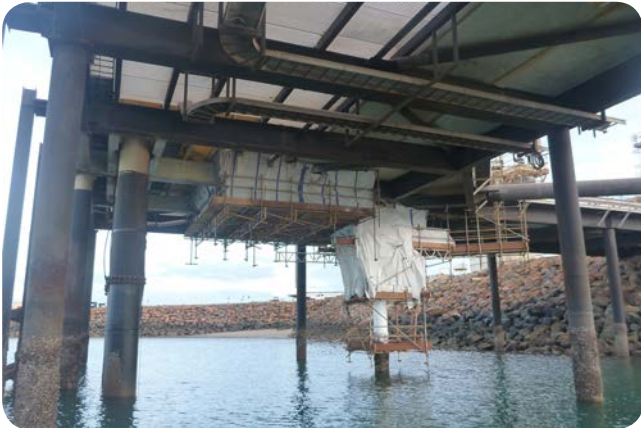
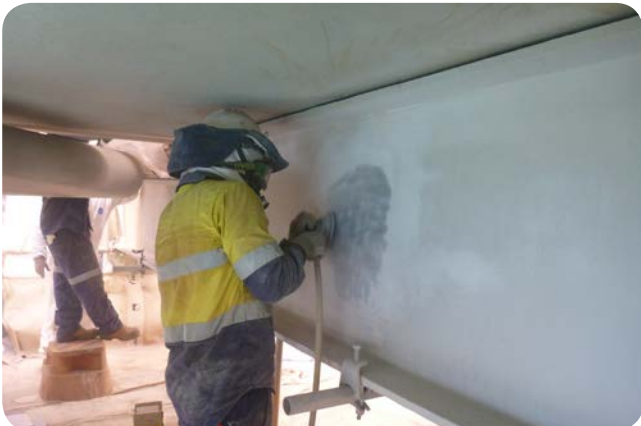
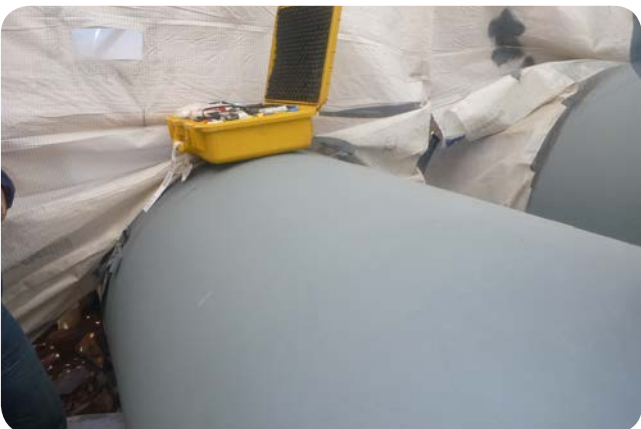
- ▶ Scaffold set up around pile and headstock.
- ▶ Surface preparation of headstock.
- ▶ Dual pipe surface protection.

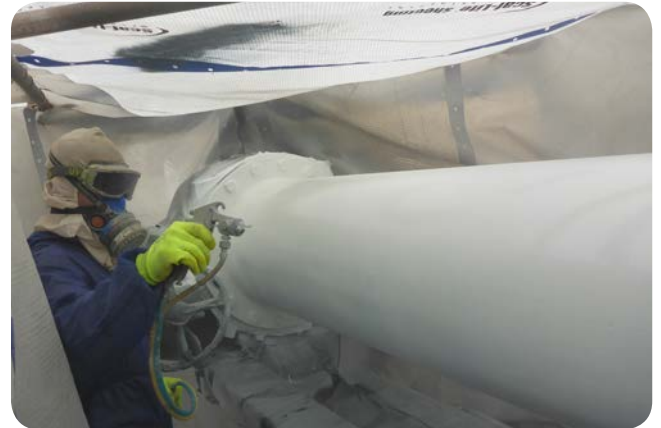
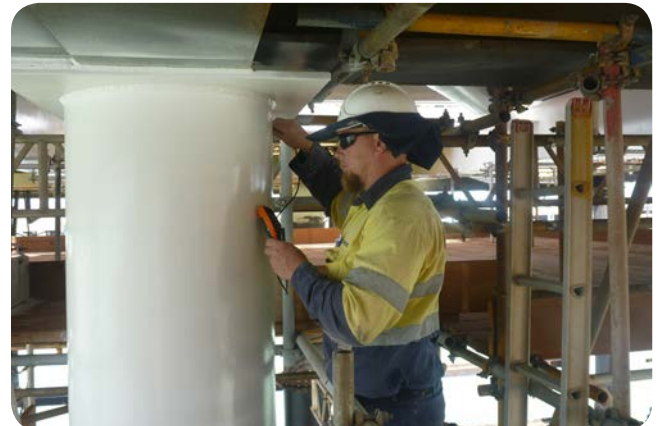
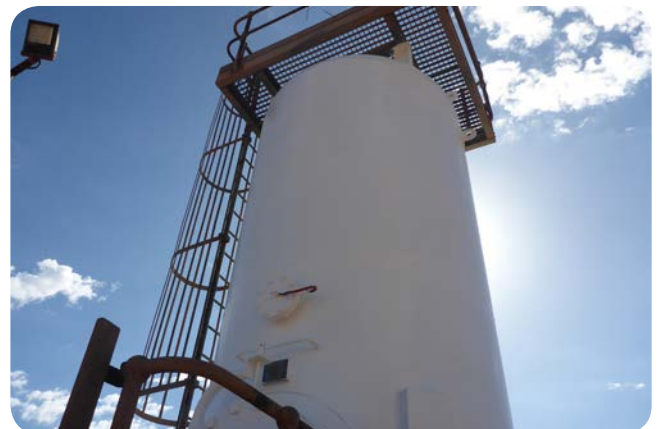
- ▶ Coating in progress.
- ▶ DFT checks to jetty pipe.
- ▶ Completed coatings to microfiltration tank.

- ▶ A three-coat protective coating system was applied including zinc-rich primer, high build epoxy and polyurethane topcoat.
- ▶ PVC backed bitumen tape was installed in nominated areas as per the scope of works to provide extra protection.
- ▶ Duratec worked closely with Water Corporations QA representative on site in order to complete all necessary quality checks and sign offs for each area.
