HORSE SHOE BRIDGE RESTORATION

PERTH, WA

MAINTENANCE - HERITAGE STRUCTURES

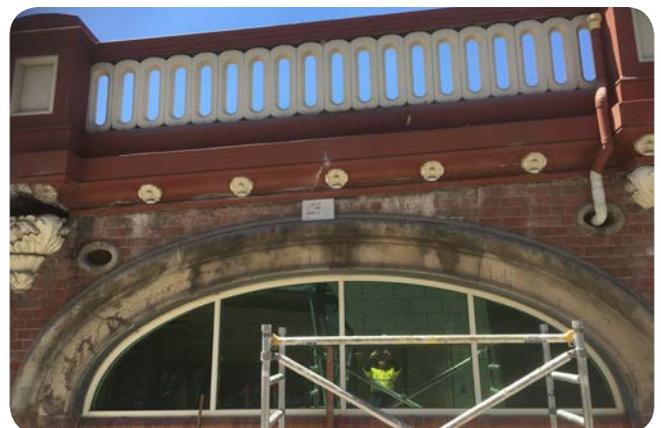
- ▶ Overview of the bridge.
- ▶ Overview of the bridge.
- ▶ Prior condition of one of the arches.

- ▶ Corbel and rosette replacement.
- ▶ Abutment padstone repairs.
- ▶ Replacement of ventilation surrounds.
- ▶ Arch steel strengthening.
- ▶ Plaster and render crack repair.
- ▶ Repair delaminated/spalled render and coke breeze concrete.
- ▶ Removal of staining to facade.
- ▶ Reinstatement of loose brickwork.
- ▶ Re-pointing of mortar joints.
- ▶ Masonry wall reconstruction.
- ▶ Repairs to existing columns and bases.

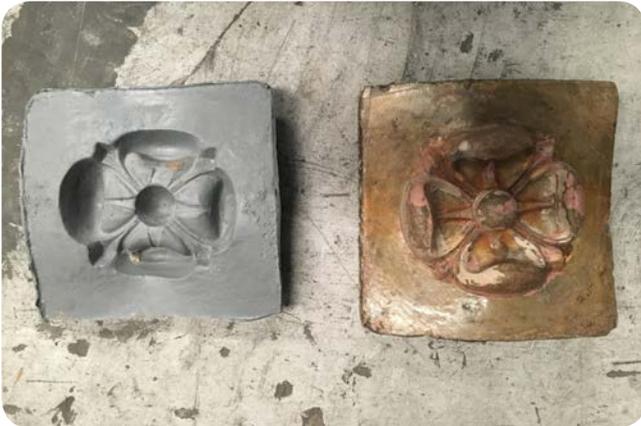
- ▶ Rosette moulds made using polyurea.
- ▶ Installation of new rosettes.
- ▶ Corbel moulds made using polyurea.

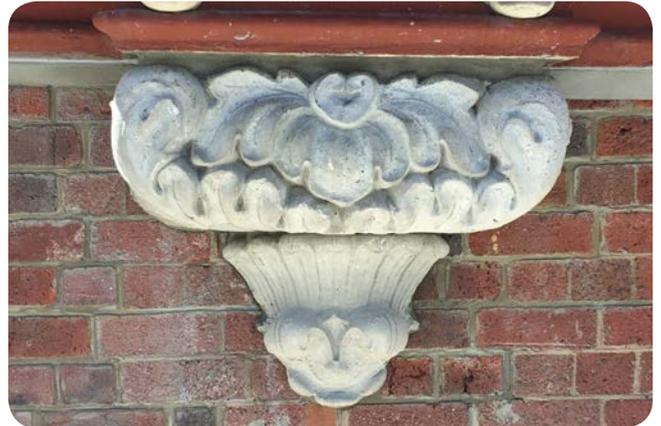
- ▶ New corbel after installation.
- ▶ Arch steel strengthening works.
- ▶ Completed corbel and wall reconstruction works.
