BORDERTOWN BLOCK 2 STEEL BIN PAINTING

ADELAIDE, SA

MAINTENANCE - BLAST & PAINT

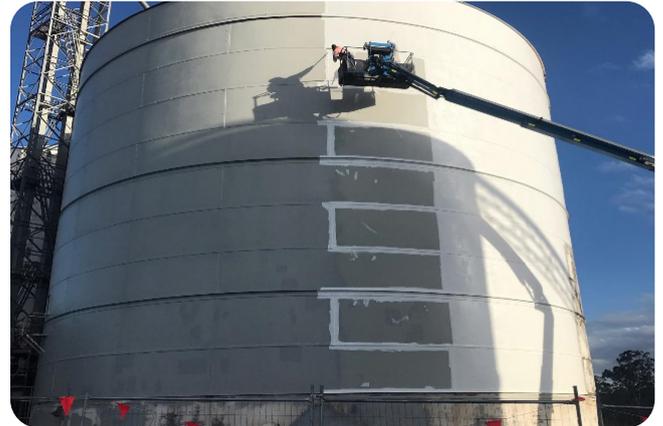
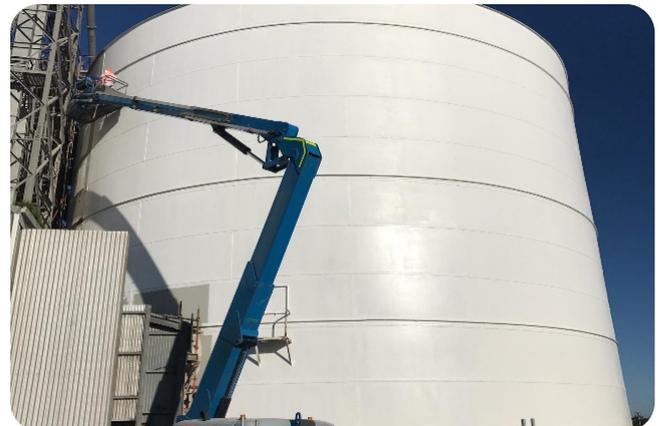
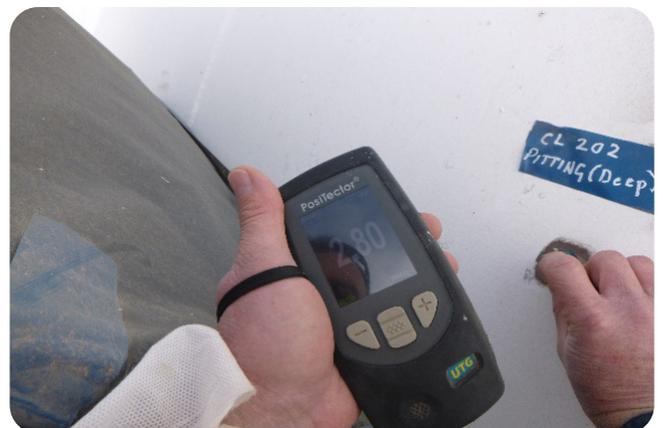
- ▶ Stripe coating of the walls using EWP access.
 - ▶ Top coat being completed via EWP.
 - ▶ Undertaking metal loss testing.

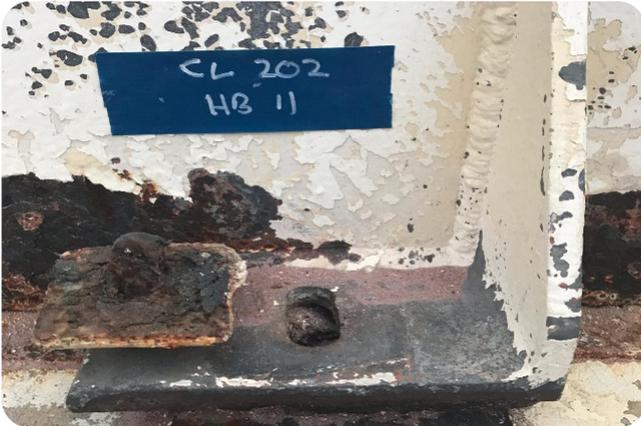
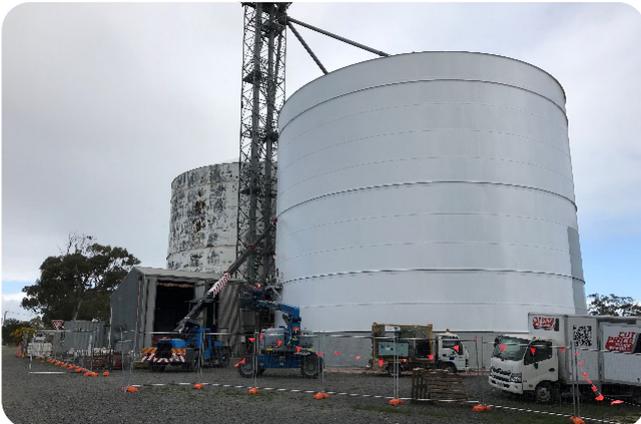
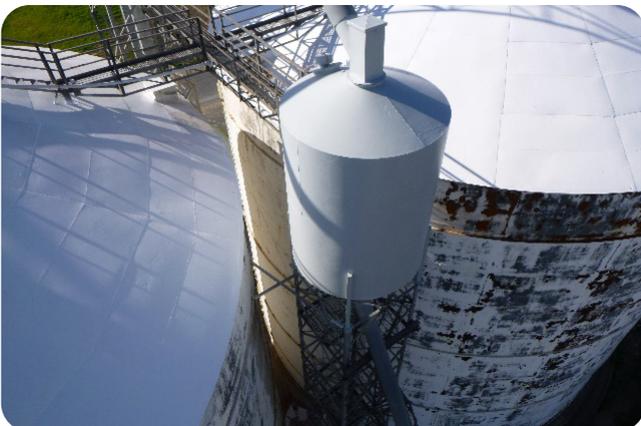
- ▶ Condition of hold down bolts prior to repair works.
- ▶ Installation of new platforms to the access hatches.
- ▶ Roof and garner bin coatings completed.

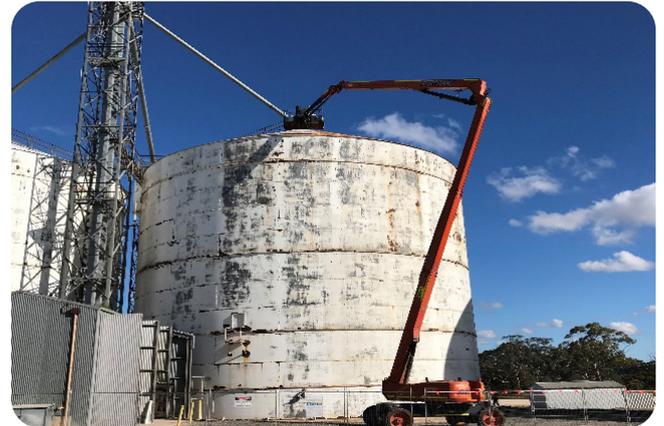
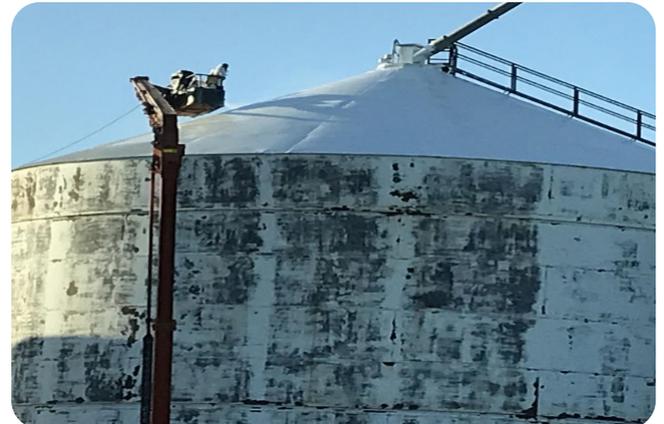
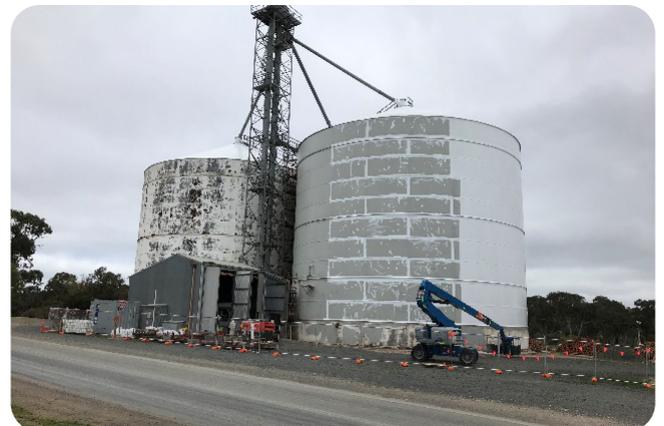
- ▶ Abrasive blasting of the silo roof.
- ▶ Protective coating applied to the roof.
- ▶ Protective coatings being applied to the silo walls.
