# GOODMAN GROUP CARTER STREET PRECINCT, HOMEBUSH, NSW

Land Capability Assessment  
Our ref: 00037445.01

**Subject: Carter Street Precinct, Homebush, NSW**

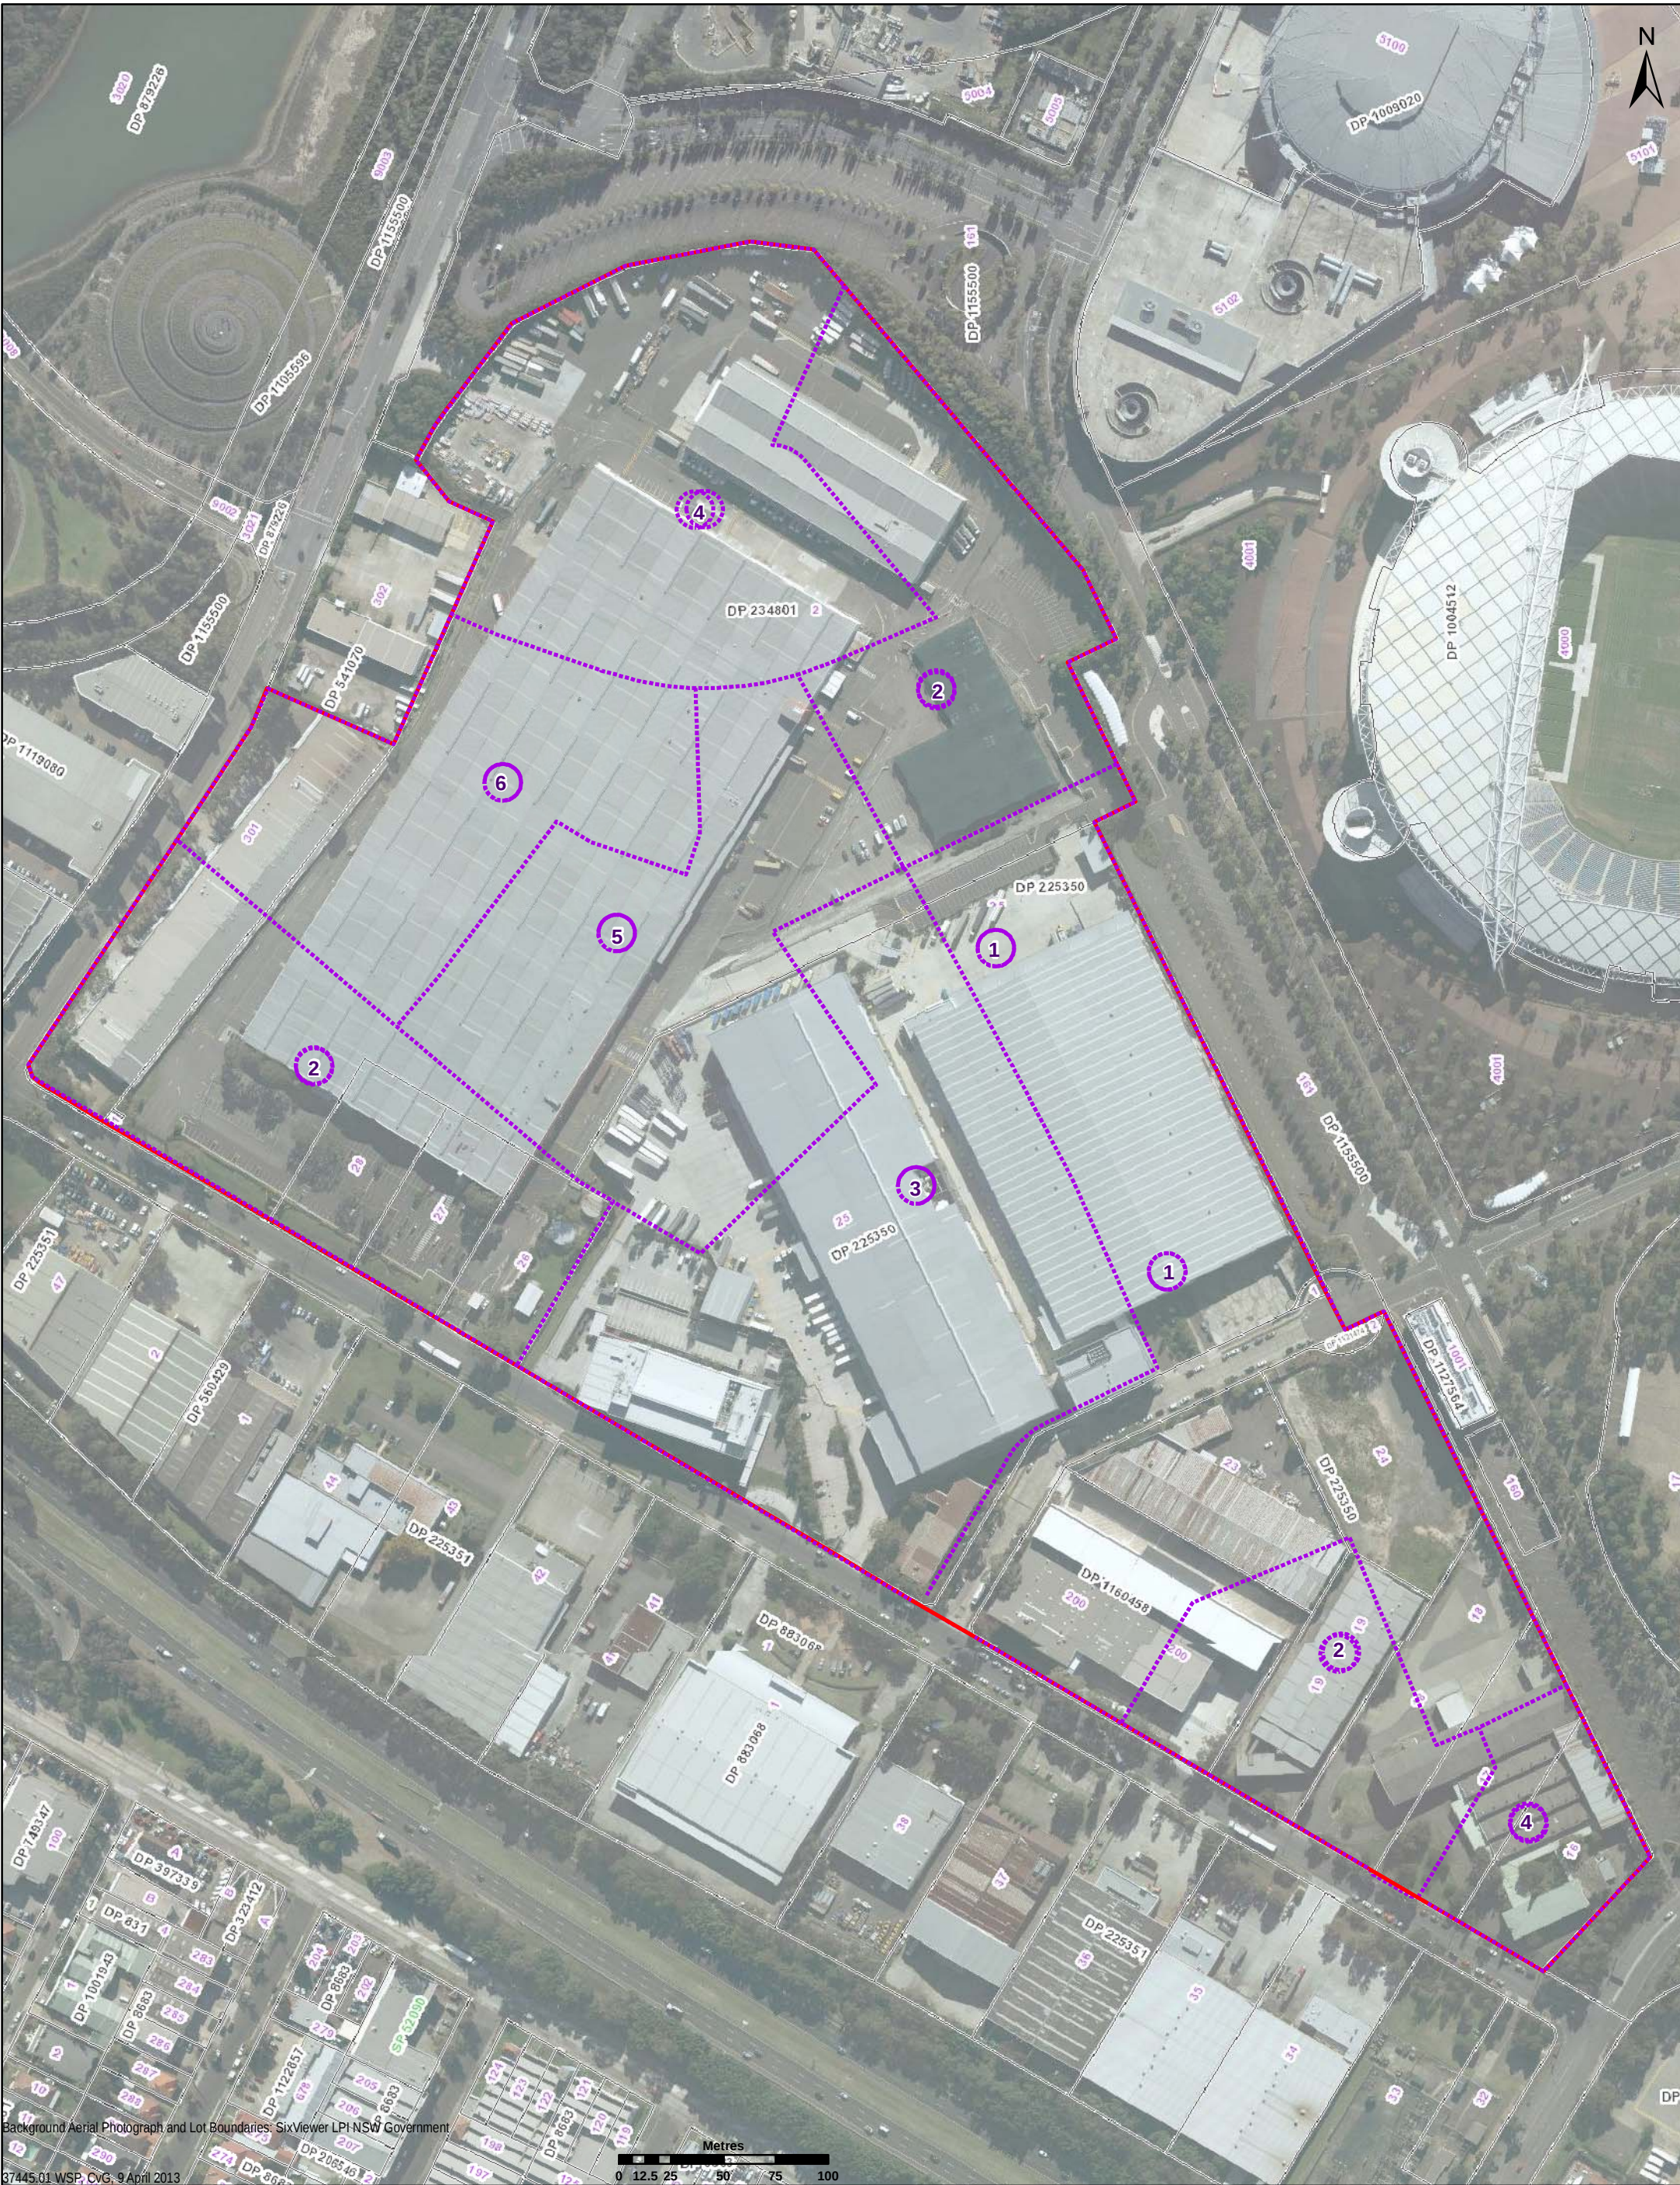
Site Administrative Boundaries  
Land Capability Assessment  
Carter Street Precinct - Homebush, NSW  
**Figure 1**

Background Aerial Photograph and Lot Boundaries: SixViewer LPI NSW Government  
87445.01 WSP, C.V.G. 9 April 2013

- Legend**
- Site Boundary
  - Stage Boundaries
  - Cadastre Lot Boundaries

Based on information provided in a letter prepared by AT&L Civil Engineers & Project Managers (AT&L) dated 8 February 2013, WSP understand that the proposed Carter Street Precinct, Homebush Masterplan will include the following six stages (see Figure 1 in **Attachment 1**):

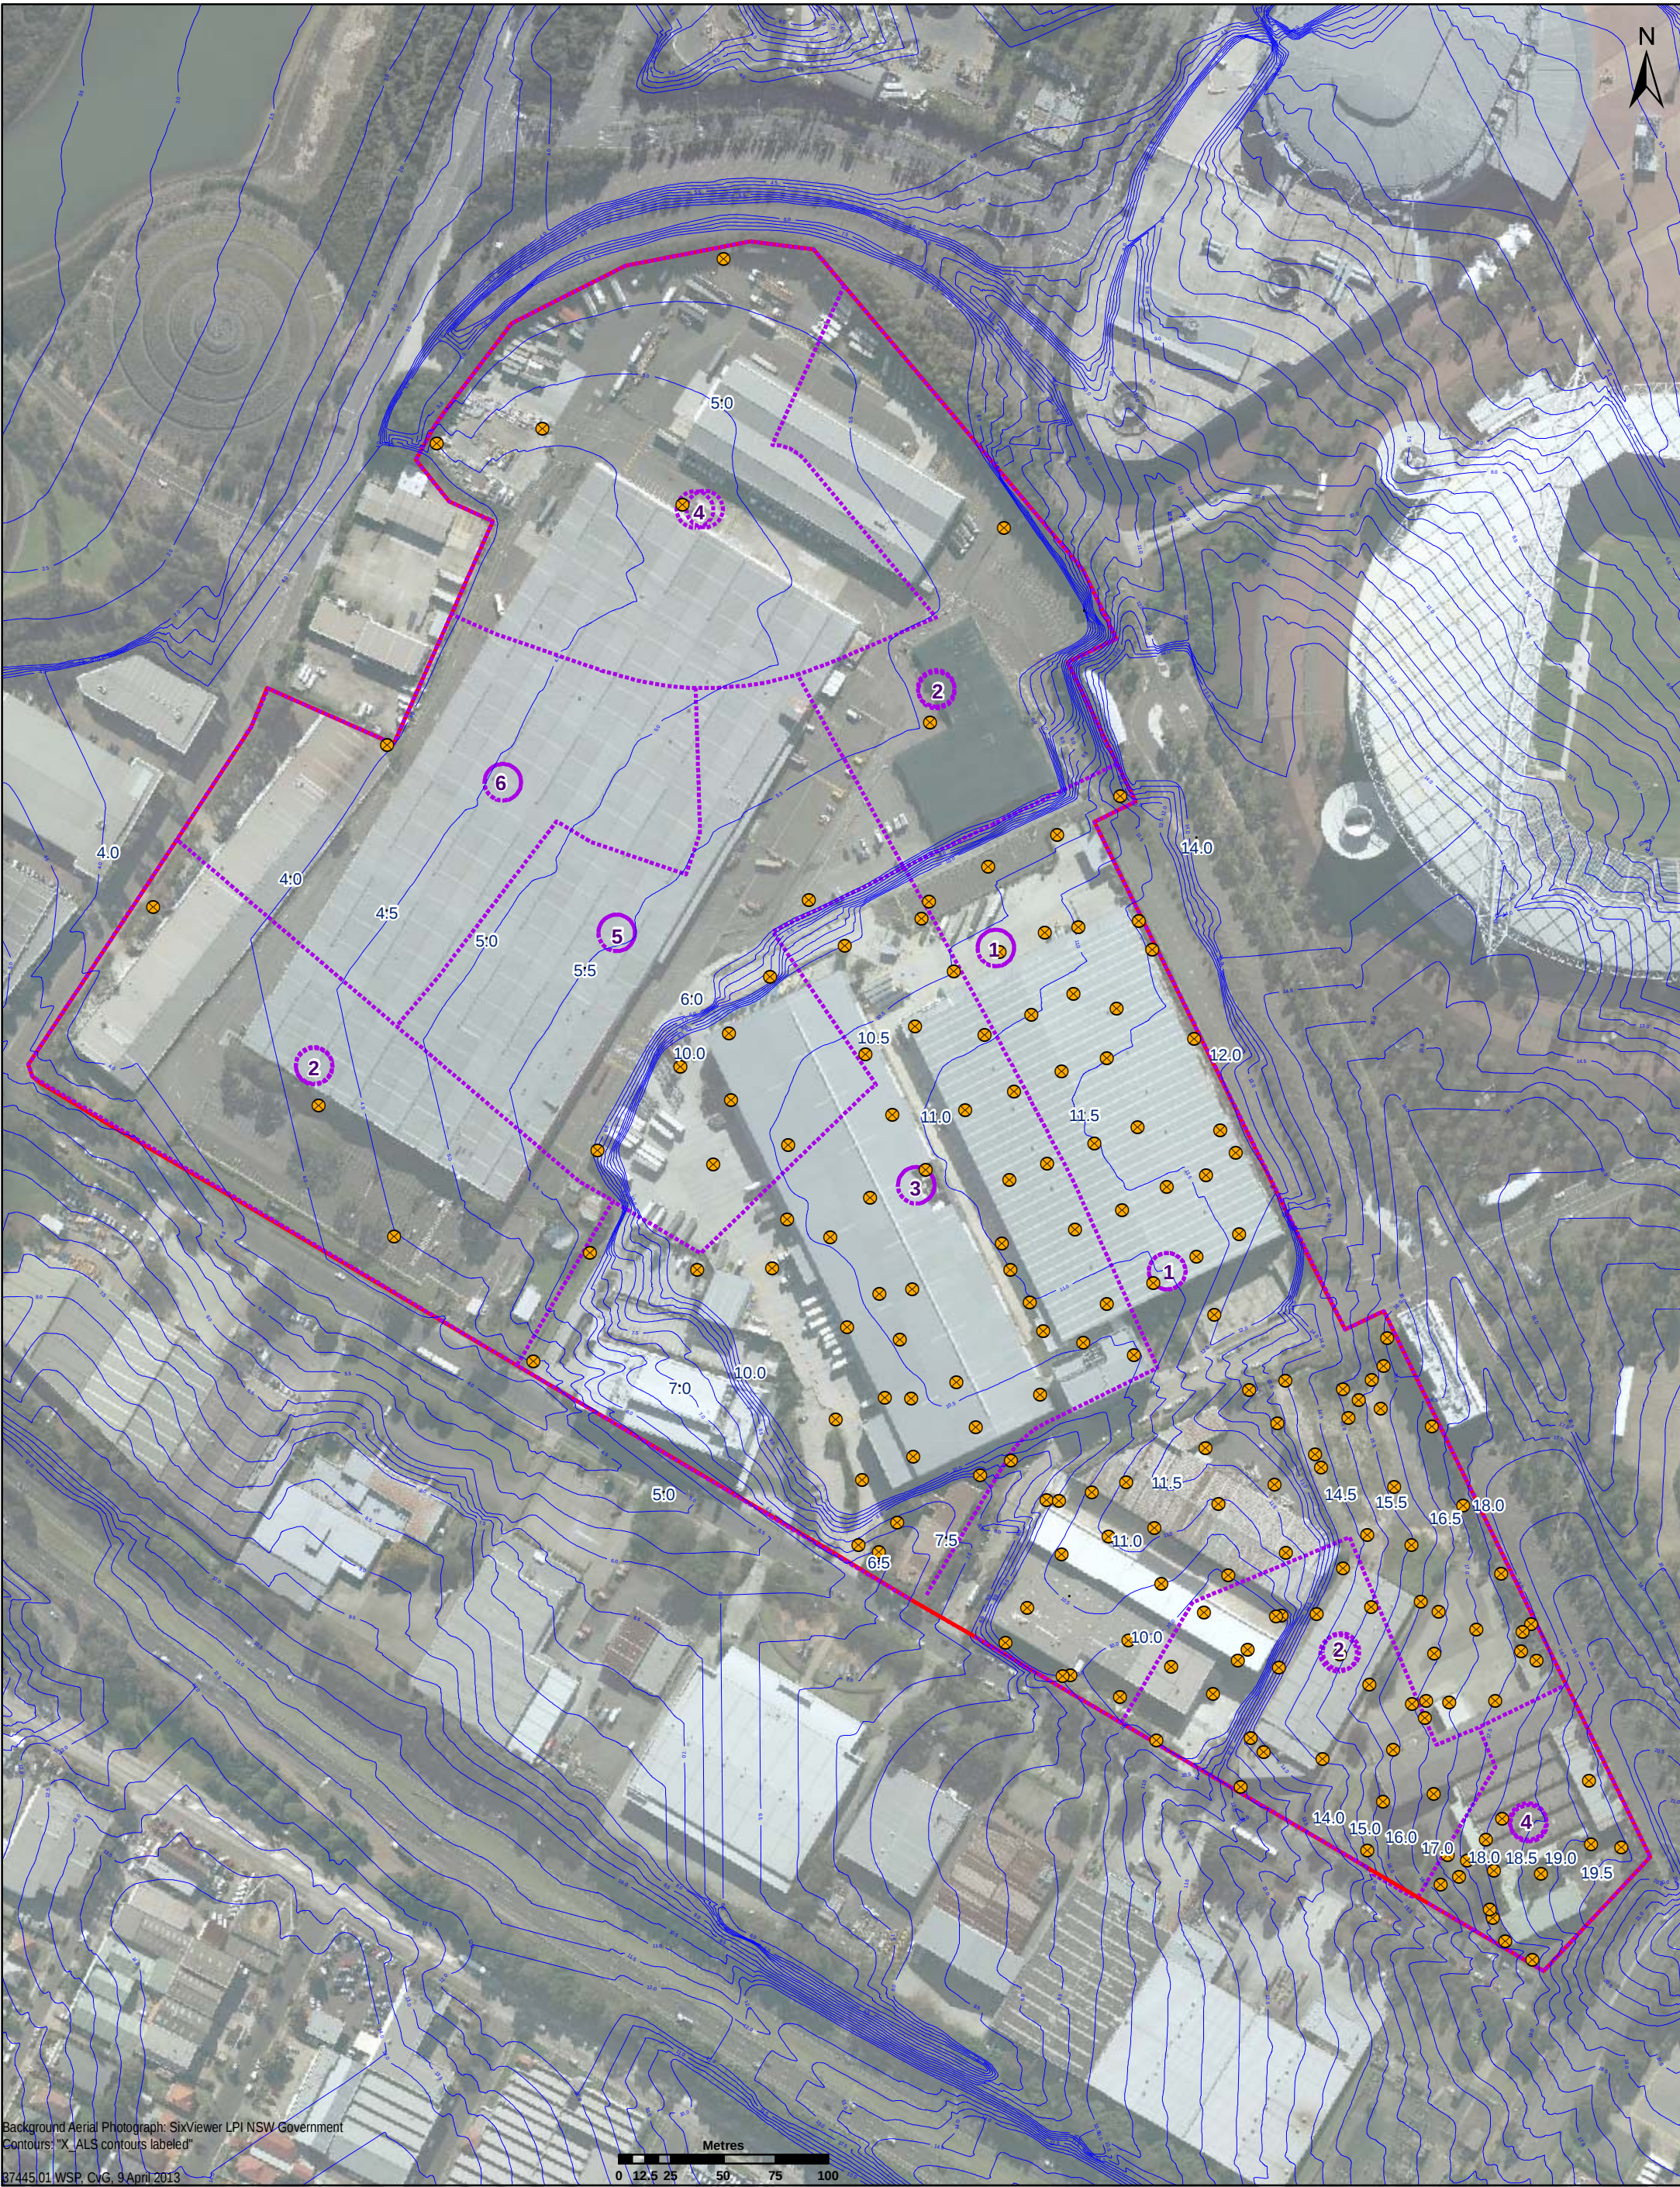
- Figure 1 in **Attachment 1** summarises the Lot and DP’s for the site and delineates the proposed development stage boundaries discussed in Section 1 above.

The Carter Street Precinct covers a total of 27 hectares which is bounded by Carter Street to the south, Hill Road to the west; the Transpacific Liquid Waste treatment facility to the north and Sydney Olympic Park on the eastern boundary (see Figure 1 in **Attachment 1** for allotment details)

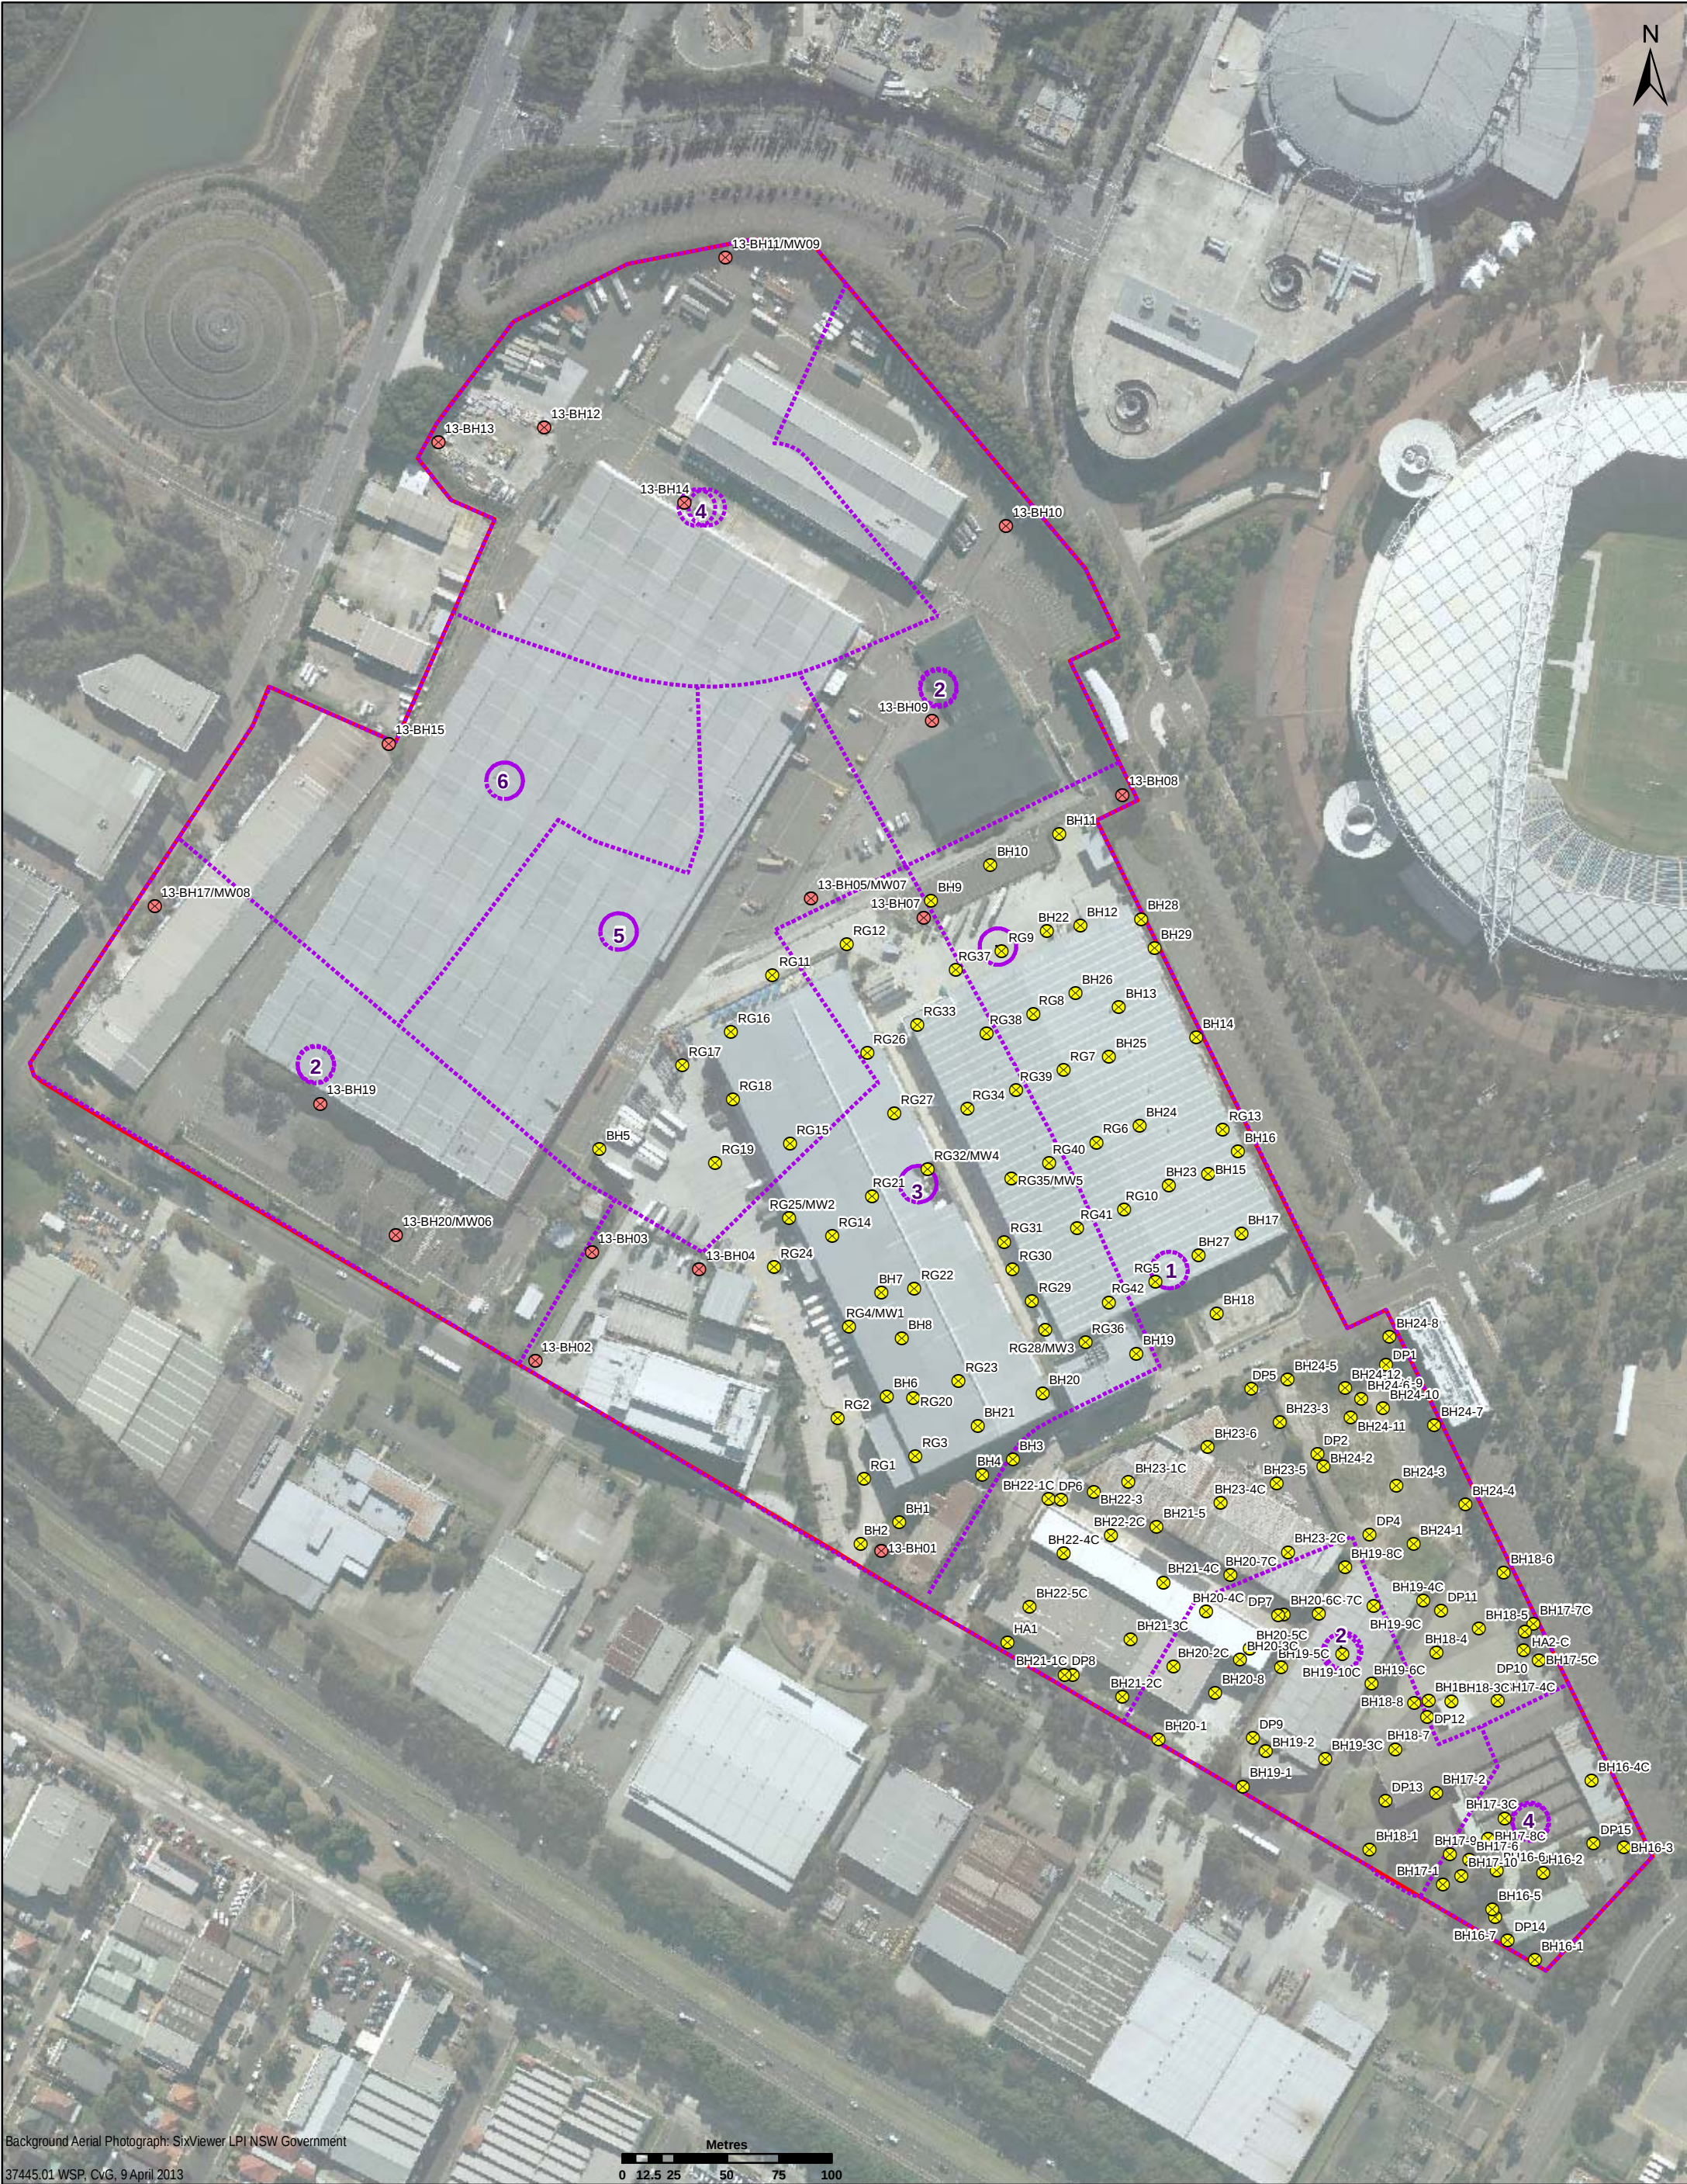
- Figure 4 in **Attachment 1** presents the geology as depicted on the available mapping for the site. The north western quarter of the site is underlain by Quaternary Sediments and then in turn by Ashfield Shale. The remainder of the site is underlain by Ashfield Shale.

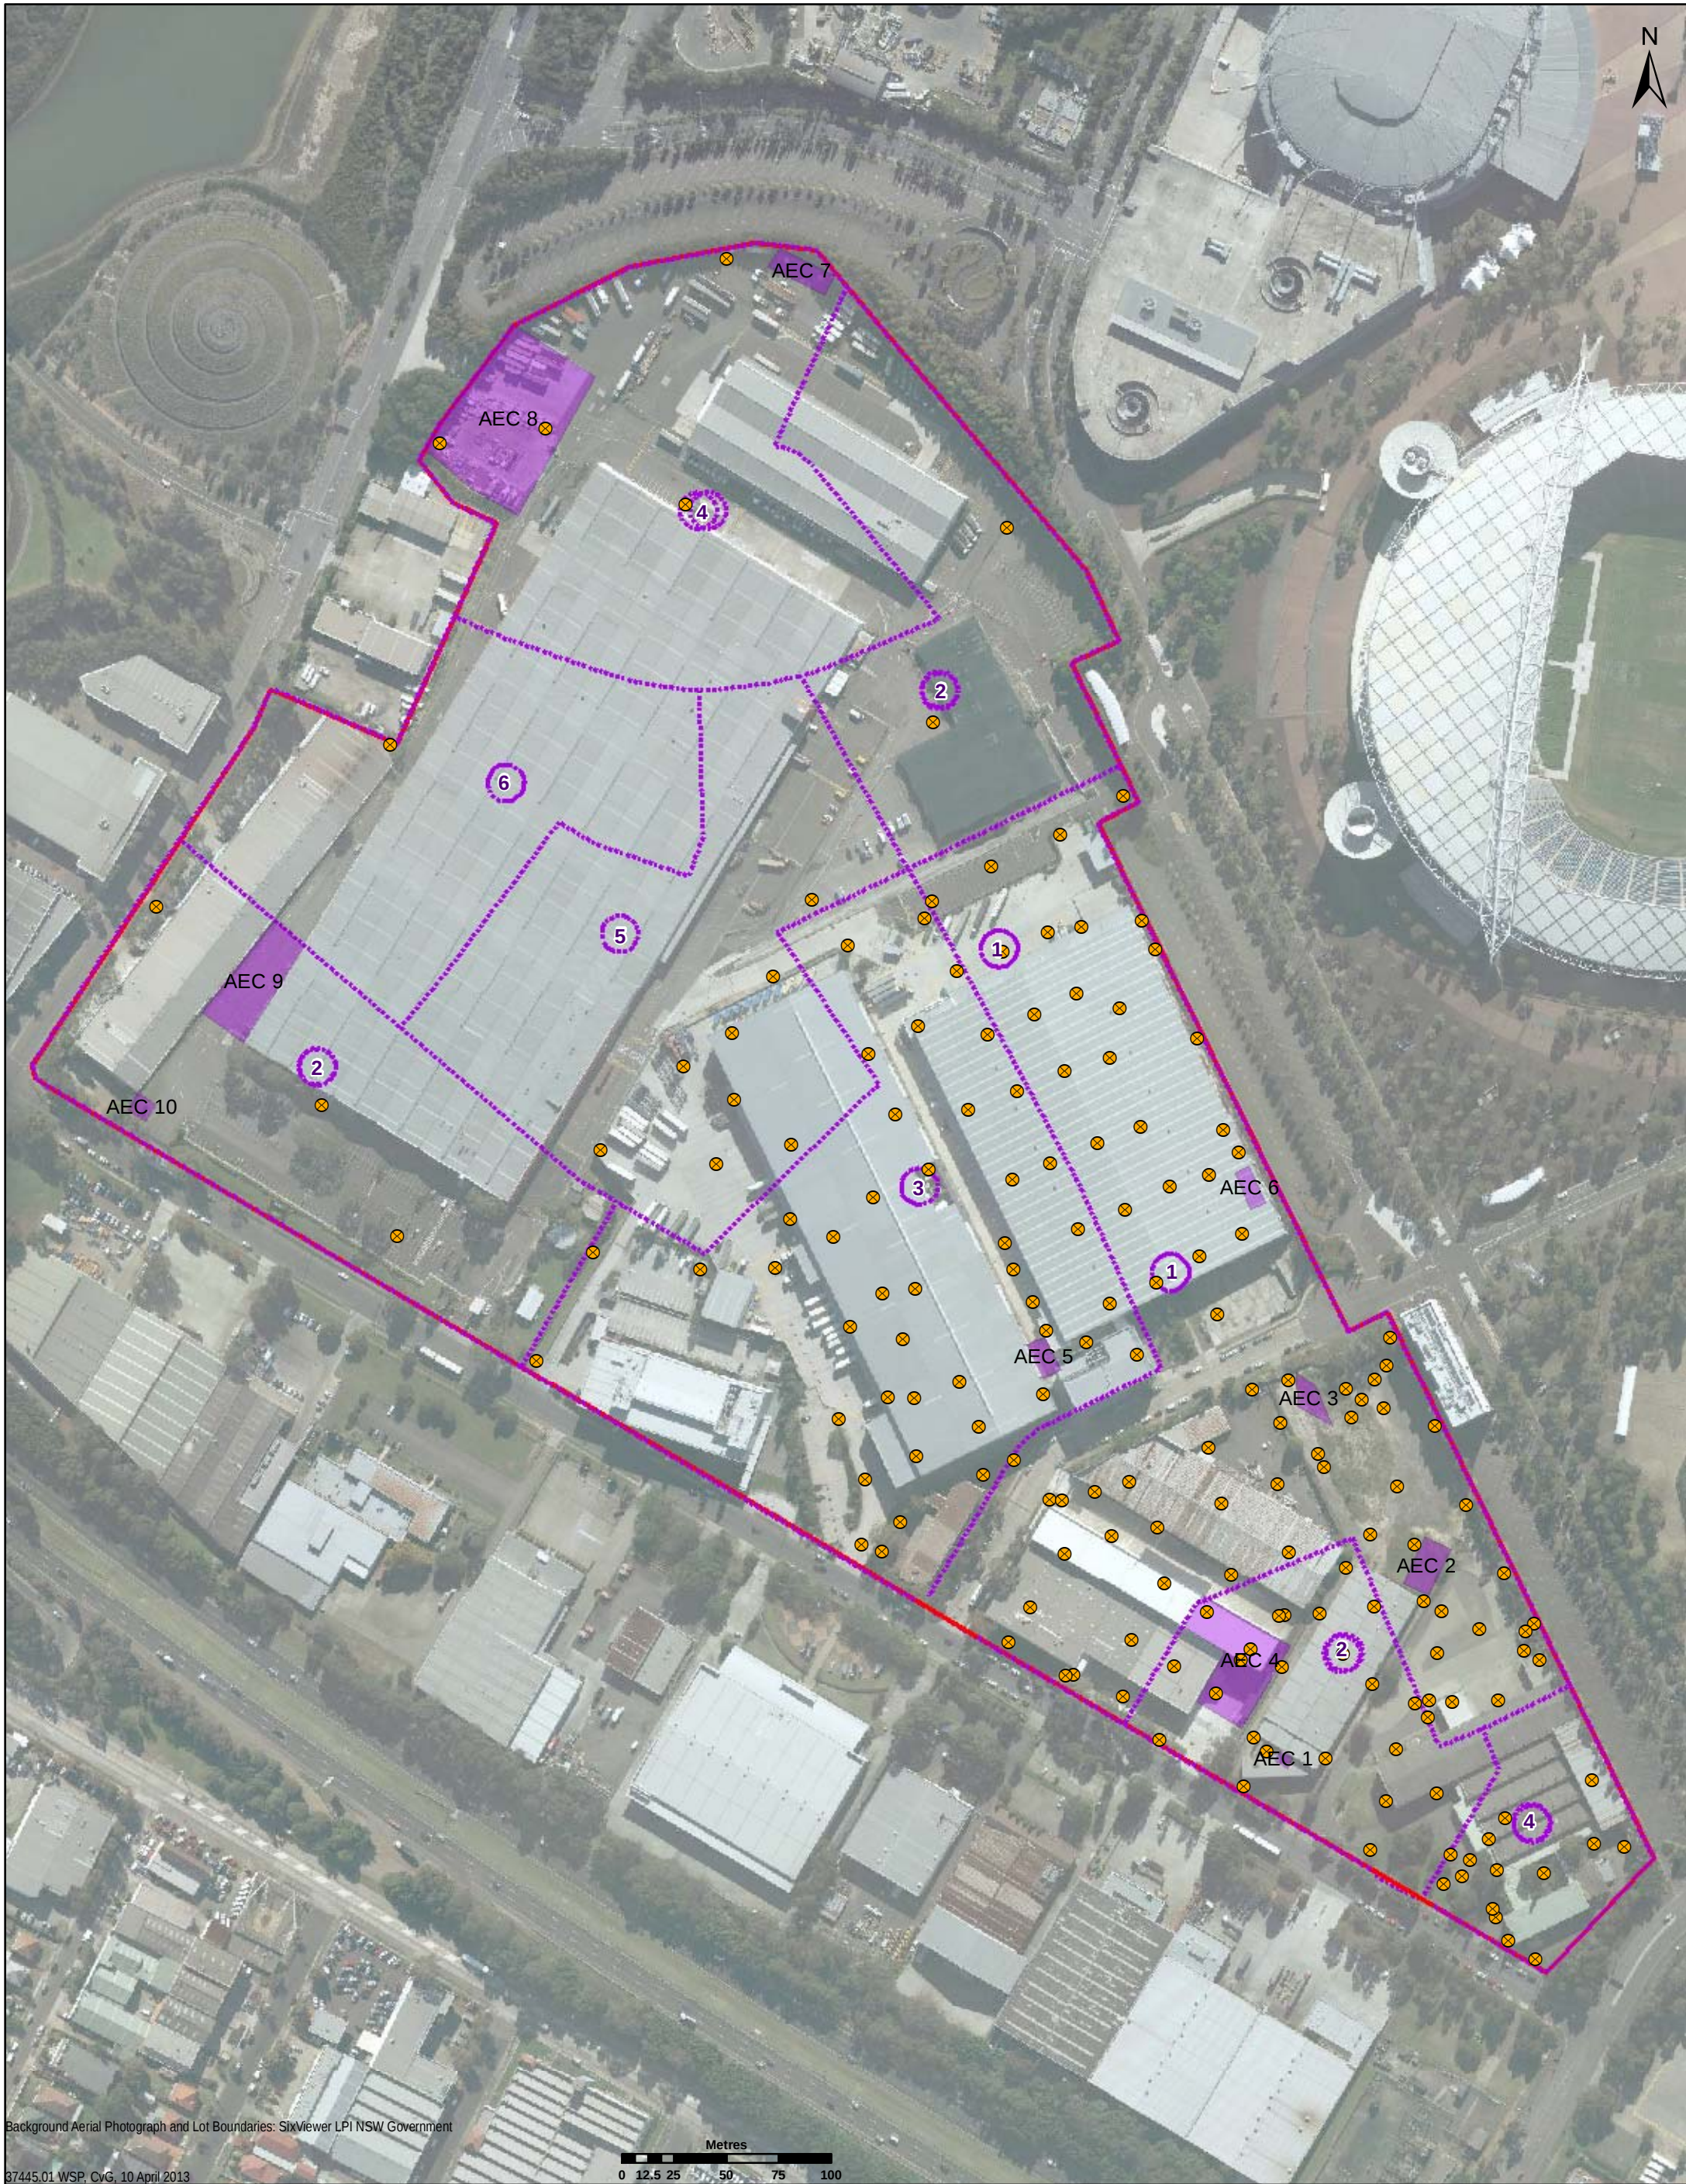
- Figure 8 in **Attachment 1** presents standing water levels in mbgl and estimated mAHD for discrete sampling events.
- Figure 9 in **Attachment 1** presents Areas of Potential Environmental Concern (AEC) that were identified during the review of historical reports. From a strategic perspective, it appears that the AEC have been appropriately targeted. Please note that the detailed environmental testing results have not been presented as these soils will be removed during basement excavation (see **Attachments 3 and 4**). During such works, care should be taken in the AEC areas to ensure that they are appropriately delineated and understood prior to off site disposal.

- Groundwater wells were installed in BH5 (MW07), BH9 (MW08), BH11 (MW09) and BH20 (MW06). The locations are shown on Figure 8 in **Attachment 1** and the installation details are shown on borehole logs presented in **Attachment 3**.

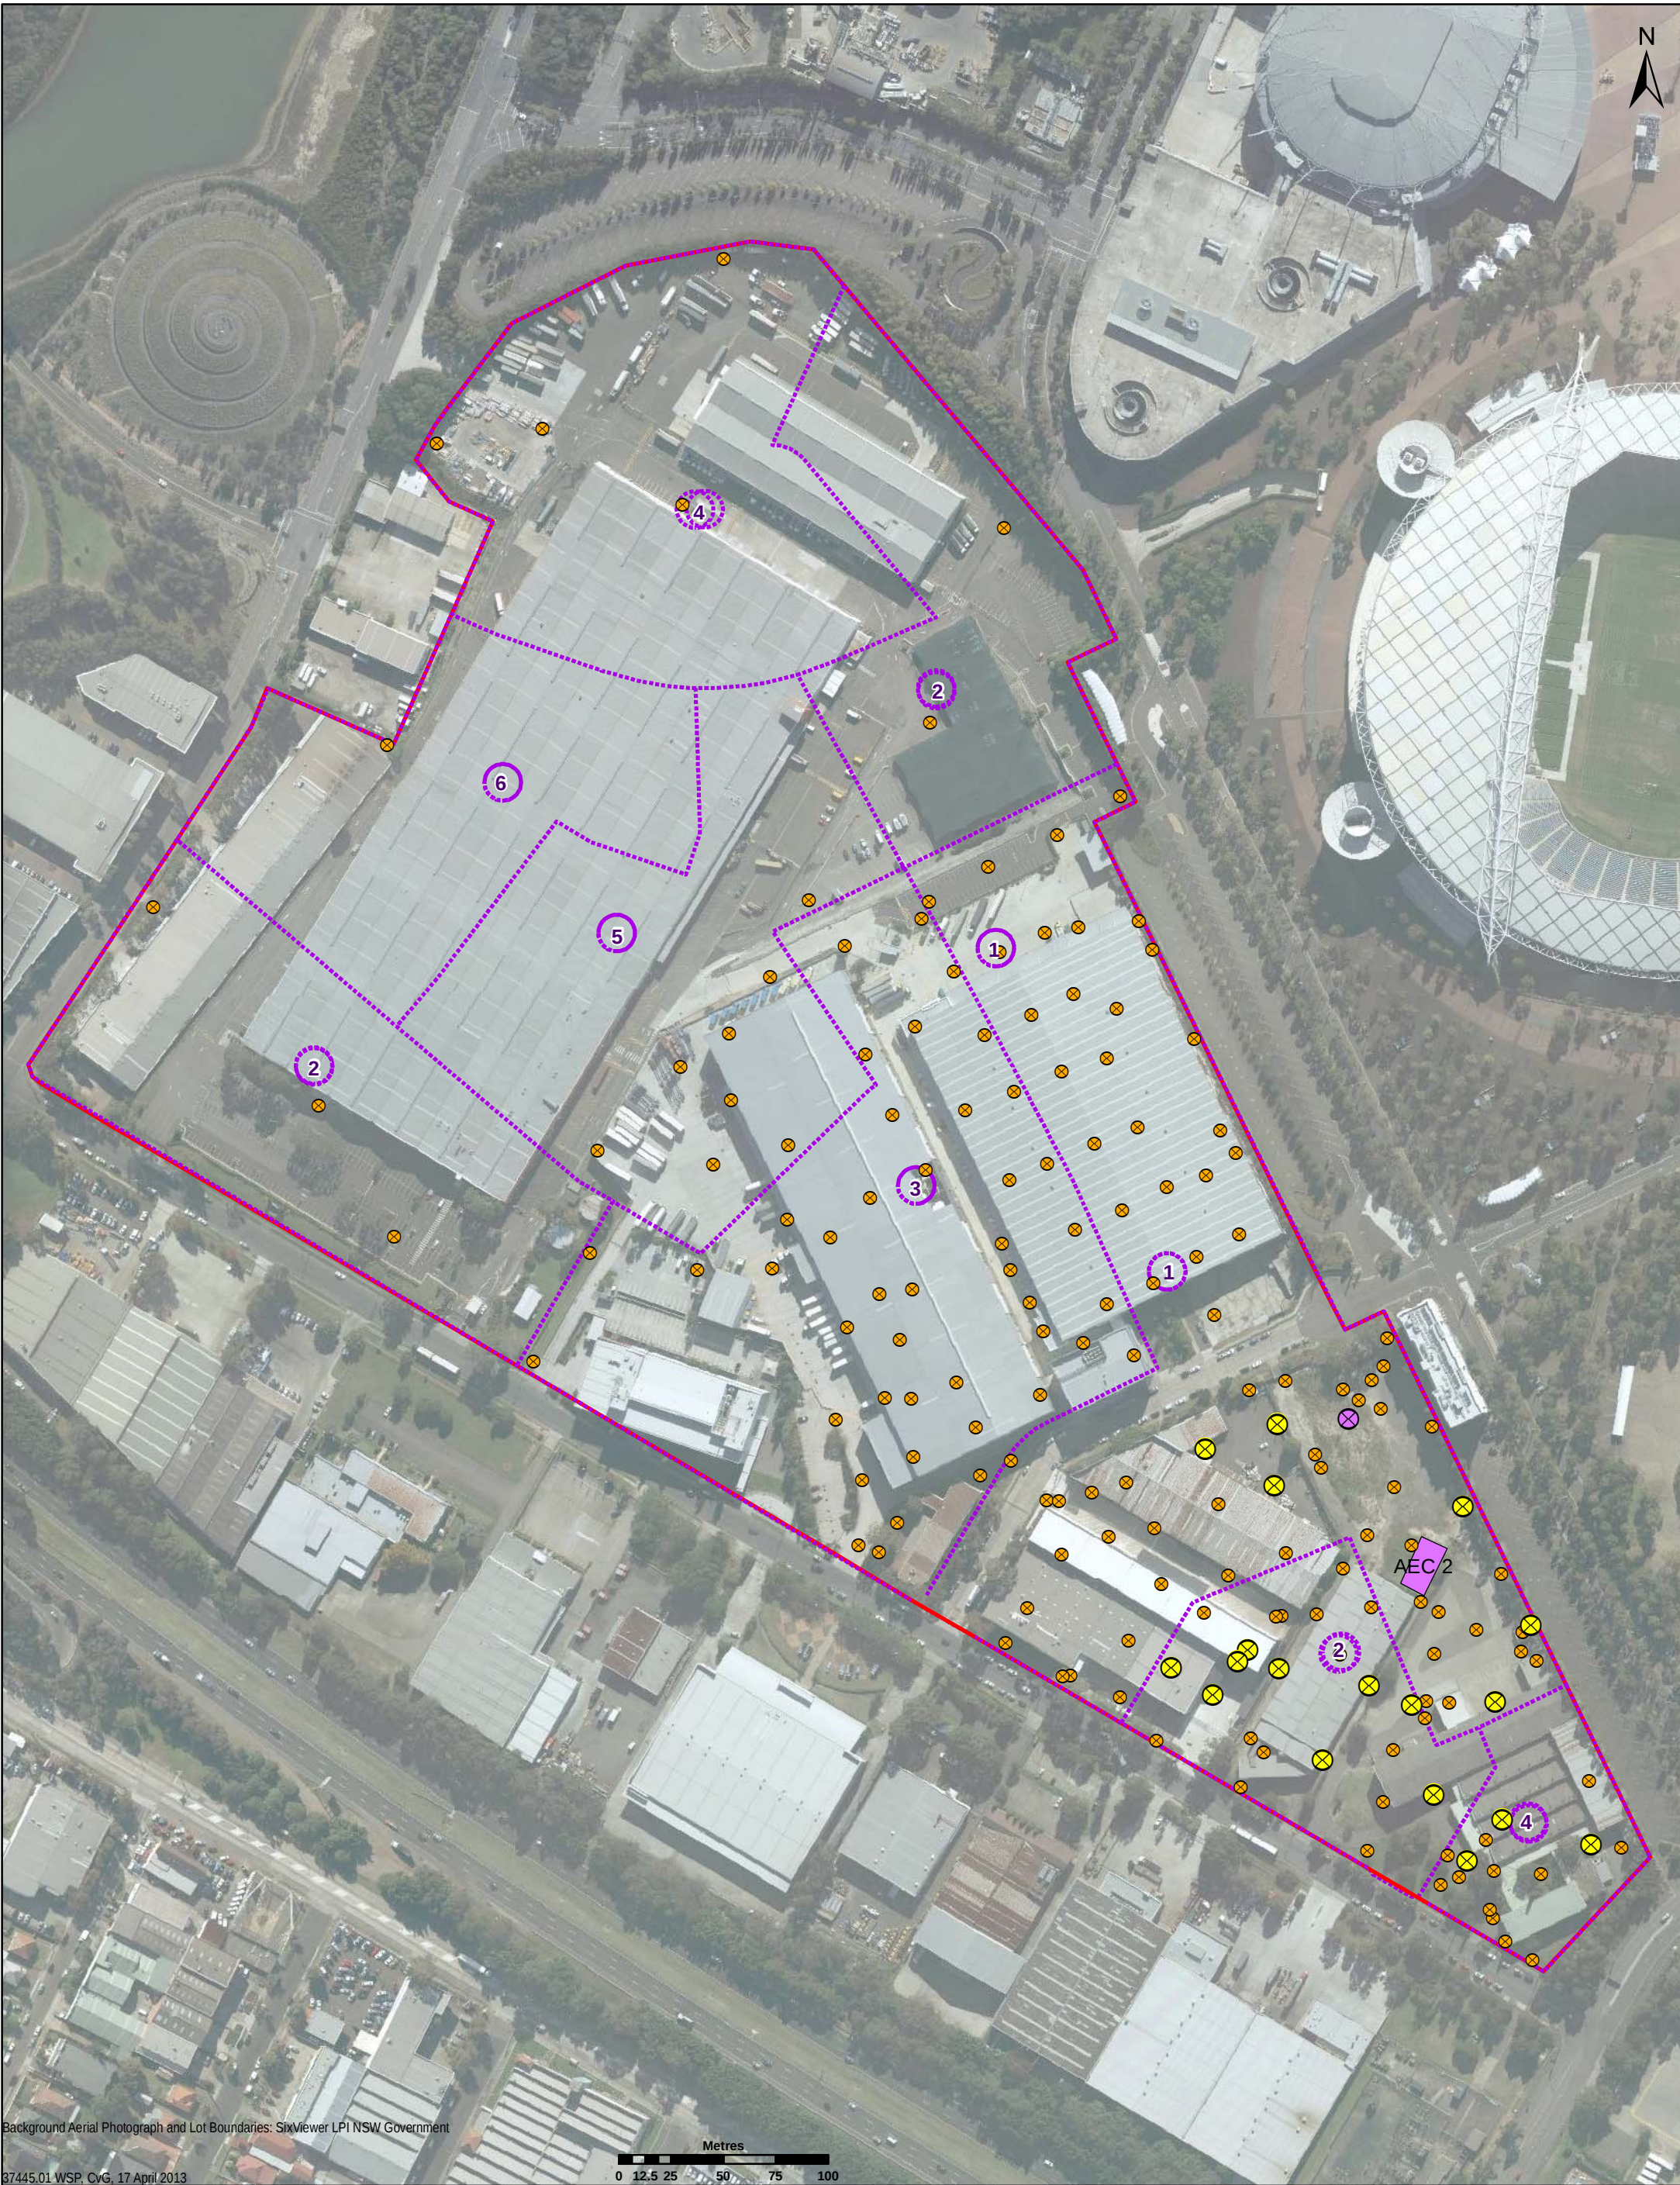
**Figure 10**

- Legend**
- ✕ Borehole location
  - Site Boundary
  - - - Stage Boundaries
  - ⊗ NSW DECC (2009) Special Waste (Asbestos)
  - ⊗ NSW DECC (2009) Restricted Solid Waste (CT2)

Waste Classification in Fill

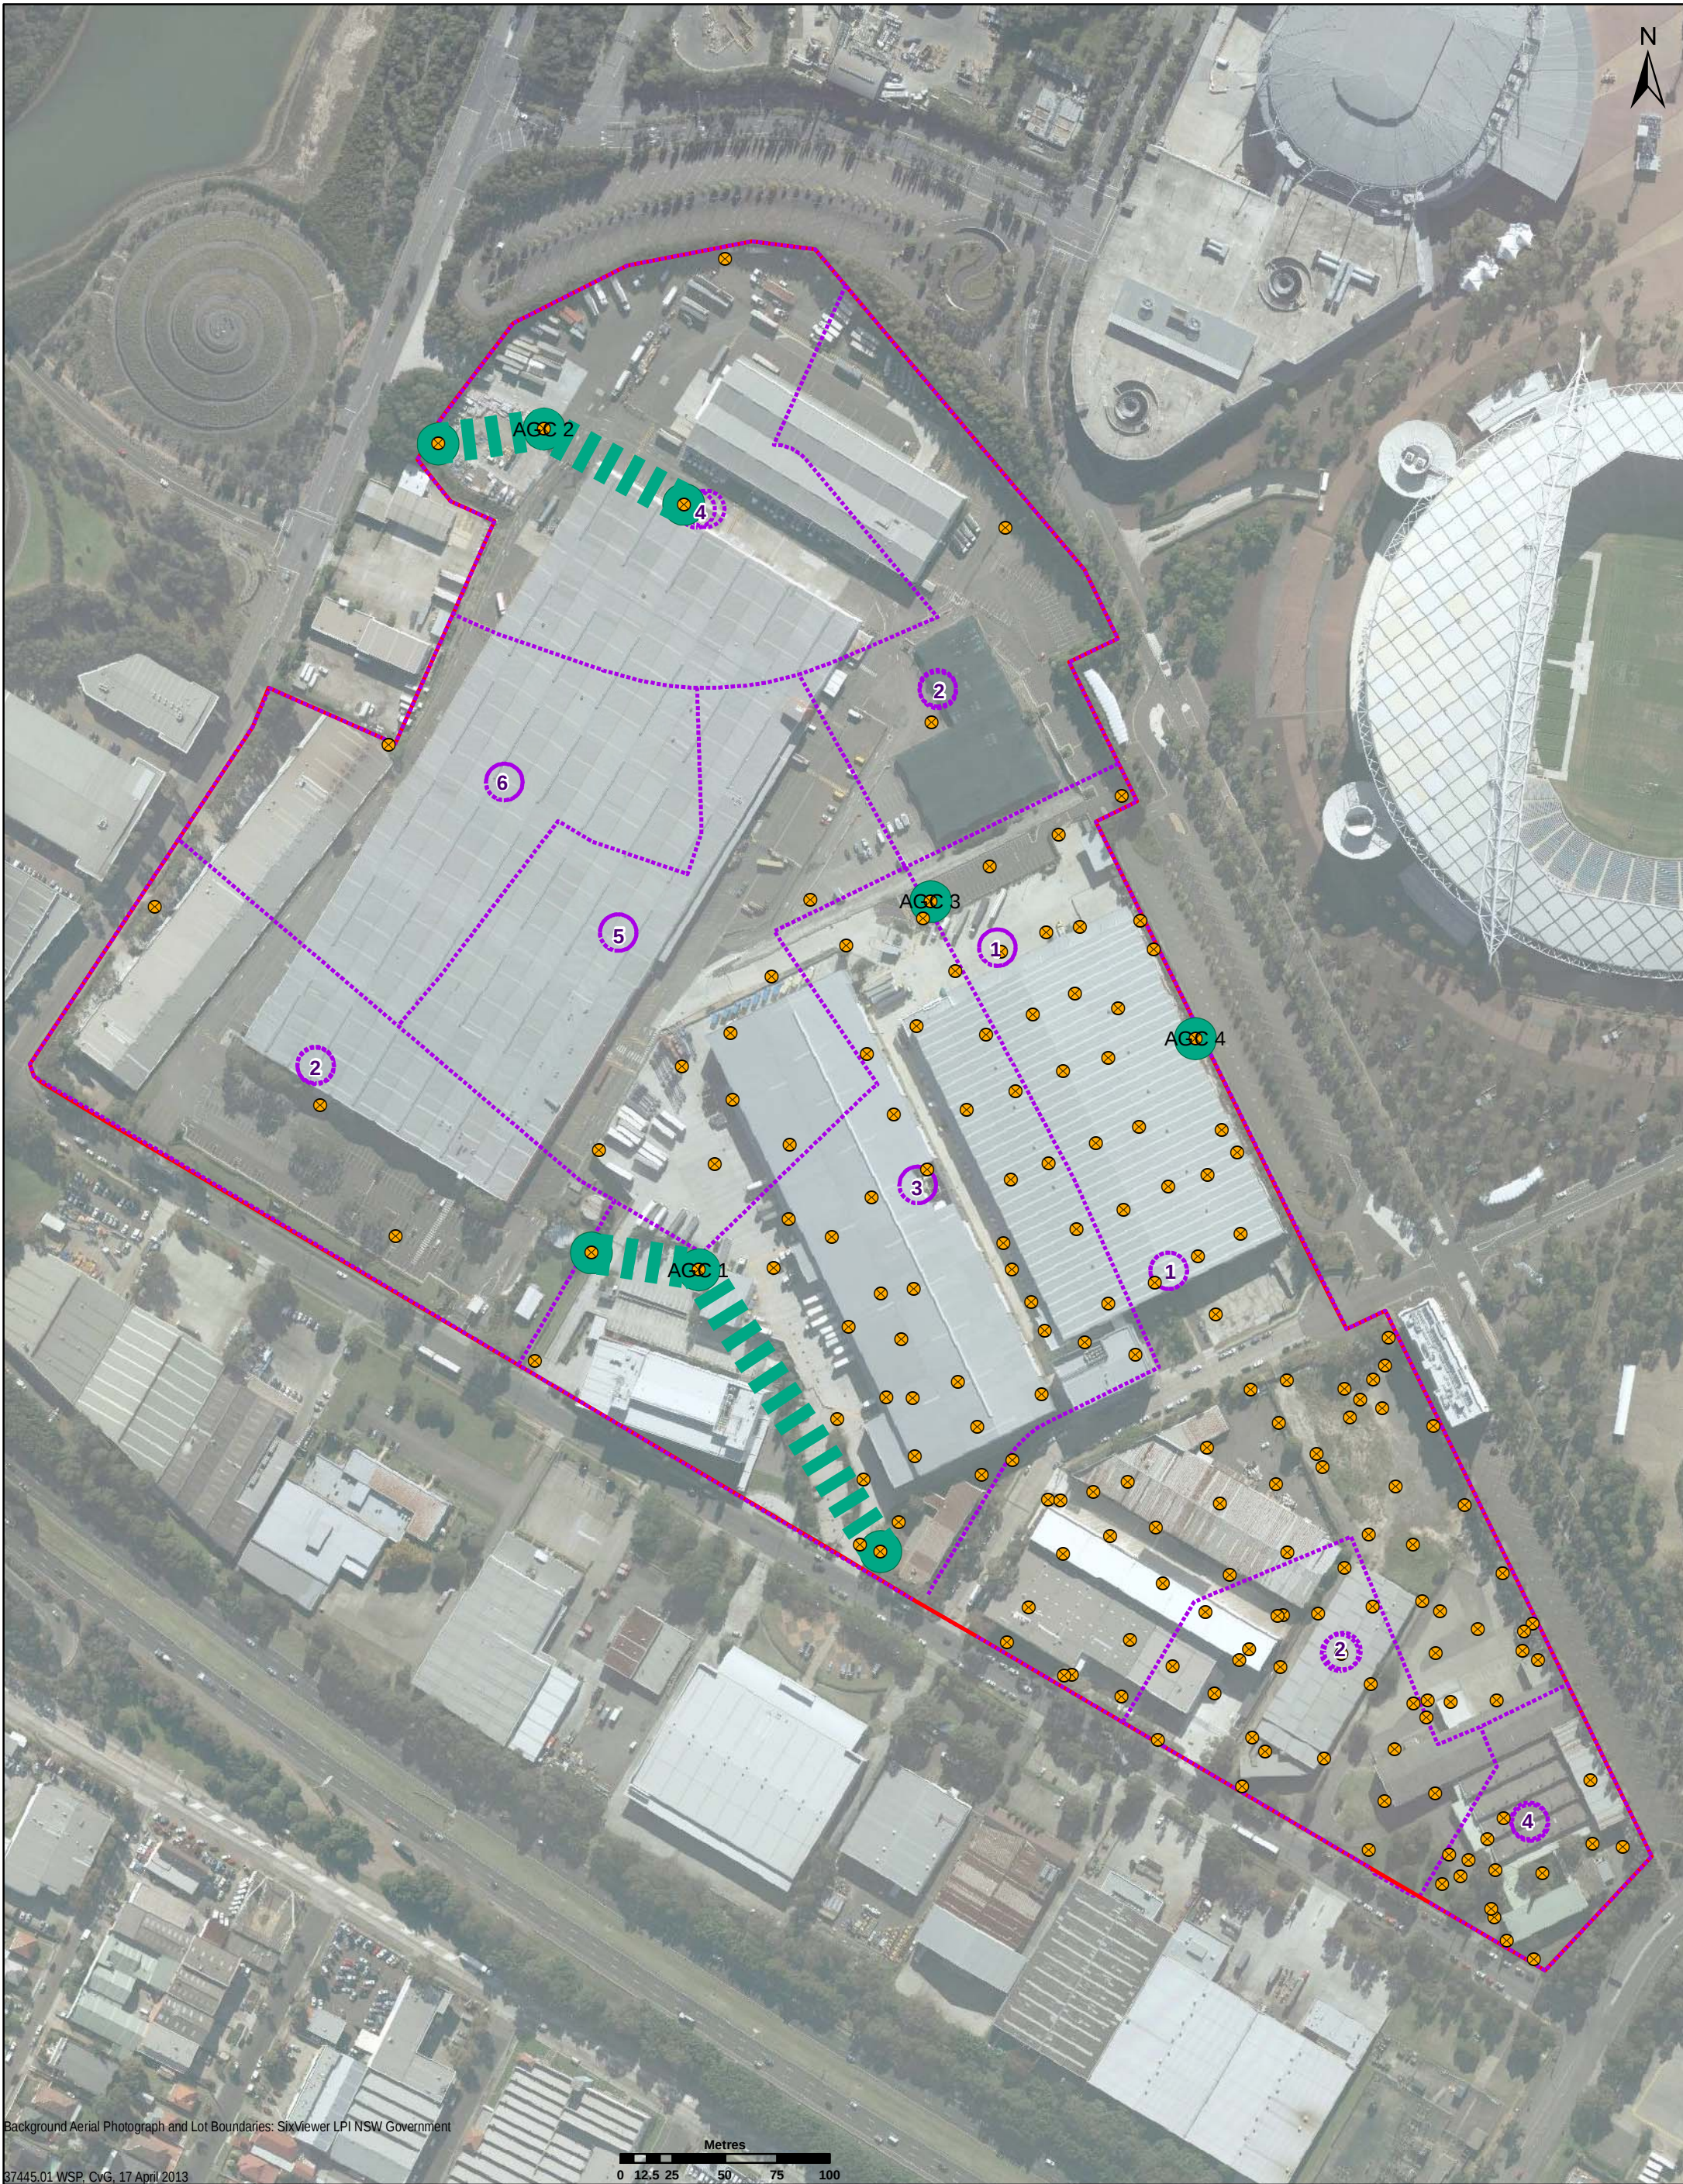
- Legend**
- Borehole location
  - Site Boundary
  - Stage Boundaries
  - AGCs, Areas of Geotechnical Concern

Areas of Geotechnical Concern

- AWG is not convinced that Natural Sand was encountered in the RES (2005) BH14 rather it is considered to be filled ground as per RES (2005) BH9 (see AGC 3 on Figure 11 in **Attachment 1**). Similarly AWG is not confident that refusal on rock occurred in RES (2005) BH14 (see AGC 4 on Figure 11 in **Attachment 1**). After the site is cleared for future development, AGC recommend that this zone needs further onsite geotechnical testing to clarify the soil conditions.
