PRELIMINARY RADIATION SITE ASSESSMENT

Iron Gates Development – Evans Head NSW

GOLDCORAL PTY LTD

Date 22 May 2014

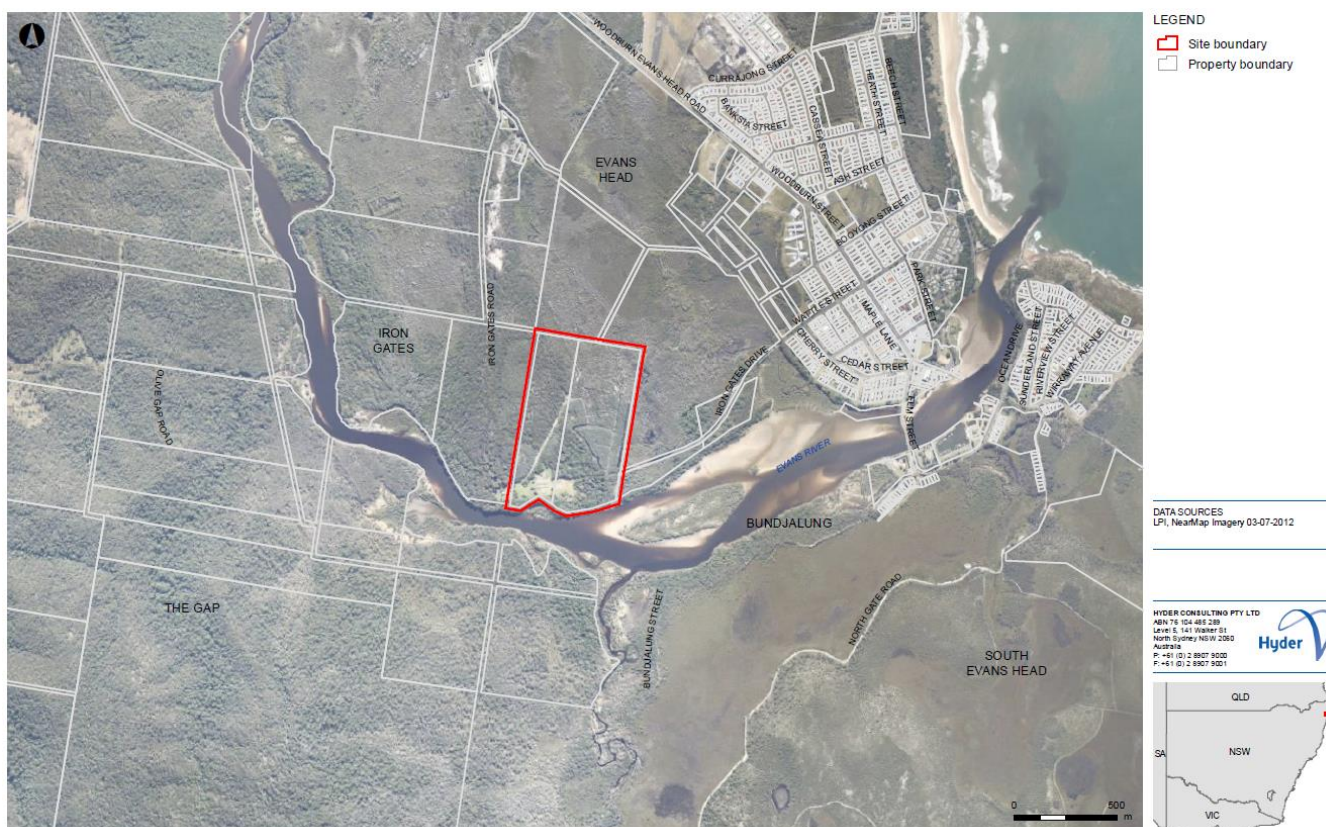
Figure 1: Site locality plan showing the development area

The scope of this study was the “development area” as detailed in the locality plan provided below. The development site is located approximately 1.7 kilometres south-west of Evans Head township. This is the area that will be directly disturbed as a result of the construction required for the development. This includes bulk earthworks, road construction and ancillary activities such as stockpile and compound sites, utility installation and access requirements, and any alterations to intersections. The location of the proposal is illustrated in Figure 1 (a detailed locality plan with development layout is provided in Appendix 1).

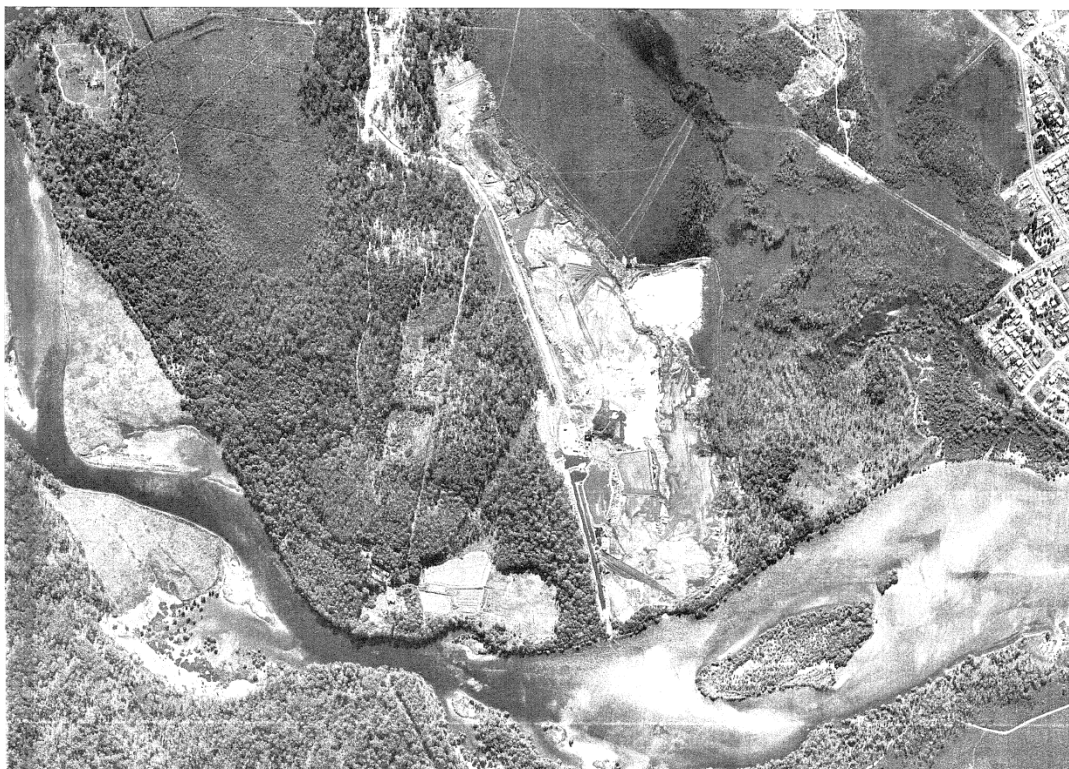
Figure 2: Aerial photograph of Iron Gates Site in 1971 with sand mining activities evident on the eastern portion of the site and adjacent property

Year	Site History Details	Potential contamination Implications
1953	Sole Dwelling with surrounding cleared land for rural use	
1964	Sole Dwelling with surrounding cleared land for rural use	
1971	Sole Dwelling with surrounding cleared land for rural use	
	Eastern portion and adjacent property to the Iron Gates property has evidence of substantial sand mining activities (Refer Figure 2)	Potential sand mining residues with elevated radiation levels
1980	Sole Dwelling with surrounding cleared land for rural use	
	Sand mining activities seem to have down sized and revegetation of areas is evident	Potential sand mining residues with elevated radiation levels
1988	Sole Dwelling with surrounding cleared land for rural use	
	Sand mining activities have ceased	
1998	Sole dwelling and cleared land and constructed roads associated with the Iron Gates development (Refer Figure 3)	
2001	Sole dwelling and cleared land and constructed roads associated with the Iron Gates development

- Previous to 1971 the area was generally rural with a sole dwelling.
- There is evidence that sand mining activities were undertaken between 1965 and 1981
- Sand mining activities ceased before 1988.
- In 1996 the Iron Gates urban development was constructed.
- The site has remained unchanged since 1996.

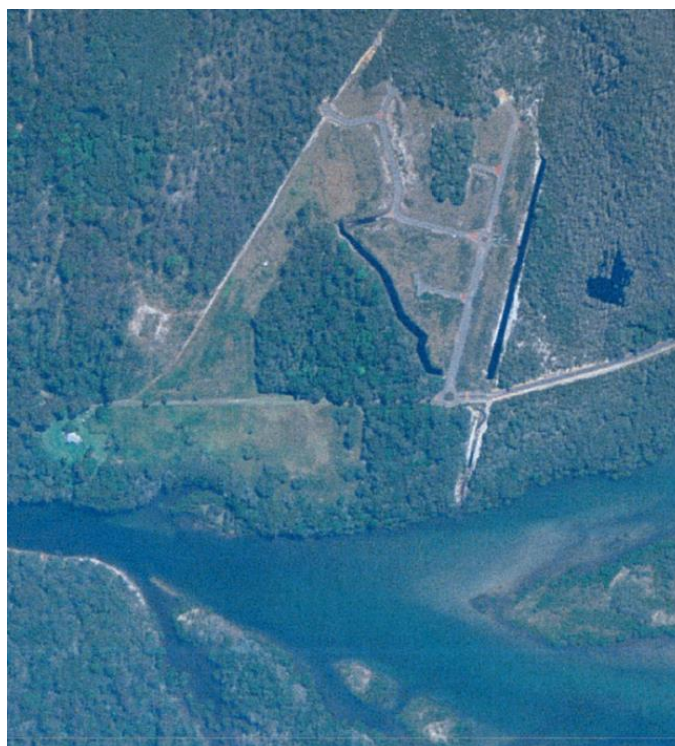
Figure 3: Aerial photograph of Iron Gates Site in 1998 with developed roads.

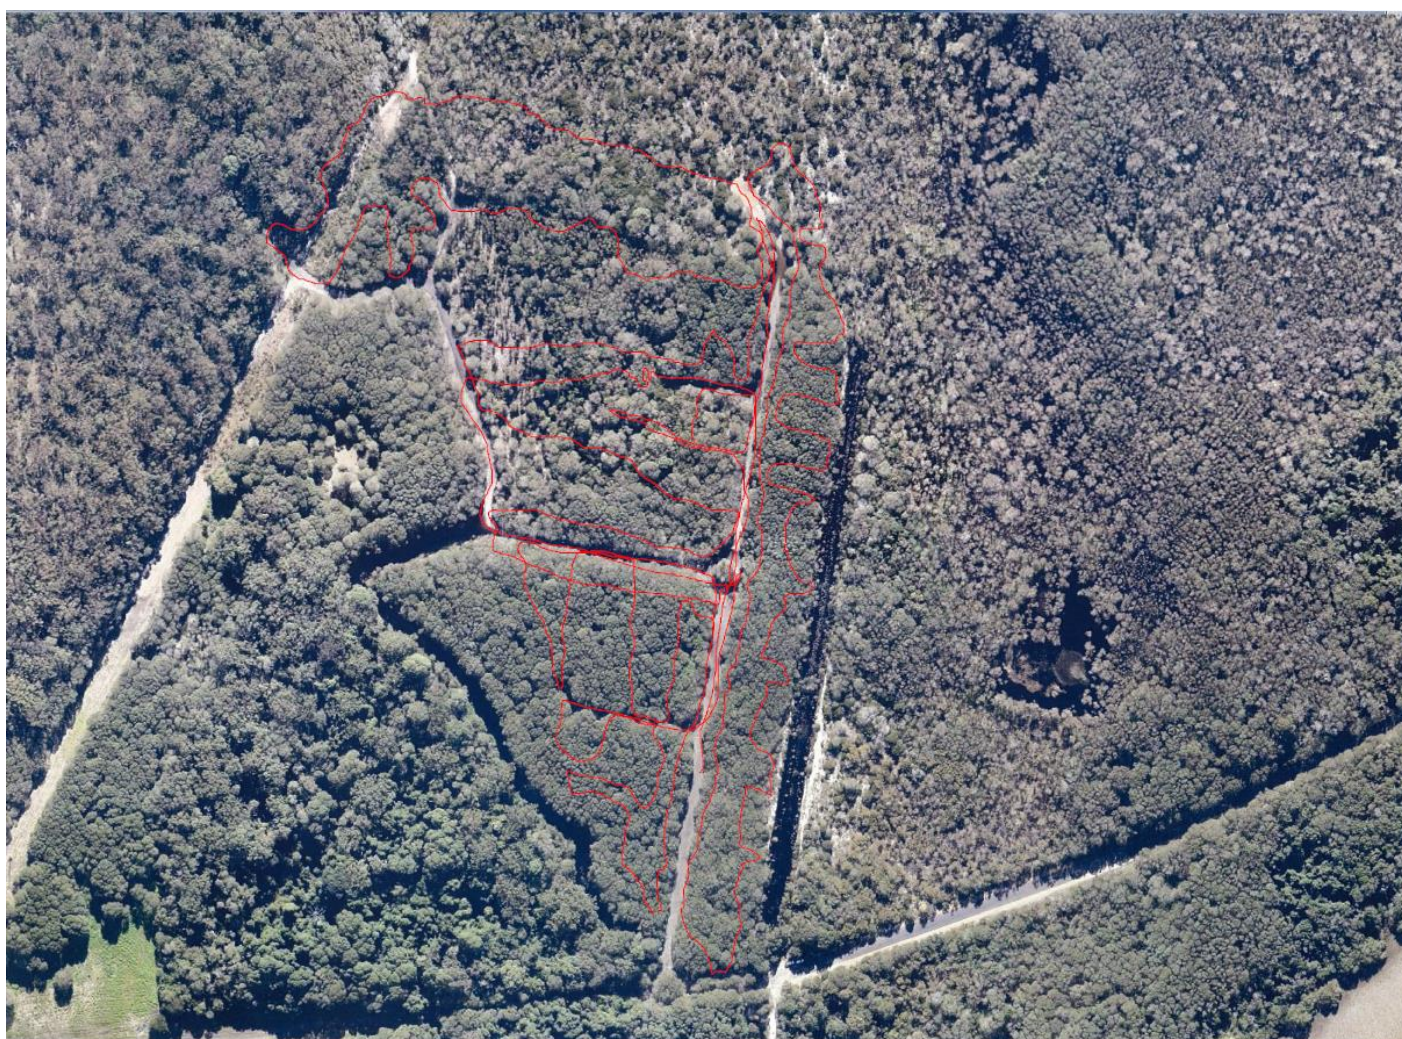
Figure 4: Surface radiation survey transects continuously monitored (in red) on the Iron Gates site.

A surface radiation survey of the development site was also undertaken using a calibrated HPI Cypher 5000 Digital Radiation Alert Monitor to measure surface gamma radiation levels and detect and locate any areas of elevated radiation levels. The assessment was undertaken by walking transects of the site approximately 20-25 metres apart with the aid of a GPS device. Radiation levels were continuously monitored at all times whilst walking transects. Transects were recorded and plotted in Figure 4 below.

The surface radiation levels monitored on the Iron Gates site in areas where previous sand mining activities were located are all equivalent to background levels displayed at the three off site background control locations. Surface radiation levels generally varied between 0.00 uSv/Hr to 0.3 uSv/Hr. Some discrete areas displayed levels of 0.4 and 0.5 uSv/Hr however these areas are still below Action Level Criteria for dwellings.

Based on the site assessment undertaken, it is considered that no further investigations or actions are required.

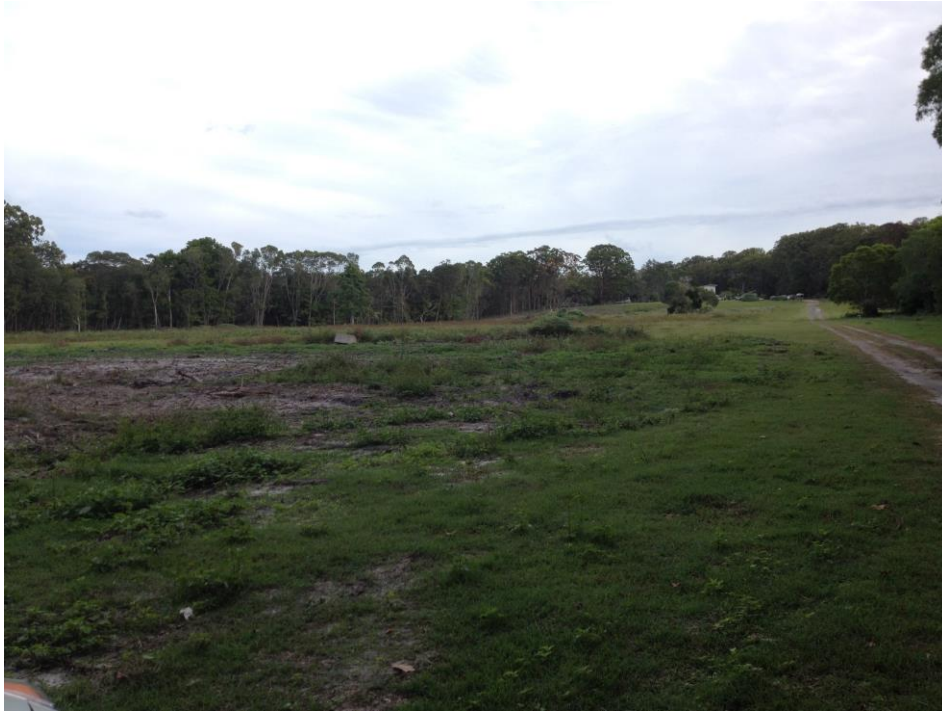
Photographic Illustration 1: Cleared area adjacent to Evans Creek with sole dwelling in the back ground.

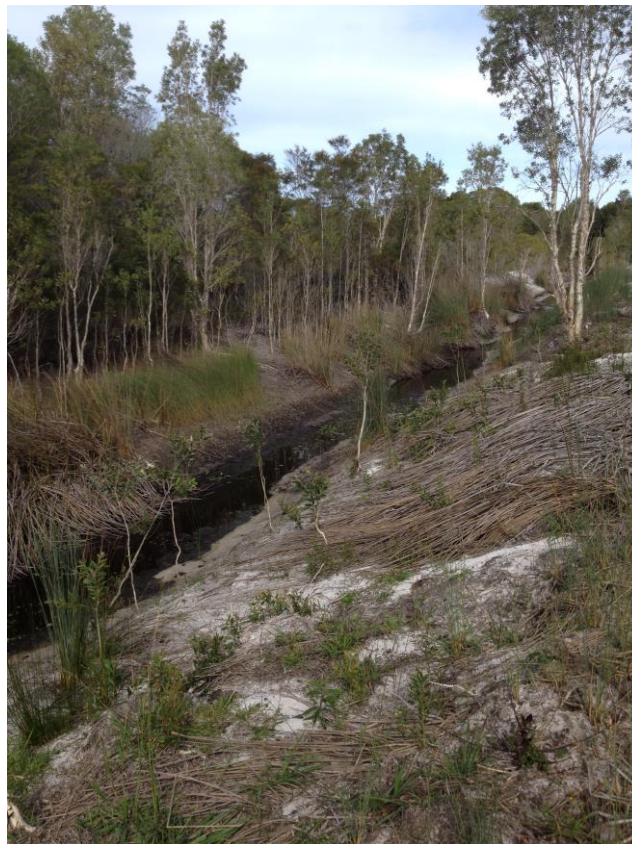
Photographic Illustration 2: Open drain located on the eastern boundary of the site were previous sand mining activities are likely to have taken place.

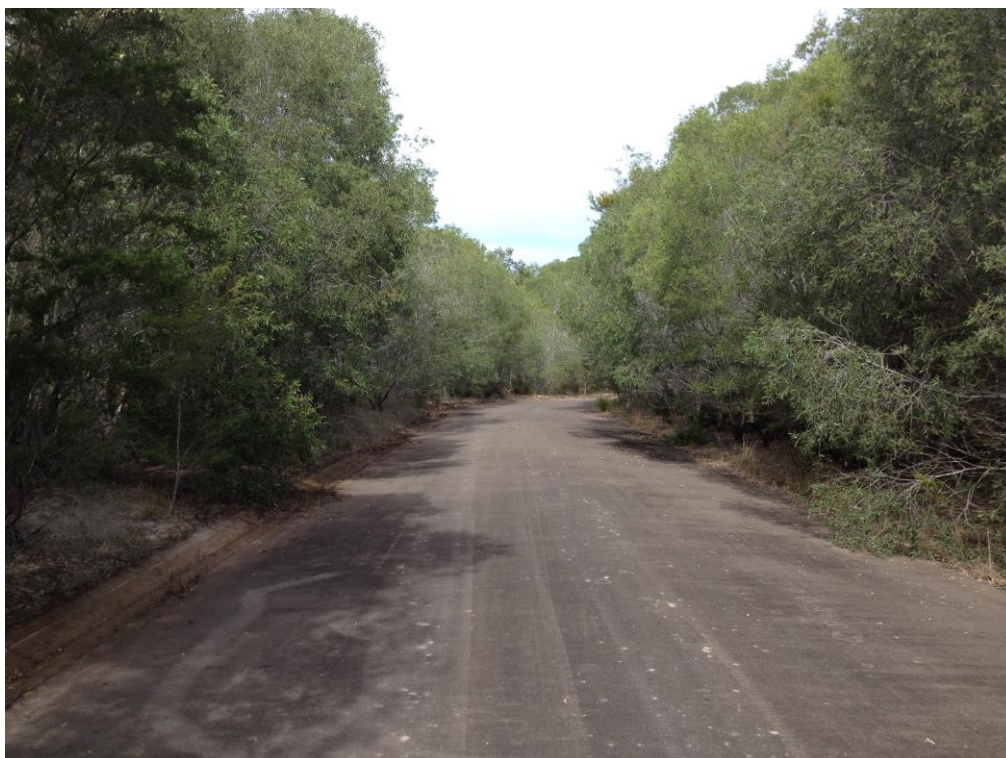
Photographic Illustration 3: Previously constructed road on the Iron Gates estate.

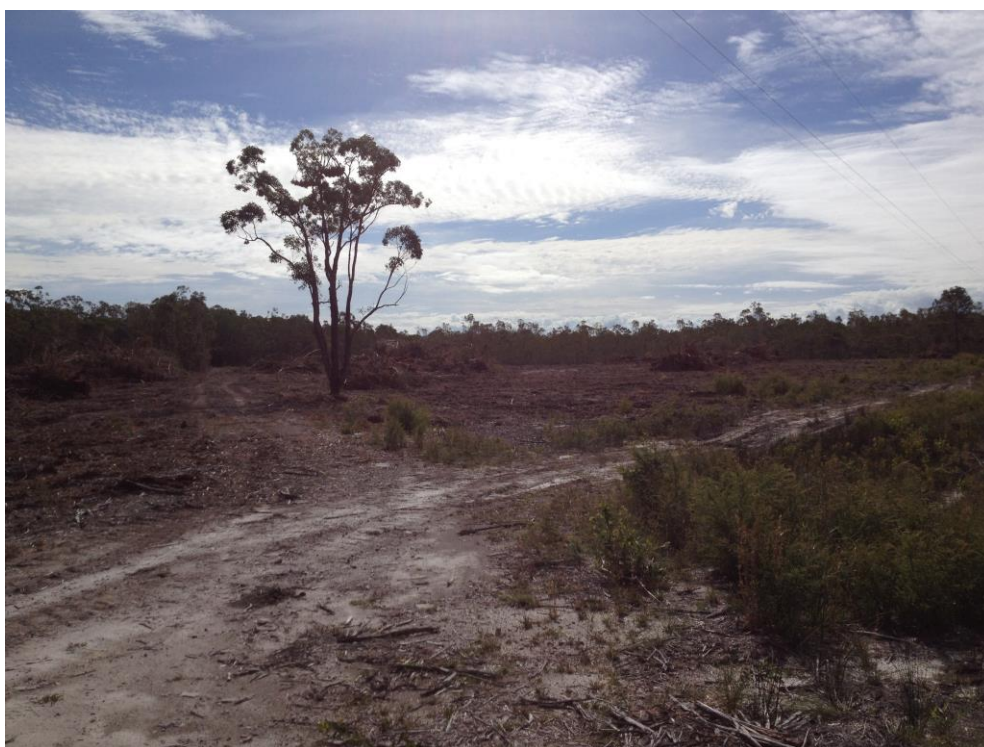
Photographic Illustration 4: Photograph of the North West portion of the Iron Gates property.
