NSW Department of Planning and Environment
Preliminary Site Investigation

Arncliffe Priority Precinct

21 August 2015
50299/100611 (Rev 0)
JBS&G

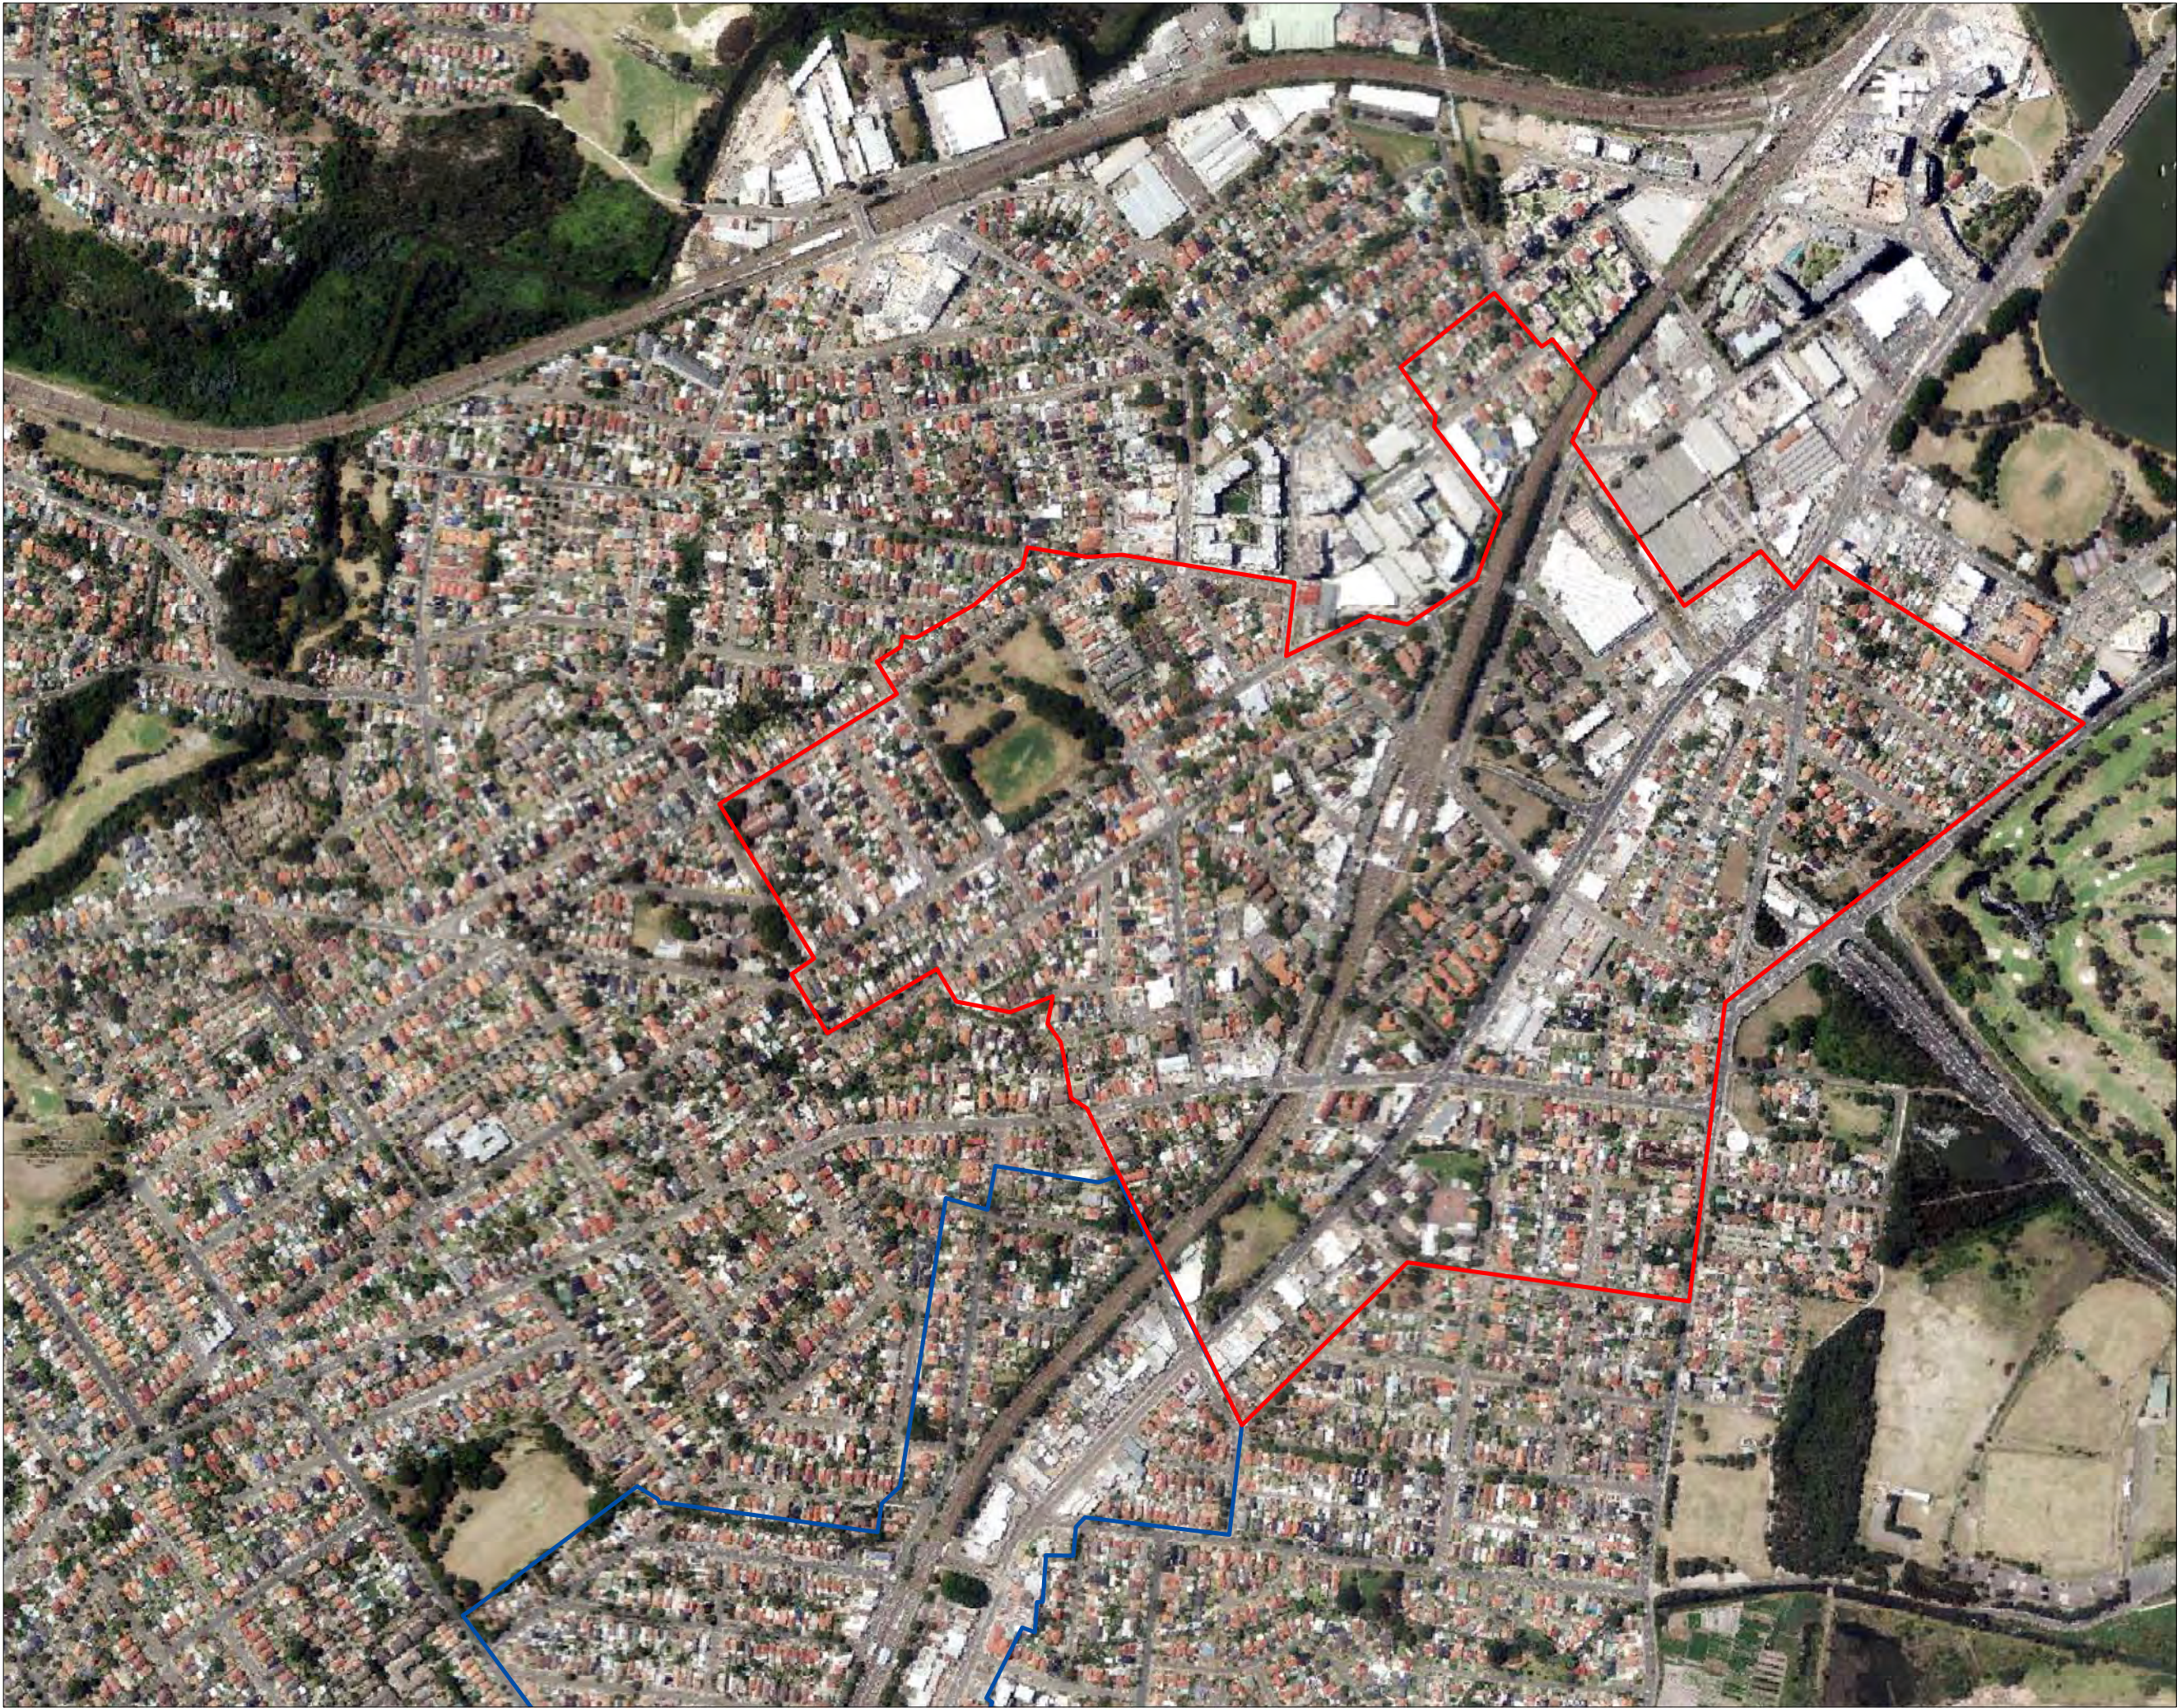
FIGURE 2

The Precinct layout is shown in **Figure 2**. The key observations made during the inspection relate to individual sites as shown on **Figure 3**.

SITE LAYOUT

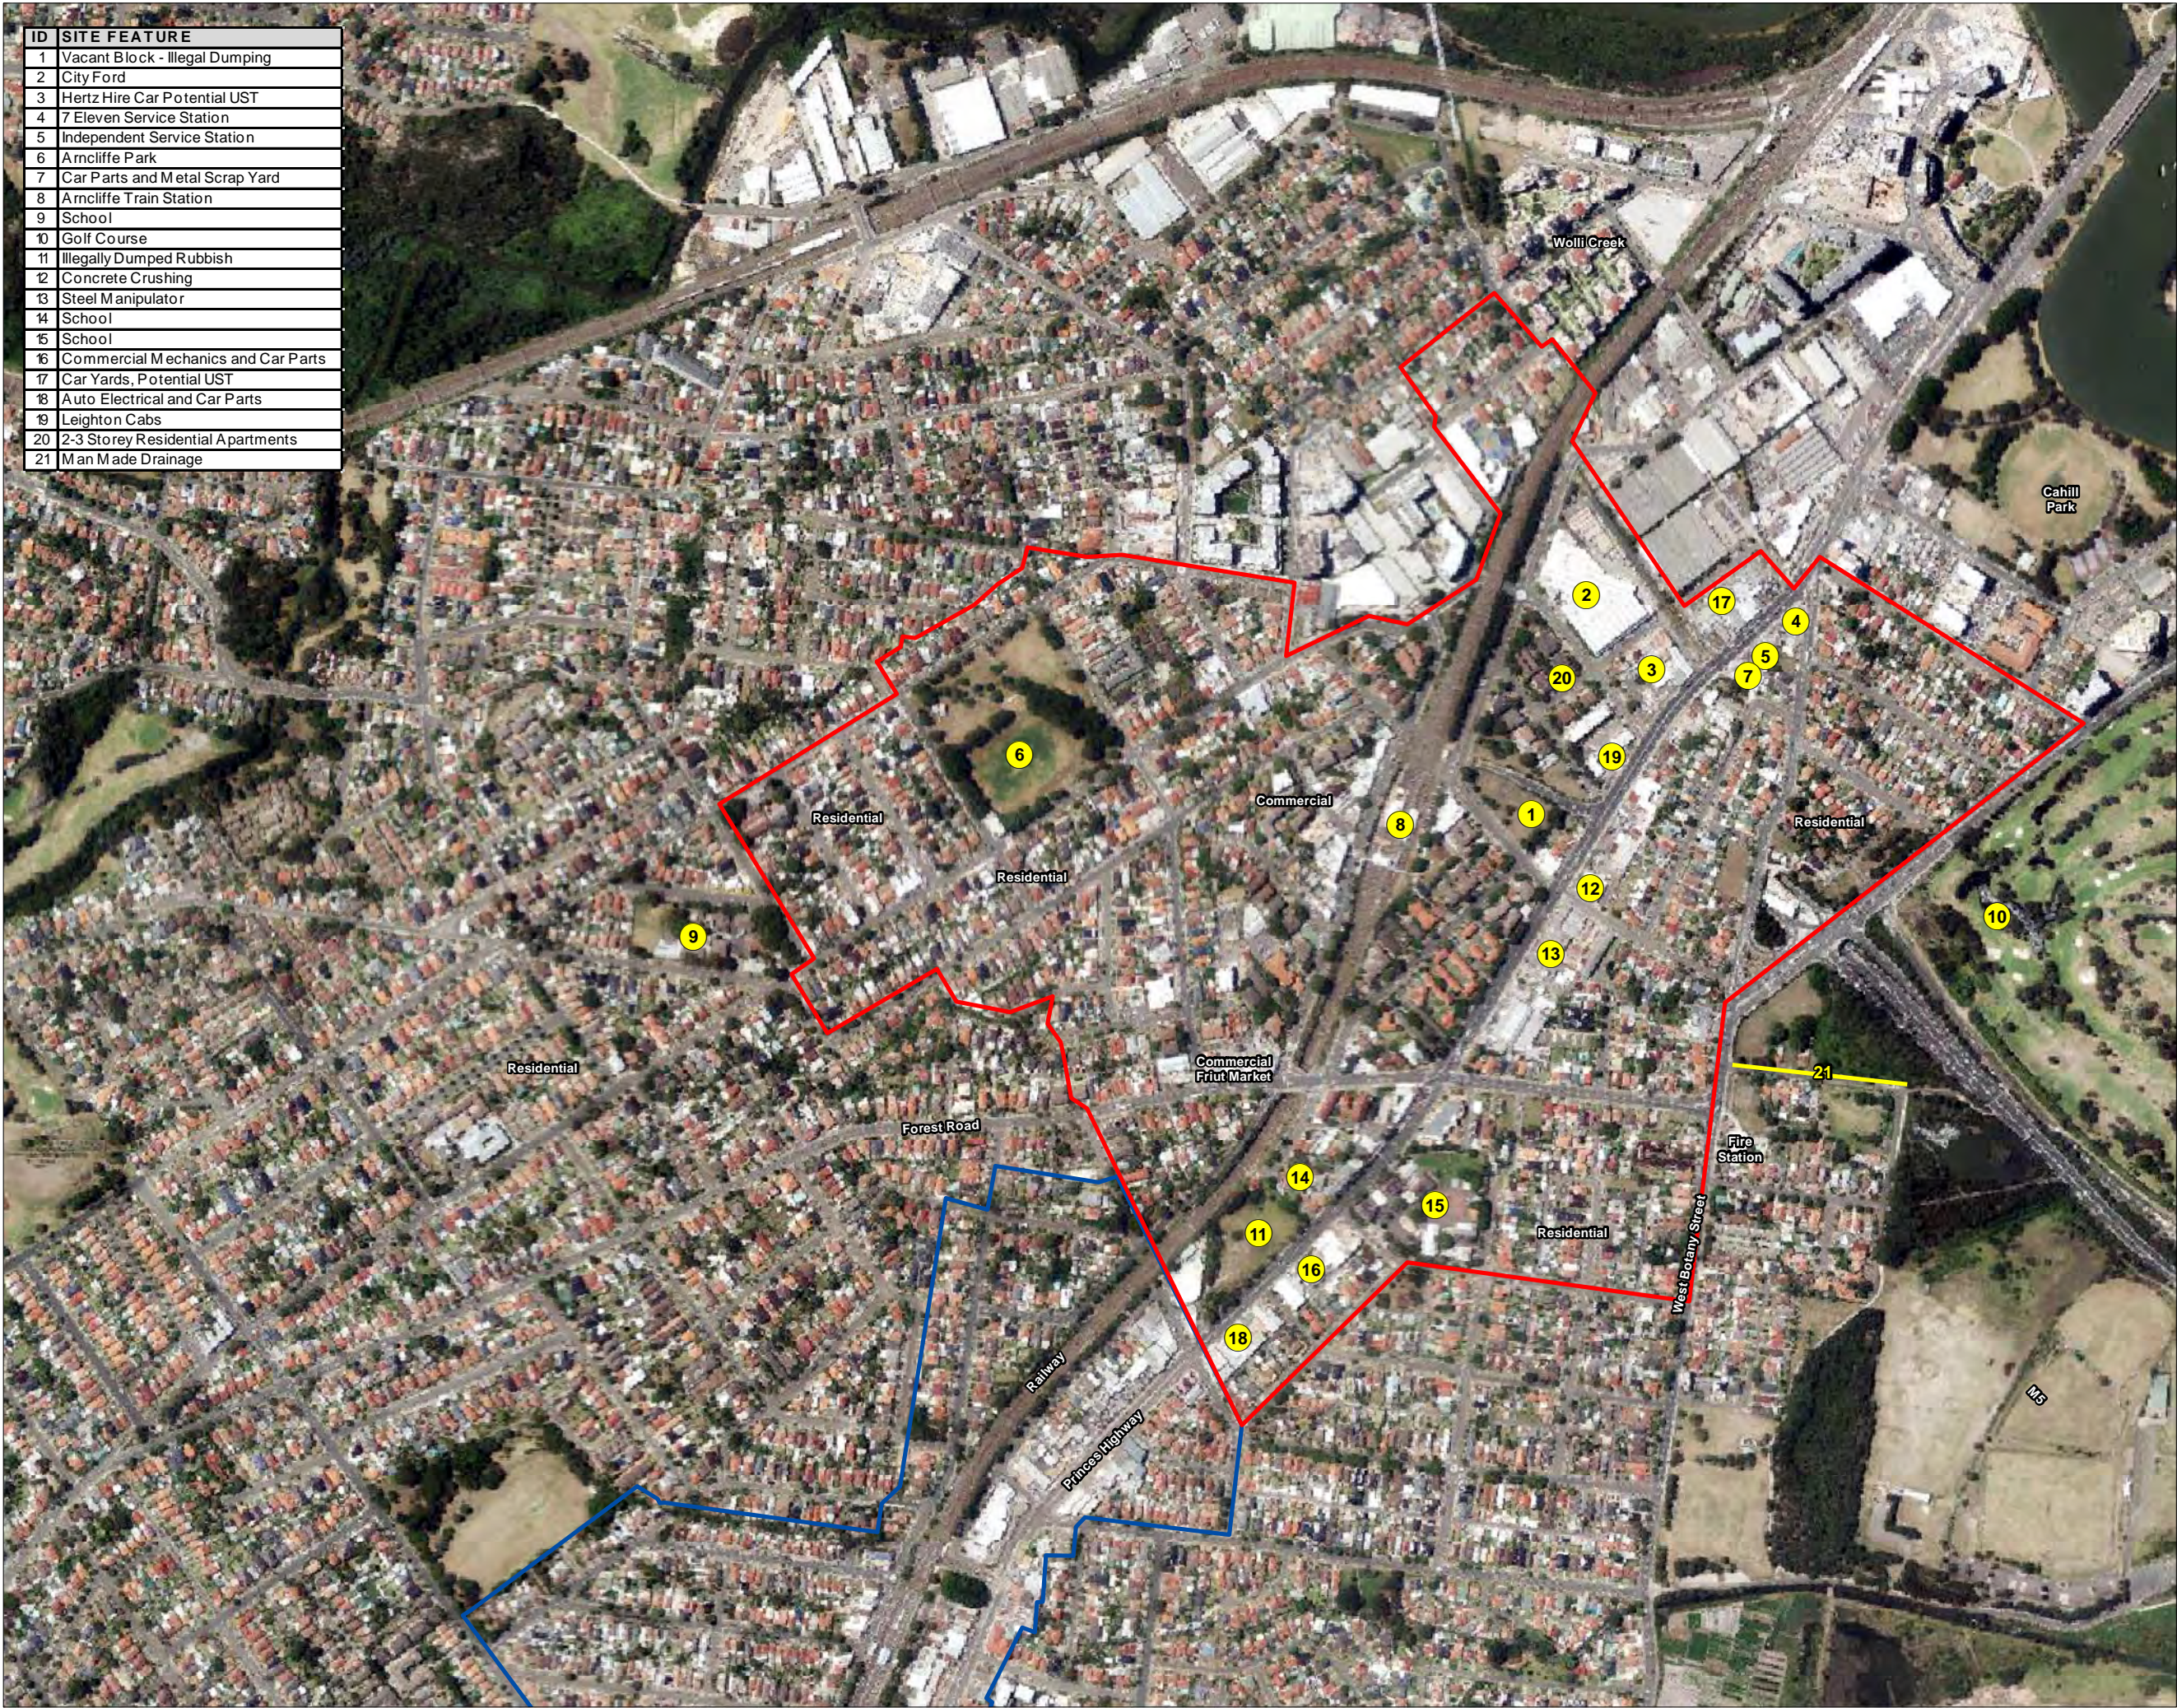
FIGURE 3

Arncliffe train station (Point 8) was located in the central portion of the Precinct, with the Princes Highway alignment located to the east of the station and associated railway line. Adjacent to the train station to the west were located commercial properties, predominantly cafes and shops that serviced the commuters using the train station. Car parking was located on either side of the train station.

To the south of the service station properties, along the Princes Highway, a car parts mechanics property was observed (Point 7). This property was occupied by a residence and a street facing hardstand area with pavements in poor condition. Numerous car and car parts in varying state of decay were apparent on the hardstand.

Along the Princes Highway, at the cross road with Kyle Street (Point 12) a concrete crushing/recycling yard was identified. Additionally, to the south of Kyle Street (Point 13) a steel fabricators property was present.

A vacant block of land was observed to the east of Arncliffe train station in the central portion of the Precinct (Point 1) and was observed to have illegal dumping of household goods present. Access to this property was restricted by metal fencing at the time of the site inspection, however the site was heavily vegetated.

ID	SITE FEATURE
1	Vacant Block - Illegal Dumping
2	City Ford
3	Hertz Hire Car Potential UST
4	7 Eleven Service Station
5	Independent Service Station
6	Arncliffe Park
7	Car Parts and Metal Scrap Yard
8	Arncliffe Train Station
9	School
10	Golf Course
11	Illegally Dumped Rubbish
12	Concrete Crushing
13	Steel Manipulator
14	School
15	School
16	Commercial Mechanics and Car Parts
17	Car Yards, Potential UST
18	Auto Electrical and Car Parts
19	Leighton Cabs
20	2-3 Storey Residential Apartments
21	Man Made Drainage

SITE FEATURES

It is recommended that individual properties within the Precinct proposed to be developed be suitably investigated in accordance with relevant NSW EPA endorsed guidelines to assess site-suitability, when detailed development proposals are made.

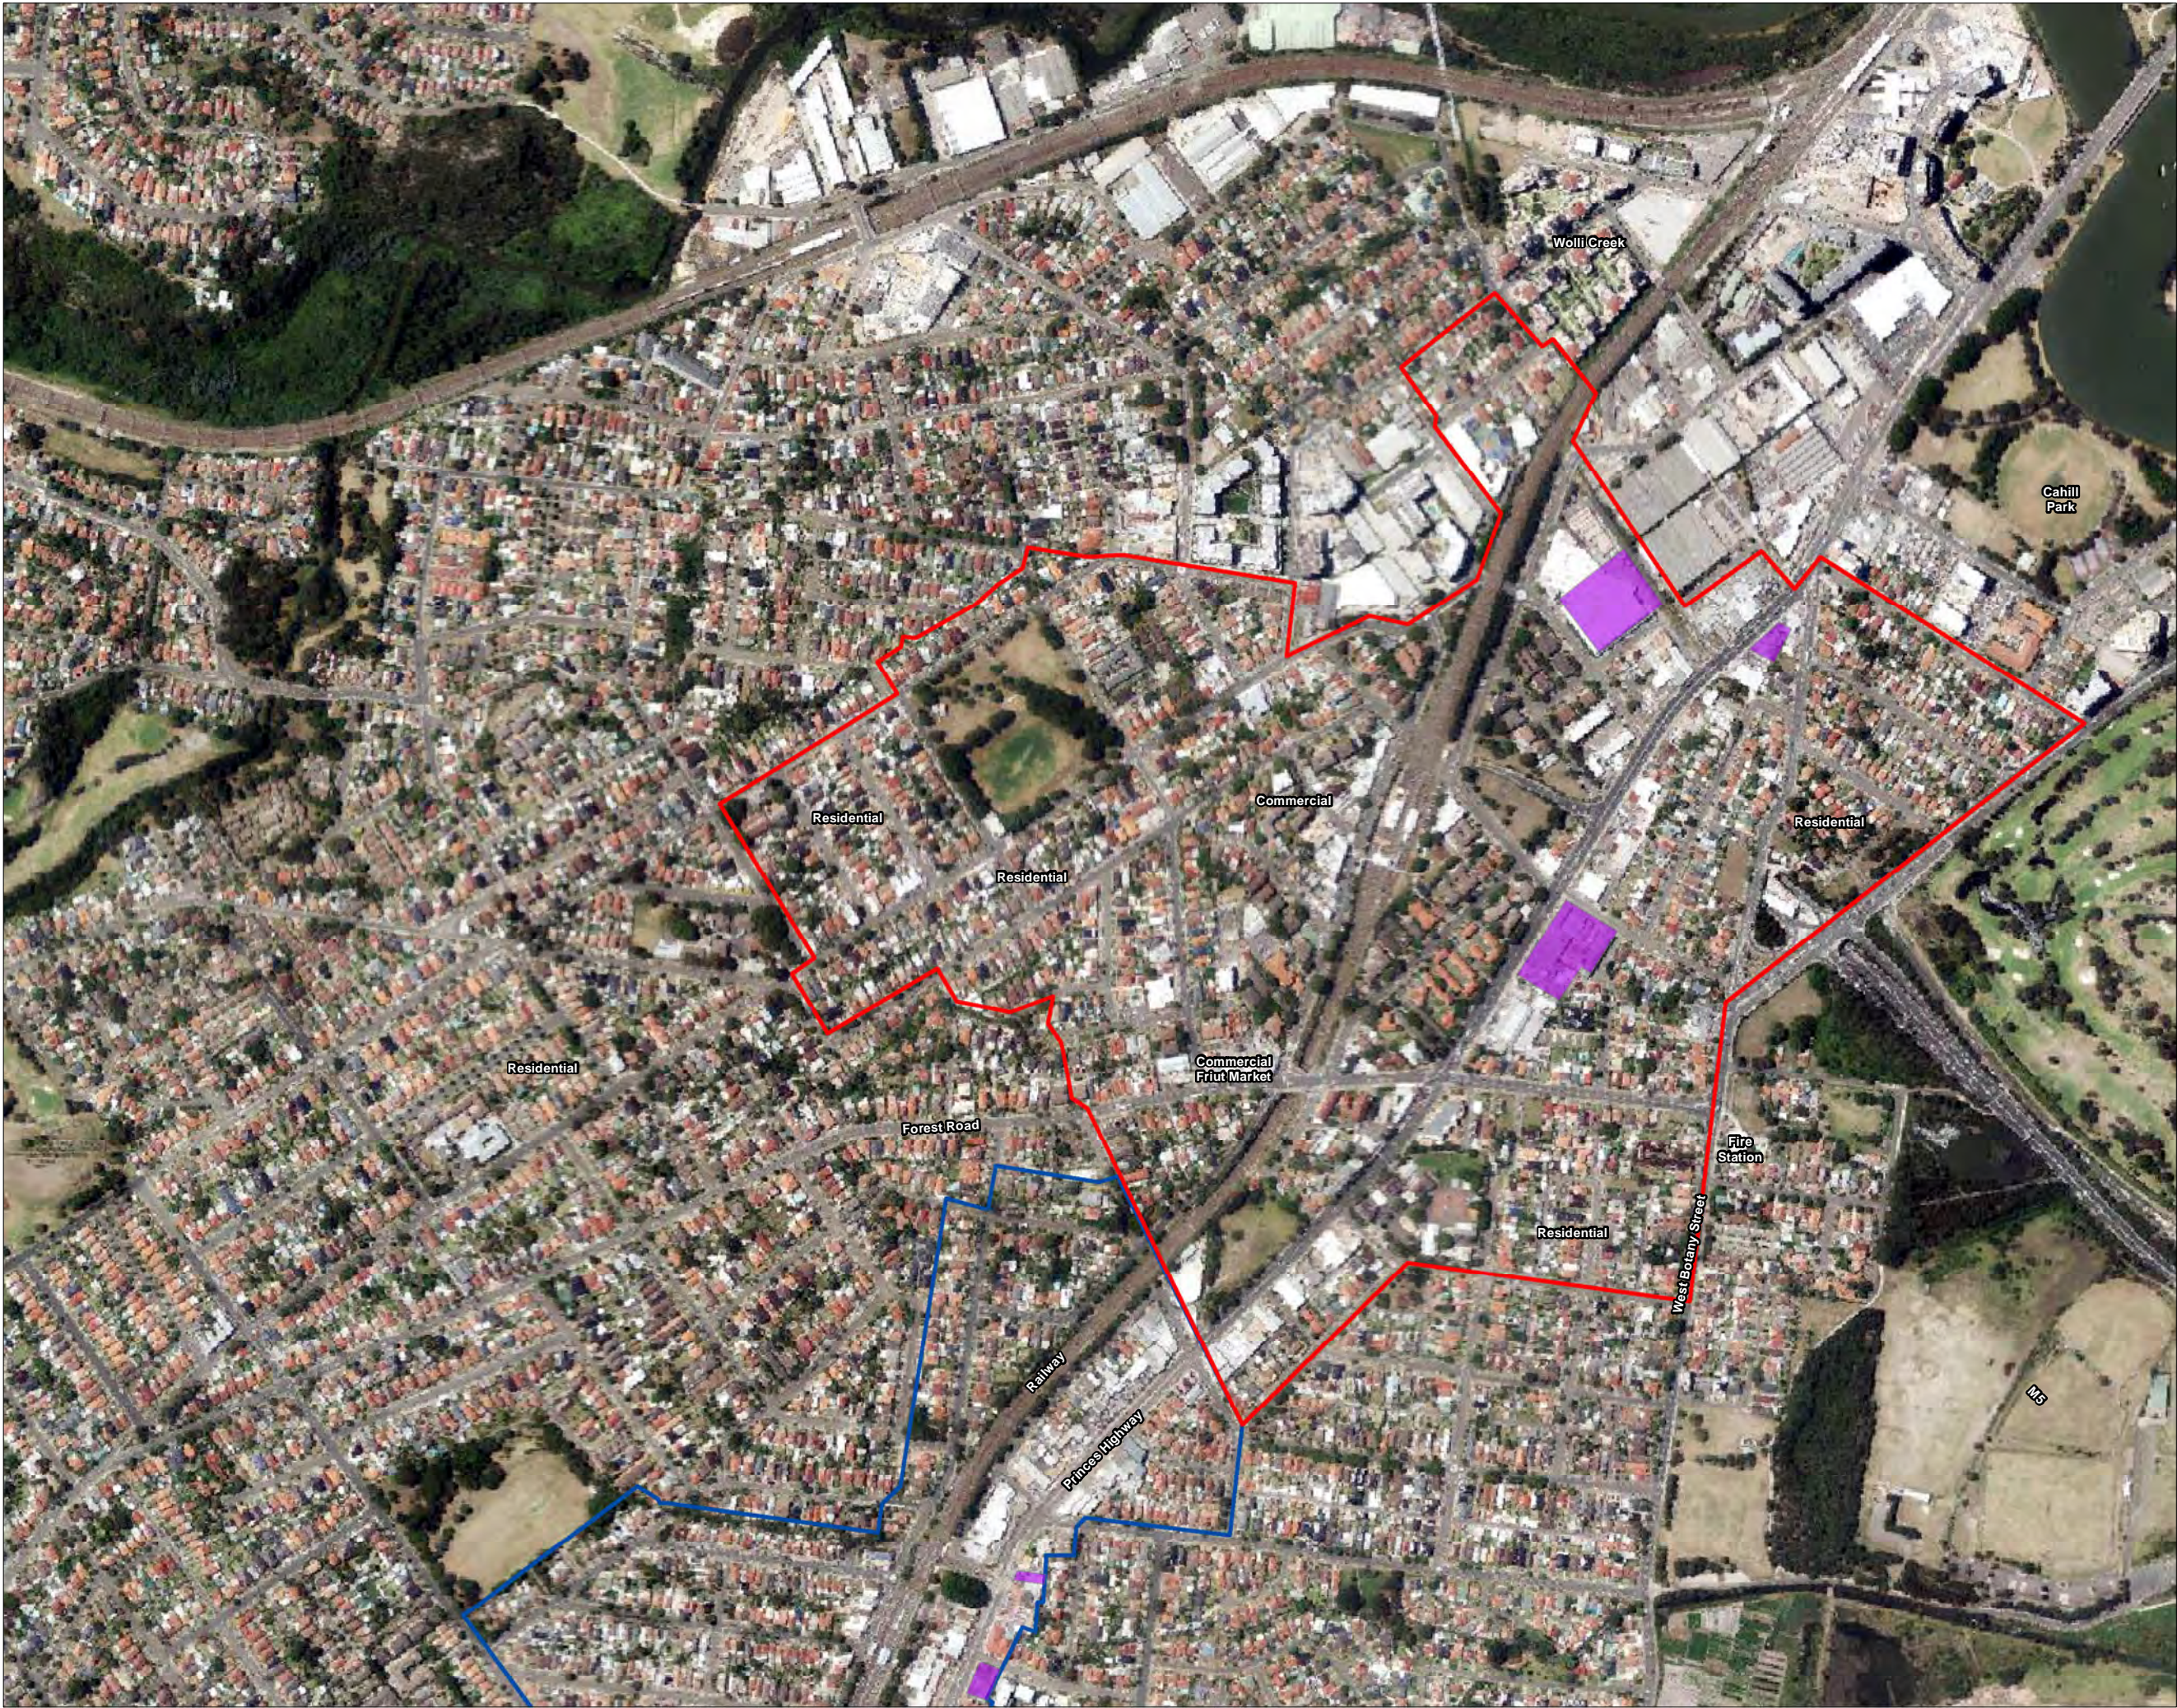
NSW Department of Planning and Environment has identified a number of typical properties within the Precinct with the potential for some form of redevelopment in the future. These 'opportunity sites', located as shown on **Figure 4**, comprise:

- 28-32 Princes Highway, Arncliffe (Lot 103 DP746547);
- 108 Princes Highway, Arncliffe (Lot 1 DP1199713); and
- 12 Arncliffe St, Wolli Creek/Arncliffe (Lot 3 DP13475).
