Rhodes East Priority Investigation Area

Contamination and Acid Sulphate Soils Report

FINAL

15 December 2016

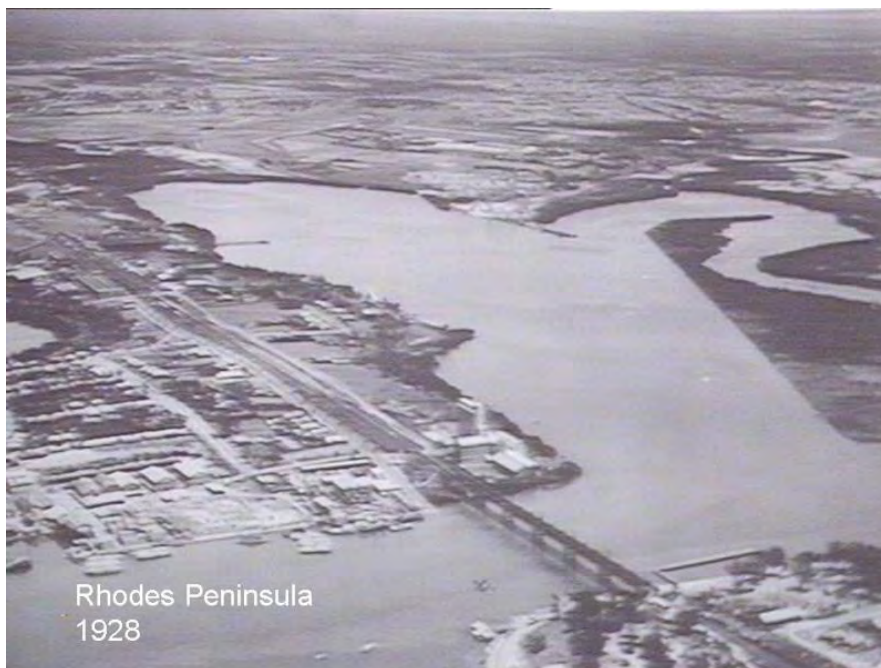
Photo 1: Rhodes Peninsula in 1928 (photo taken towards the south west) (City of Canada Bay Council Image Library)

Aerial photos from 1928 supplied by Council and from the State Library are presented below (Photos 1 and 2). The sawmill site in the north of the Investigation Area and the John Darling & Son flour mill on the northern end of the western side of the Rhodes Peninsula can be seen. The flour mill is discussed further below. It is noted that the northern portion of the sawmill site appears to have already been reclaimed from Parramatta River at this point.

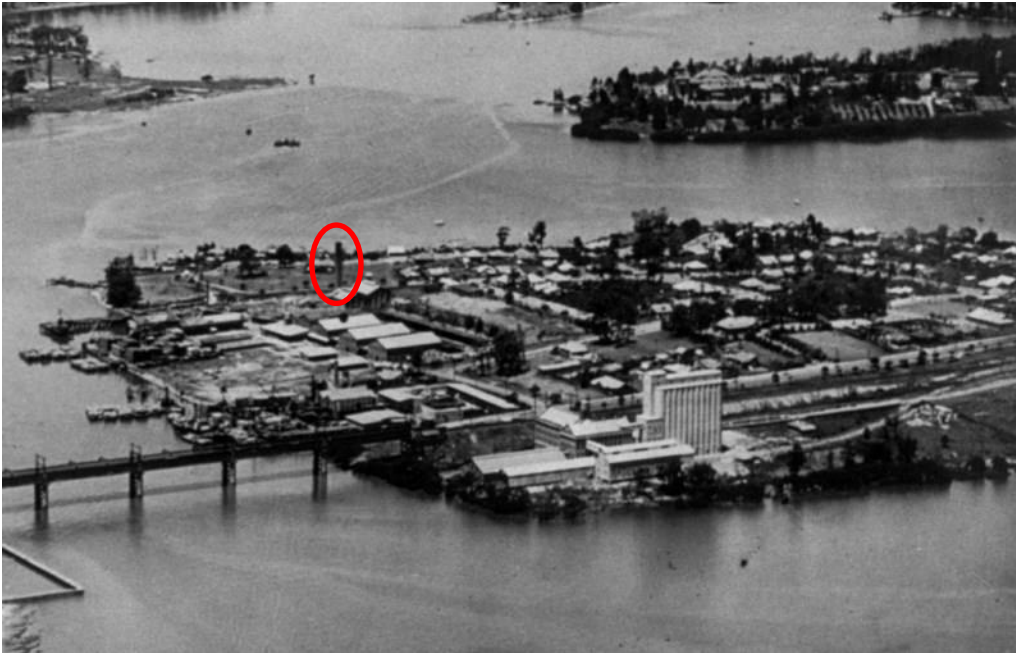
Photo 2: Rhodes Peninsula in 1928 (photo taken towards the east) (sourced from State Library by GBA Heritage). Stack possibly associated with the State Power Station is shown in red circle.

Information from the NSW Government Gazette dated 28 October, 1914 and 19 September, 1922 obtained by GBA Heritage indicates that there was a State Power Station at Uhr's Point which received the major portion of sawmill waste and also had facilities for use of coal. The station appears to have been developed in 1914. A stack can be seen in Photos 2 and 3 which may have been associated with this power station. The power station appears to have been located on the land currently known as Lots 19 and 20 DP239579 (4 and 2 Leeds St).

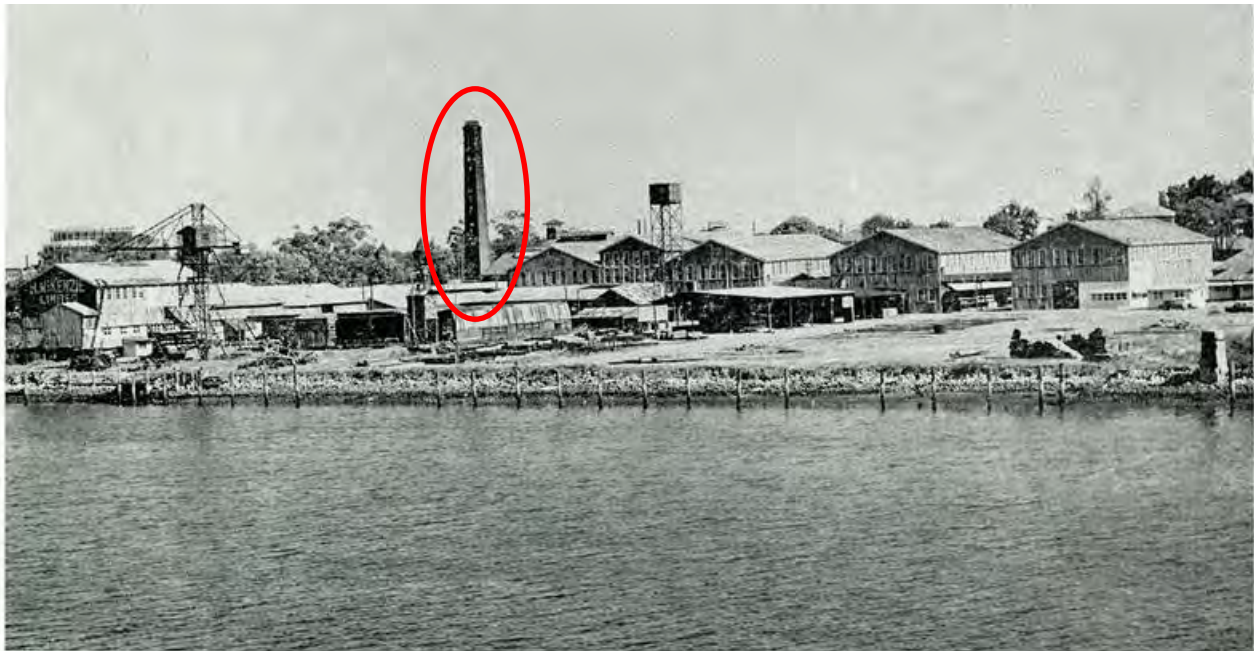
Photo 3: H.McKenzie Limited Timber Merchants circa 1969 (sourced from State Library by GBA Heritage). Stack possibly associated with the State Power Station is shown in red circle.

The NSW State Sawmill site was later purchased by H. McKenzie, timber merchants and joiners who continued on the site until 1969. A photo of the H.McKenzie site is provided below.

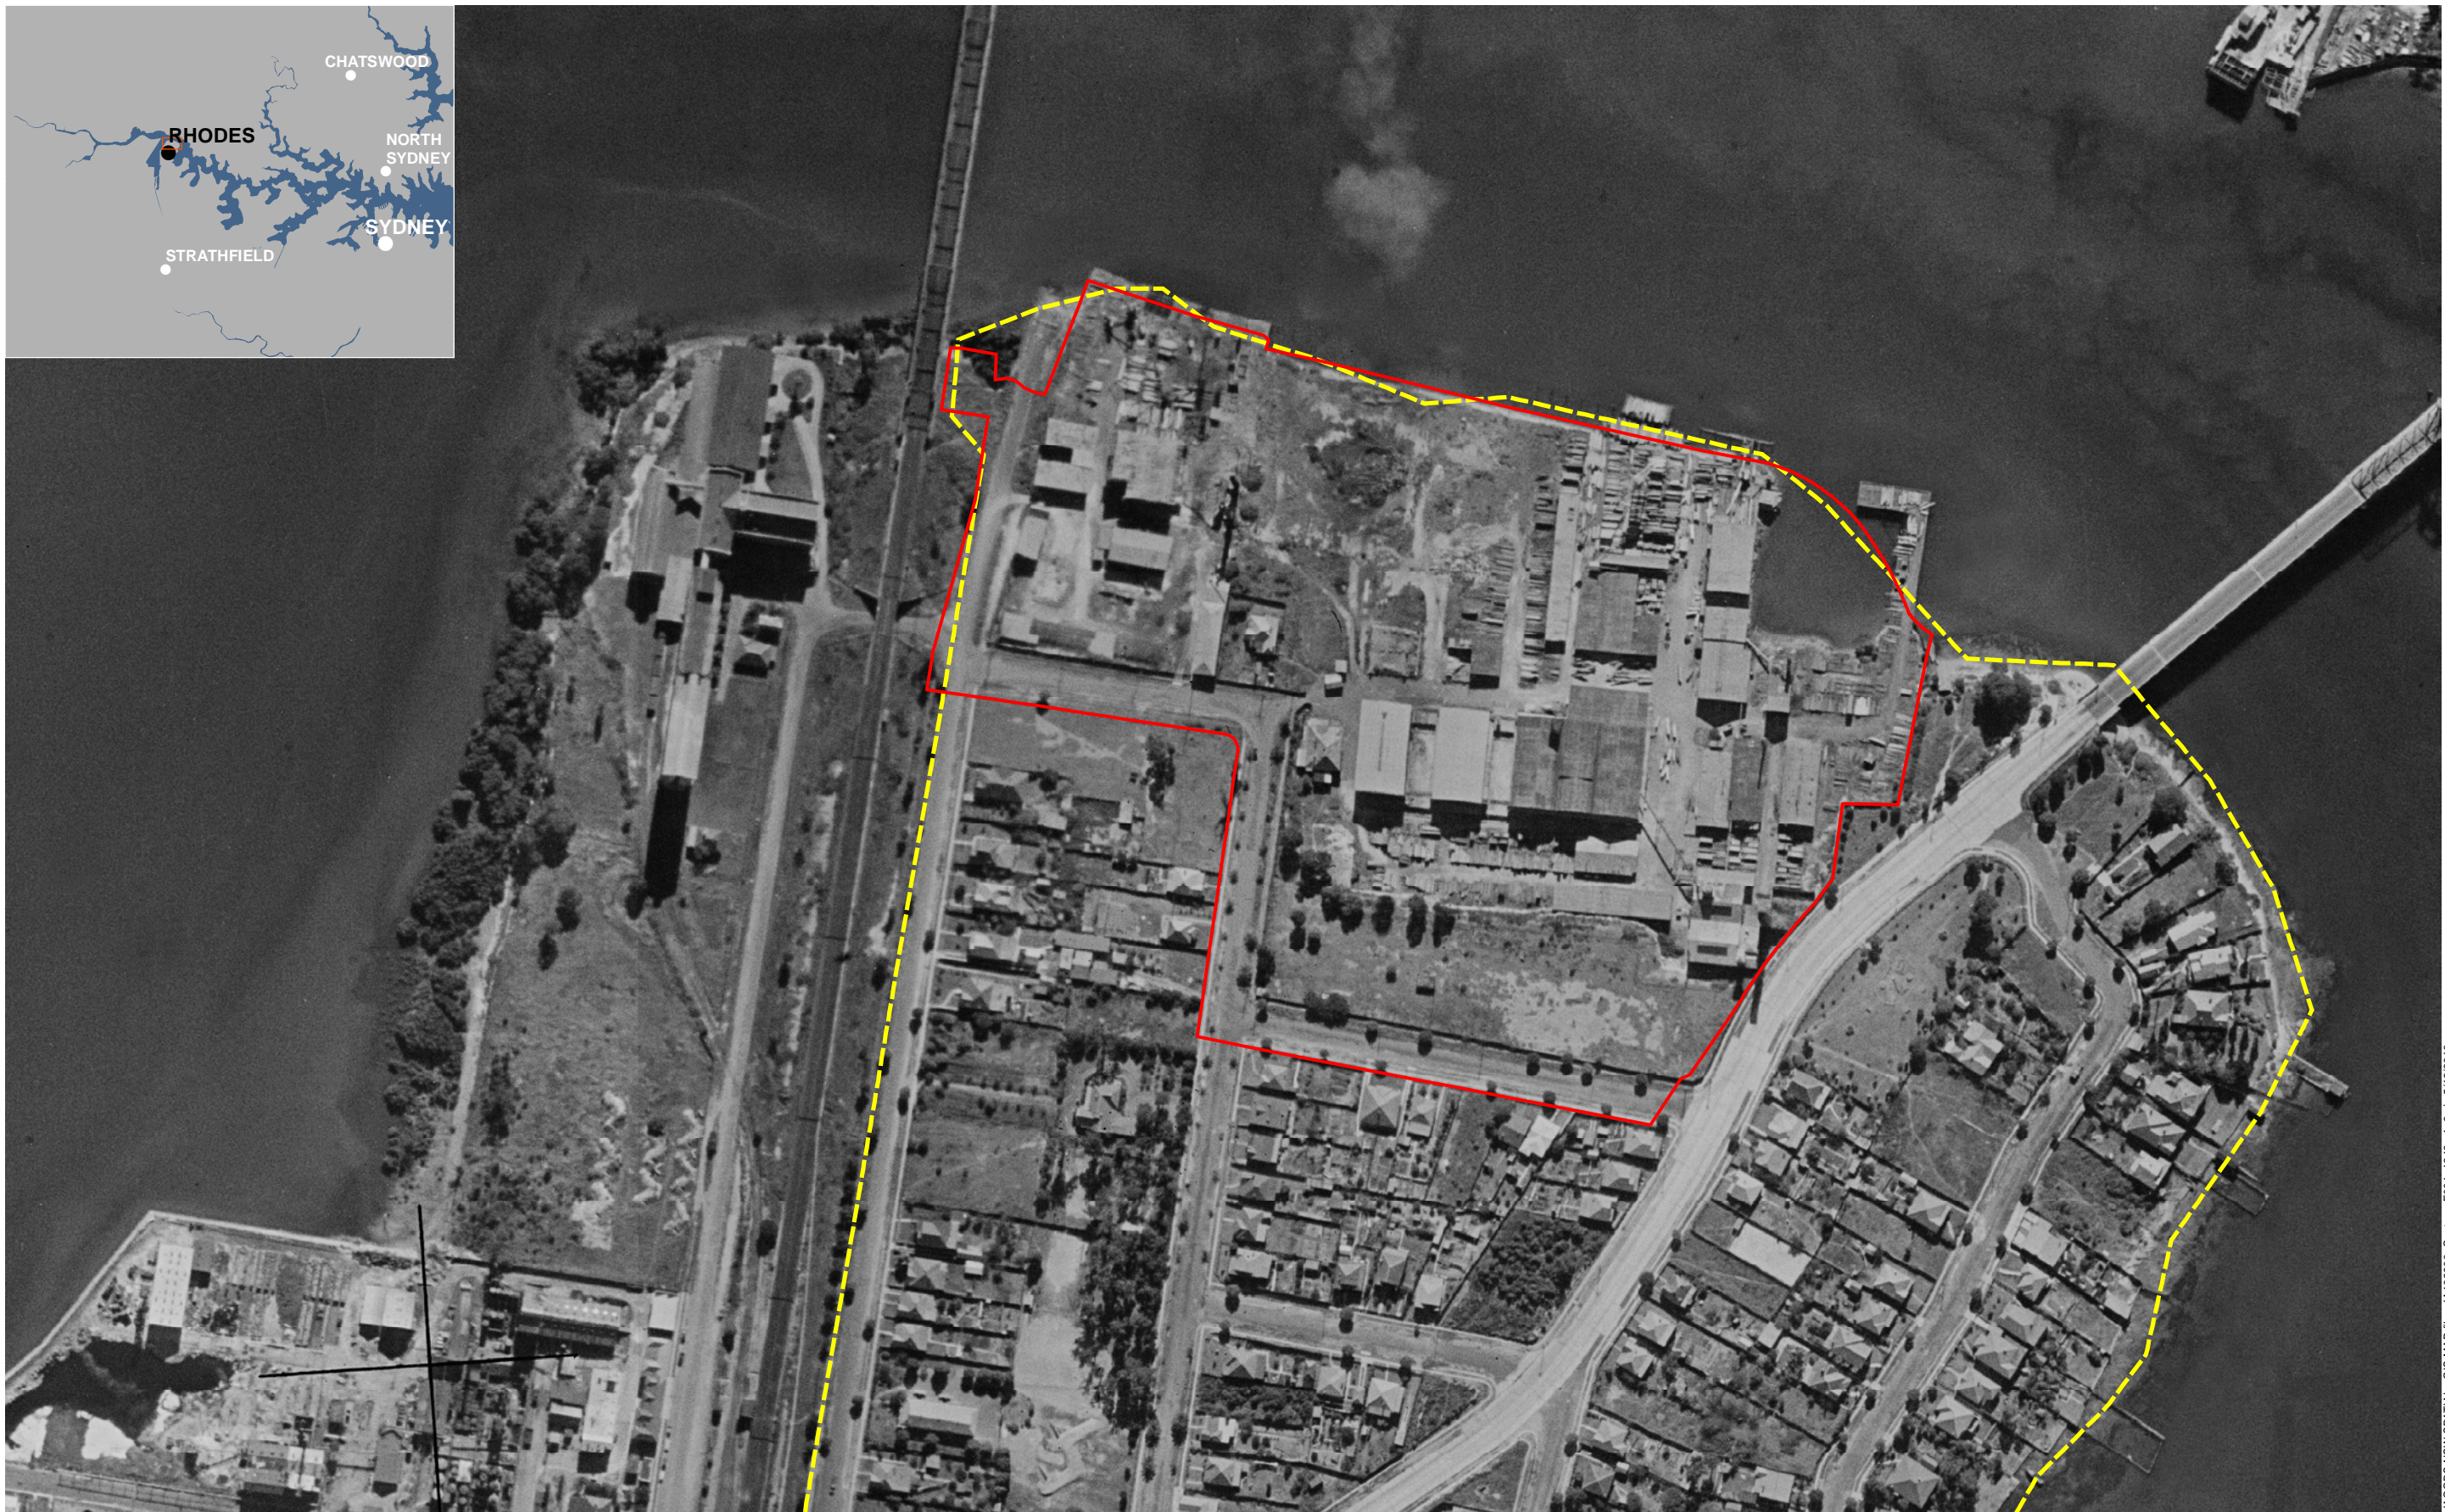
Figure 4 | Aerial photograph from 1930

- The historical titles for several of the properties indicate land along the north of the IN1 area was reclaimed from Parramatta River. The approximate historical shoreline is shown on Figure 4. The reclaimed land was owned by the Maritime Services Board and leased to the adjacent land owners until approximately 1972 when the reclaimed area became part of the adjacent property lots.
