Report on
Phase 1 Contamination Assessment

Proposed Residential Subdivision
Wilton Junction

Prepared for
Elton Consulting Pty Ltd

Project 73467.00
June 2013

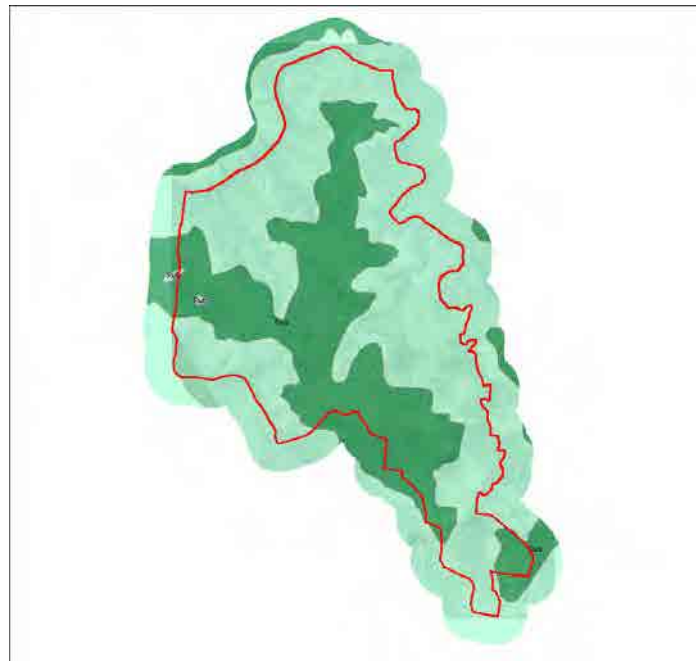
Figure 1: Geology Sheet

The 1:100 000 Wollongong-Port Hacking Geological Series Sheet also indicates that the riparian zones within the Site are underlain by Hawkesbury Sandstone (mapping unit Rh) of Triassic age. This formation typically comprises medium to coarse-grained quartz sandstone, very minor shale and laminite lenses.

The 1:100 000 Wollongong-Port Hacking Geological Series Sheet also indicates that some minor areas are underlain by Bringelly Shale (mapping unit Rwb) of Triassic age. This formation typically comprises shale, carbonaceous claystone, laminite, and coal in parts.

Light green = Ashfield Shale

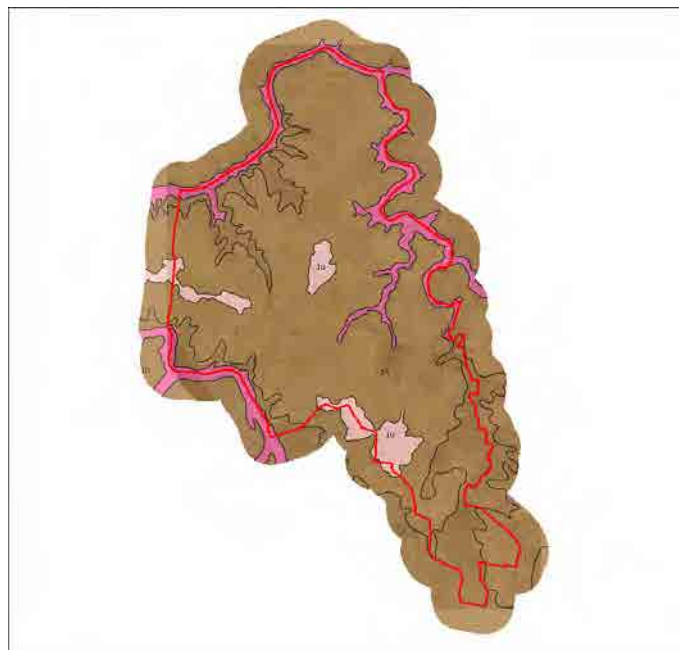
Figure 2: Soil Landscape

Areas surrounding the Nepean River, Cordeaux River and Allen Creek are within Hawkesbury soil landscapes group (mapping unit ha) which is characterised by *Rugged, rolling to very steep hills on Hawkesbury Sandstone*. Hawkesbury soil landscape group is associated with colluvial soils with extreme soil erosion hazard, mass movement (rock fall) hazard, steep slopes, rock outcrop, shallow, stony, highly permeable soil, low soil fertility.

Some areas of the site are situated on the Luddenham soil landscape group (mapping unit lu) which is characterised by *undulating to rolling low hills on Wianamatta Group shales, often associated with Minchinbury Sandstone*. Luddenham soil landscape group is associated with erosional soils with high soil erosion hazard, localised impermeable highly plastic subsoil, moderately reactive.

Brown = Blacktown soil landscape group
Dark Brown = Lucas Heights soil landscape group
Dark Pink = Hawkesbury soil landscapes group
Light Pink = Luddenham soil landscape group

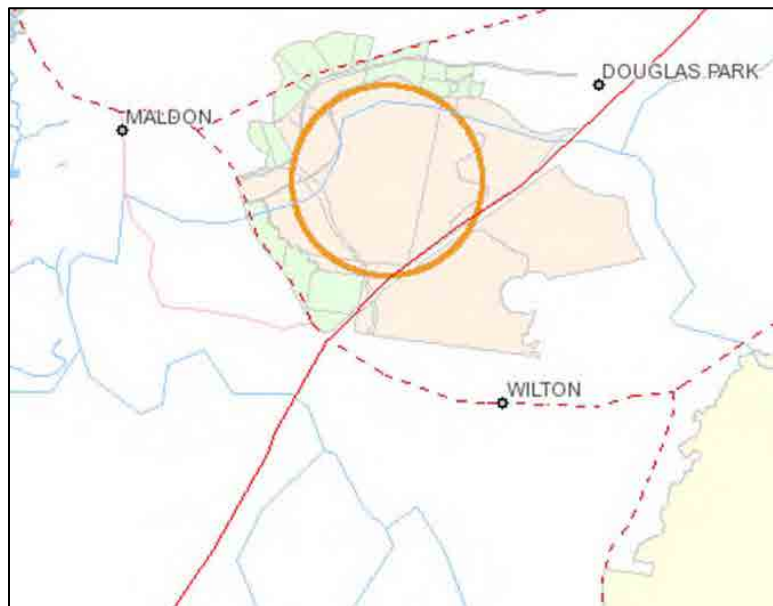
Figure 3: Area affected by Unexploded Ordnance

A search on 25 June 2013 for sites affected by Unexploded Ordnance (UXO) on the Department of Defence website indicated that the site was partially within the Douglas Park World War 2 Bombing Range (refer figure 3). The Department of Defence characterised the site as having a slight UXO potential.

The Department of Defence indicates that sites with a 'Slight' UXO potential are *"areas with a confirmed history of military activities that have resulted in residual UXO but Defence considers it inappropriate to assess as substantial."*

Based on this information, no further investigation of the UXO area within the site is considered warranted from a contamination stand point. DP agree with the JET 1999 report which recommended that subdivision approval should be conditional upon any contractors or workman being alerted to the possible presence of Unexploded ordinance and advised not to move any suspicious items but to call in qualified military personnel for identification and handling.

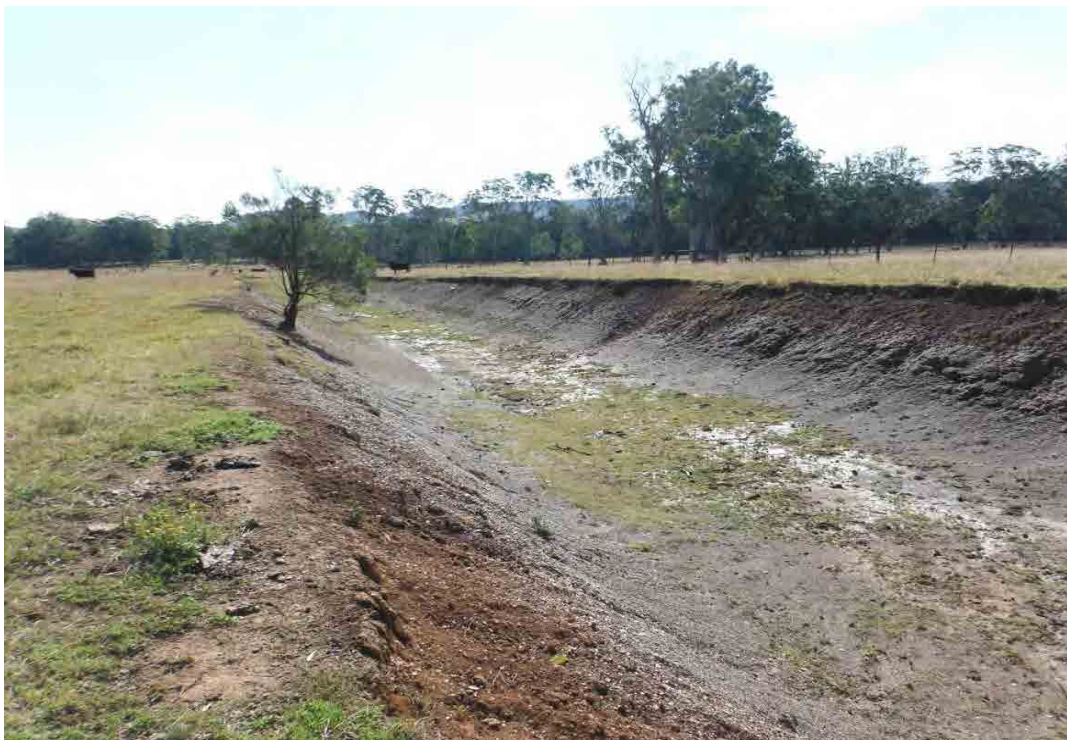
Photo 6 - Excavation observed within railcorridor in Bradcorp Land (PAEC 18 - 20)

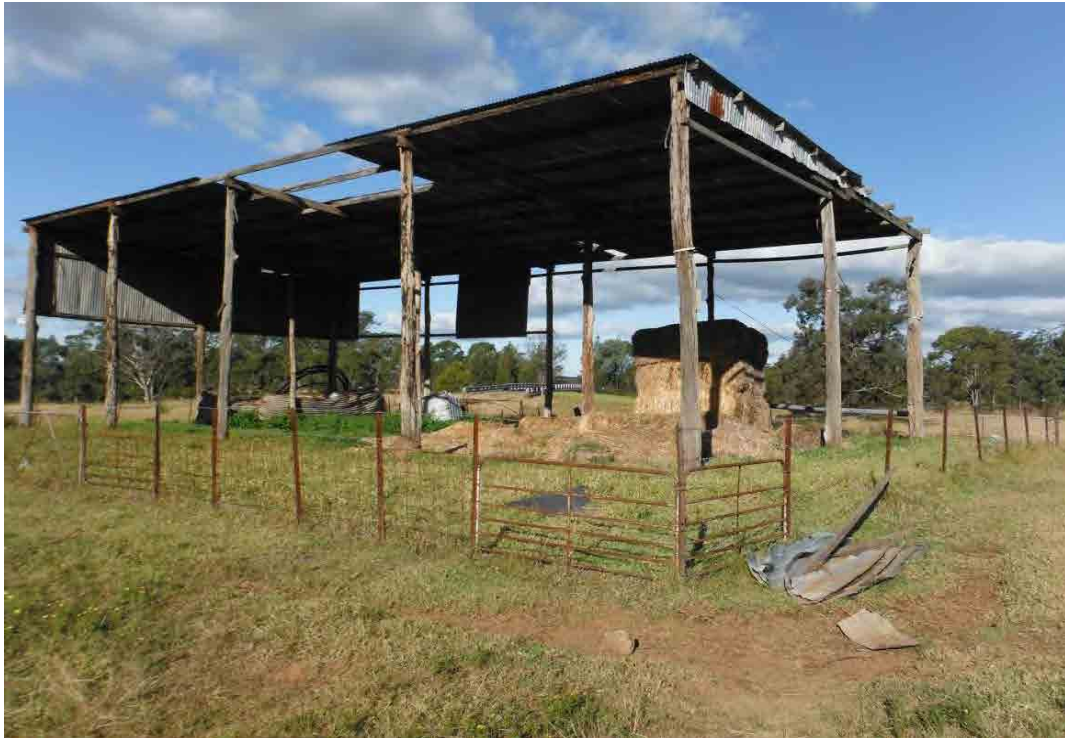
Photo 7 - Hay Shed in Bradcorp Land

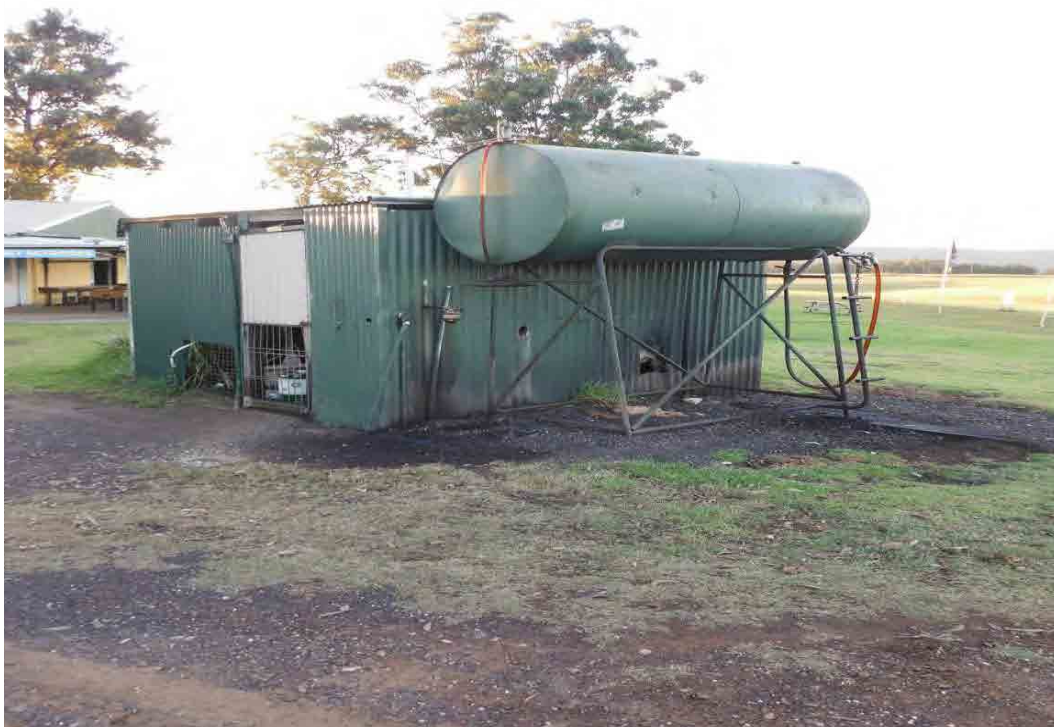
Photo 9 - Deisel AST within AEC38

- A 1000L diesel AST and generator were observed within the airfield area. Ground staining was observed around the AST.
- Two shipping containers (used for storage) were observed to the south of the Jet Fuel tank. Two 44 gallon drums of unleaded petrol were observed within one of the shipping containers. A ride on lawn mower was observed in the second.

| PAEC # | Identified from | Brief Description | Inspection Type | Outcome |
|---|---|--|---|---|
| 70 | Site Inspection | Airfield Area - including Jet Fuel tank, Bowser, Shipping Containers with Fuel Storage within, Diesel AST with generator and staining on ground | - | AEC |

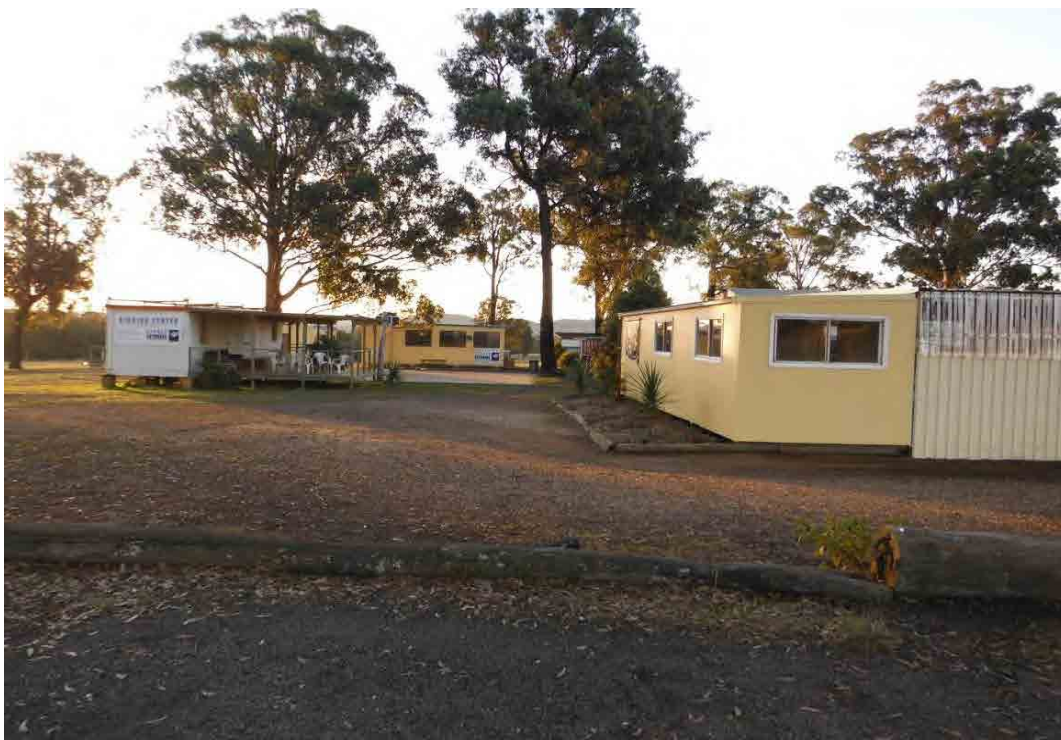
Photo 10 - Buildings associated with the Airfield operations (Within AEC38)

- A minor stockpile of anthropogenic materials were observed with some possible shallow filling within the vicinity of the stockpile.
- The airfield consists of multiple portable buildings and more than 20 caravans. The portable buildings were constructed with cladding and corrugated roofing.

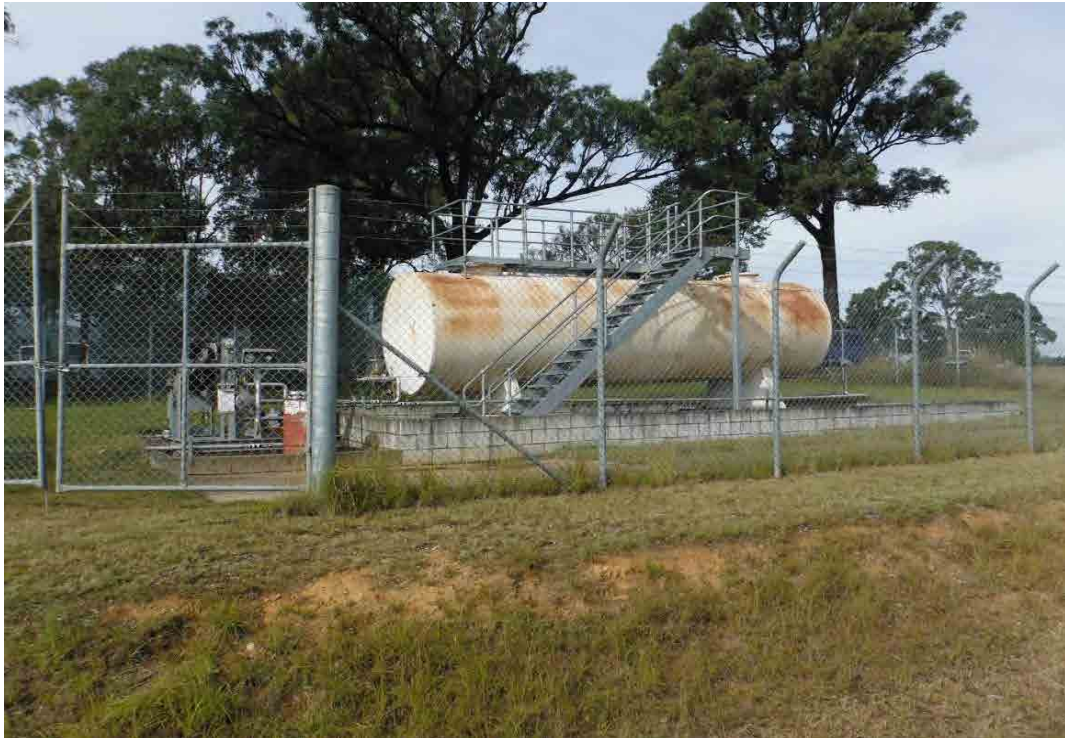
Photo 11 - 30000 L Jet Fuel AST (Within AEC38)

- A 30 000 L above-ground storage tank (AST) of Jet Fuel was located adjacent to the runway within the airfield area. The Jet Fuel bowser is located approximately 20 m from the AST and a fuel odour was noted. Some minor staining was observed around the bowser.

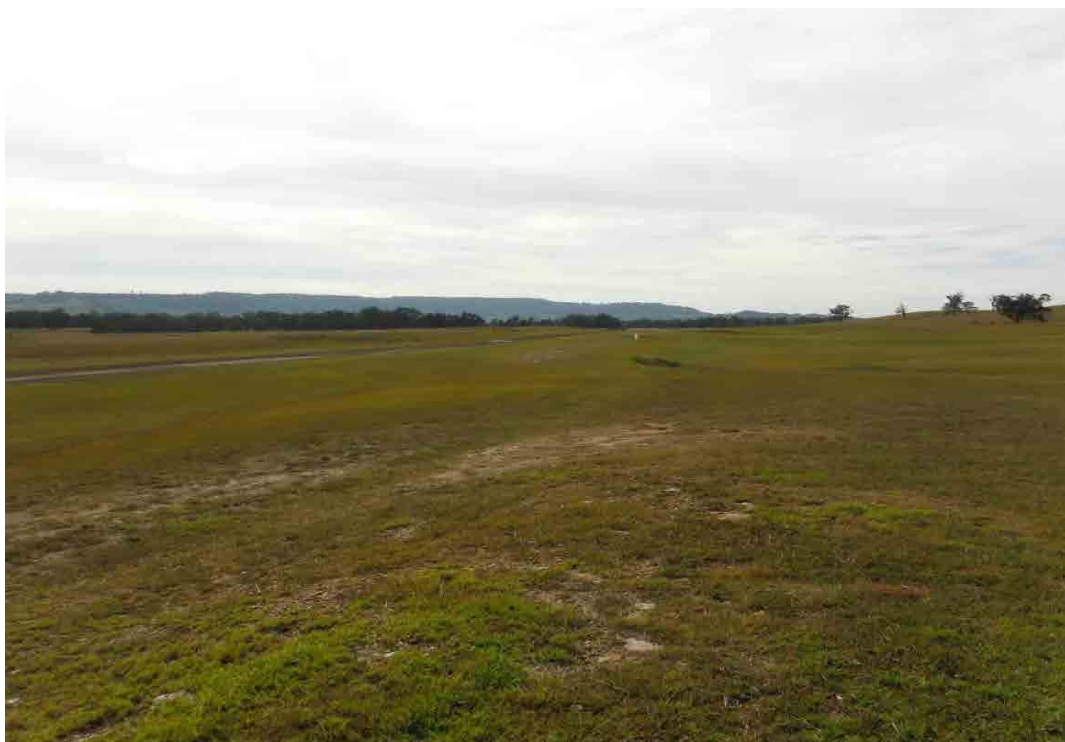
Photo 14 - Runway

- Two runways were observed in approximately perpendicular directions. It appears that some filling would have been required to achieve the current runway level.

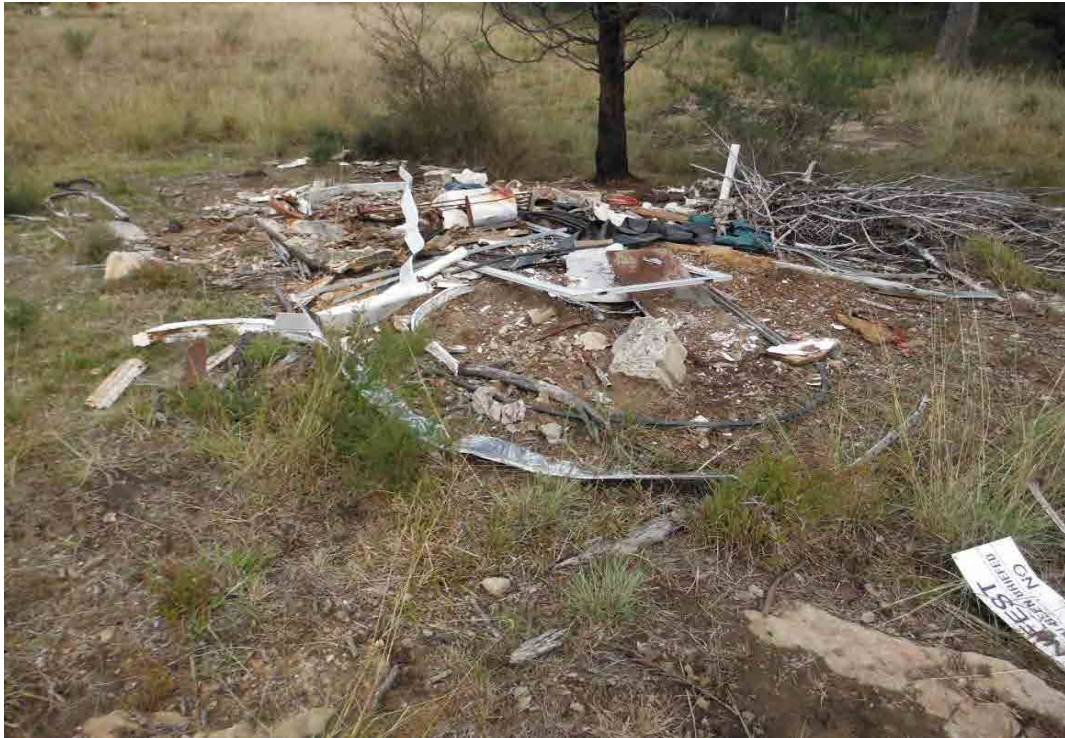
Photo 15 - Surface anthropogenic refuse (AEC53)

| AEC # | PAEC# | Brief Description | Contaminants of Concern |
|---|---|--|--|
| 53 | 85 | Area of landfill, shipping containers and anthropogenic materials observed in stockpiles | Heavy metals, TRH, BTEX, PCB, PAH and asbestos |

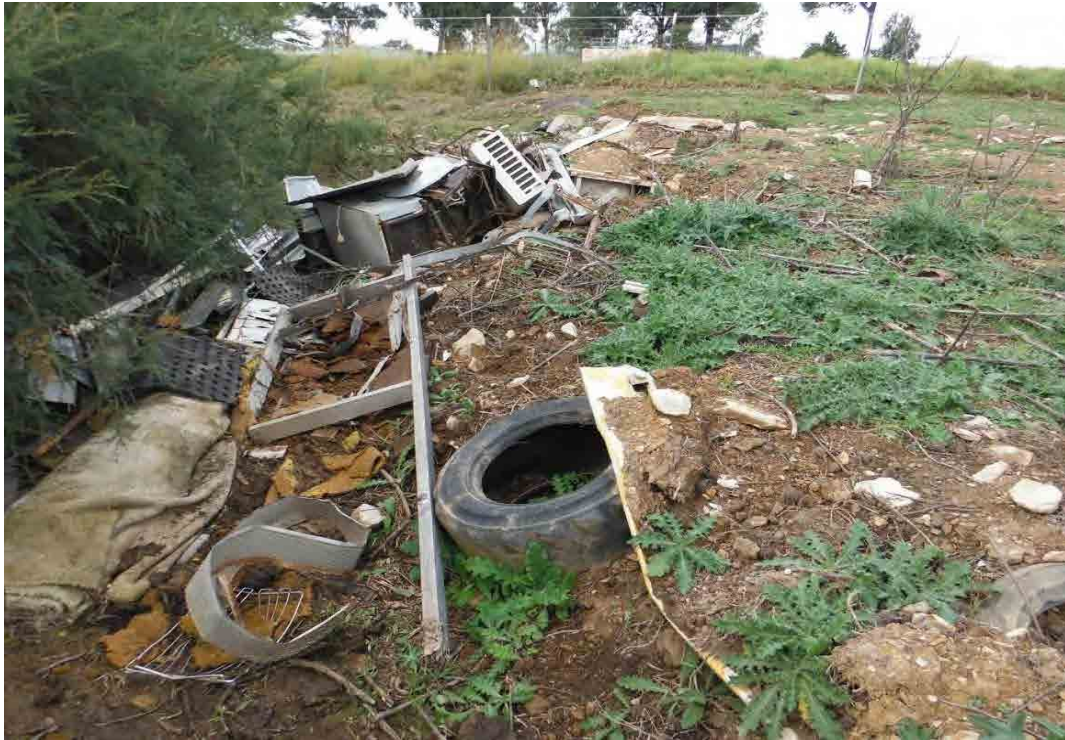
Photo 17 - Land Fill within AEC53

- A toilet block and septic tanks were also observed within the airfield.
- An asphalt stockpile was noted to the south of the airfield.
- A landfill was observed on the northern side of the runway. Anthropogenic materials were observed within the landfill which included metal, plastic, concrete, tyres, wood and fibrous cement fragments (possibly asbestos-containing material).

| PAEC # | Identified from | Brief Description | Inspection Type | Outcome |
|---|---|--|---|---|
| 85 | Site Inspection | Area of landfill, shipping containers and anthropogenic materials observed in stockpiles | - | AEC |

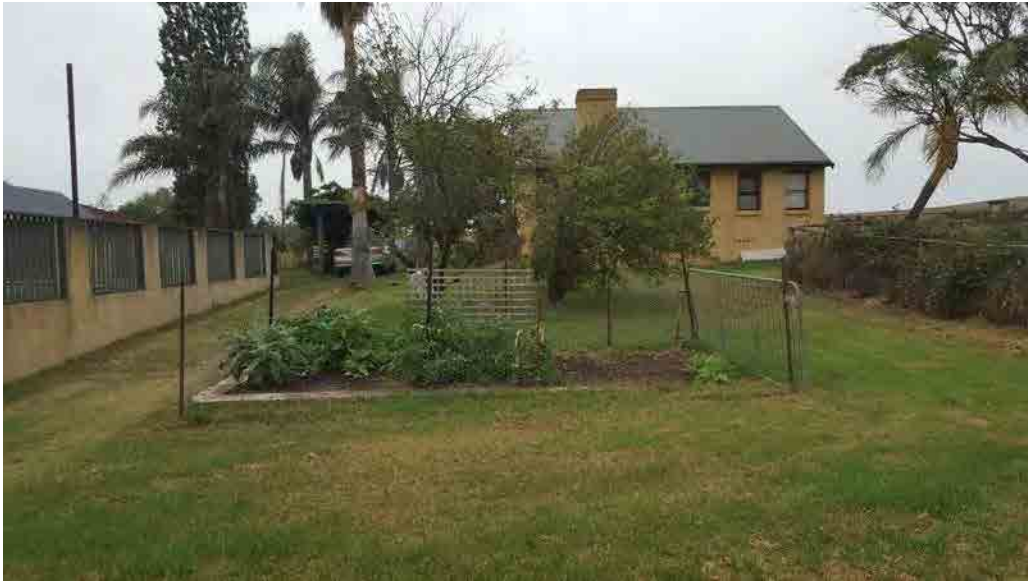
- At the time of the inspection, the balance of the site was used for mixed horse, sheep and alpaca grazing. The house (Photograph 1) appeared to be constructed from brick and concrete or terracotta tile. A fragment of fibre-cement sheeting (laboratory analysis – see attached laboratory report) was observed on the garden surface to the south west of the house. Laboratory analysis did not report any asbestos in the fragment (see attached). A septic tank is located adjacent to the house;

Photograph 1 – House and garden area

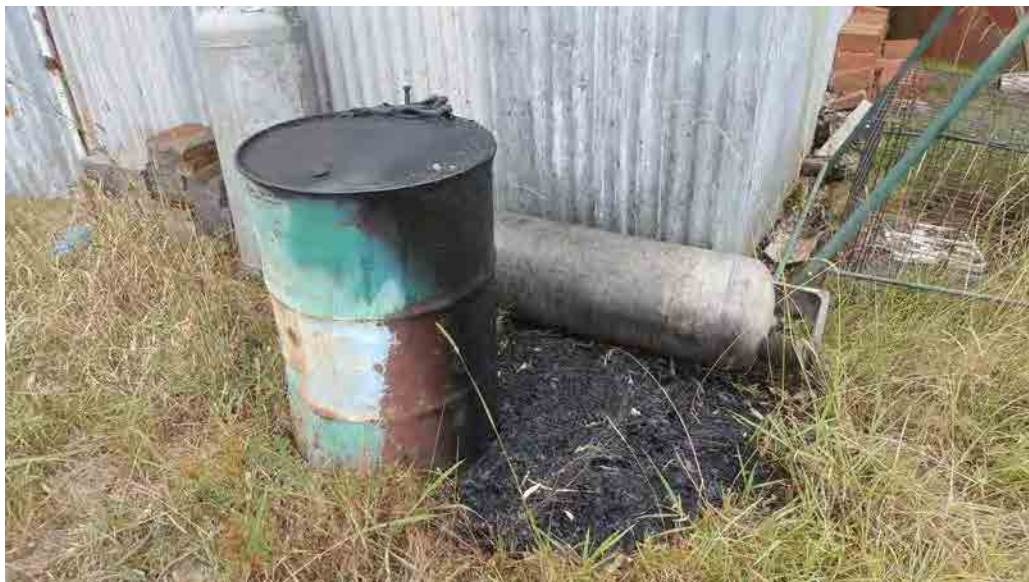
Photograph 2 – Drum and gas cylinder next to corrugated steel shed with charred residue.

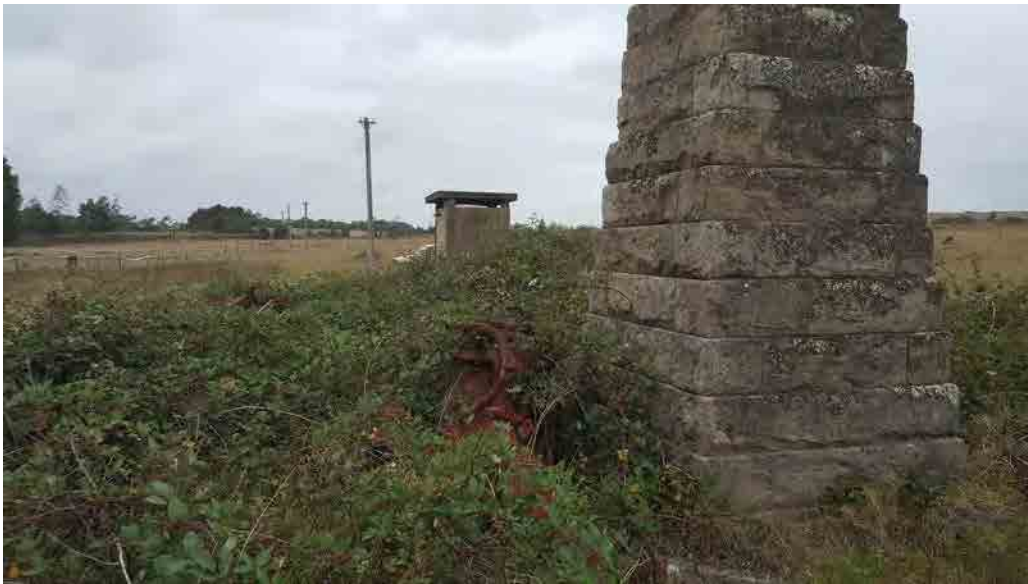
Photograph 3 – Structures possibly from a former homestead

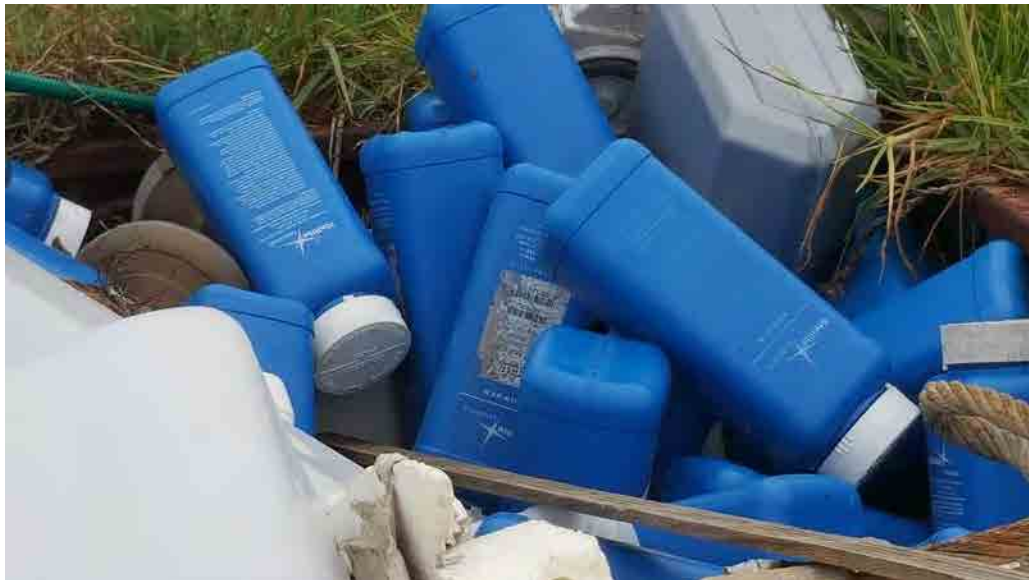
Photograph 4 – Empty containers of 'Stellite Coatings' visible in several areas

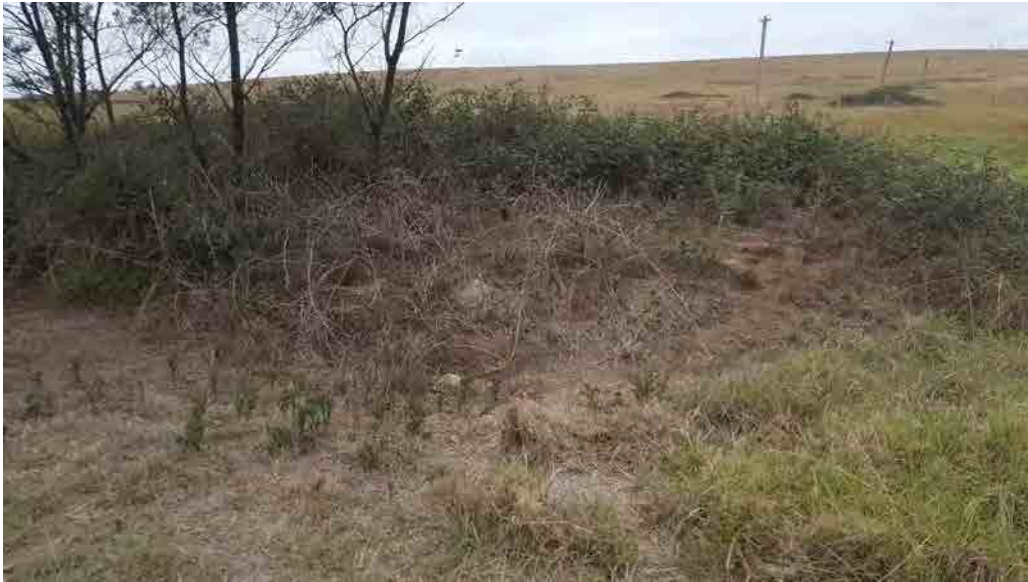
Photograph 5 – Possible fill containing construction and demolition material

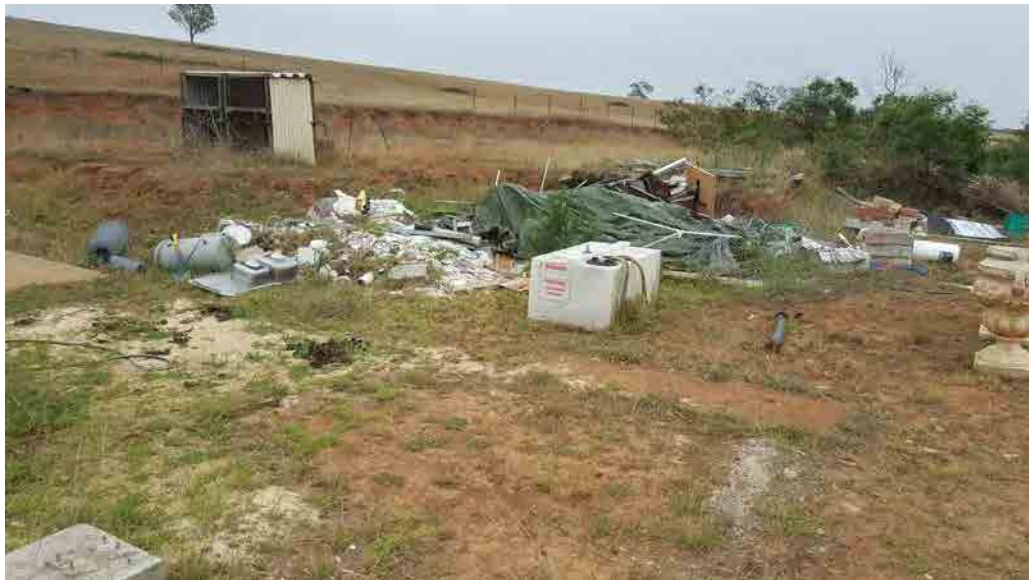
Photograph 6 – Open container with liquid, and labelled as containing pesticides

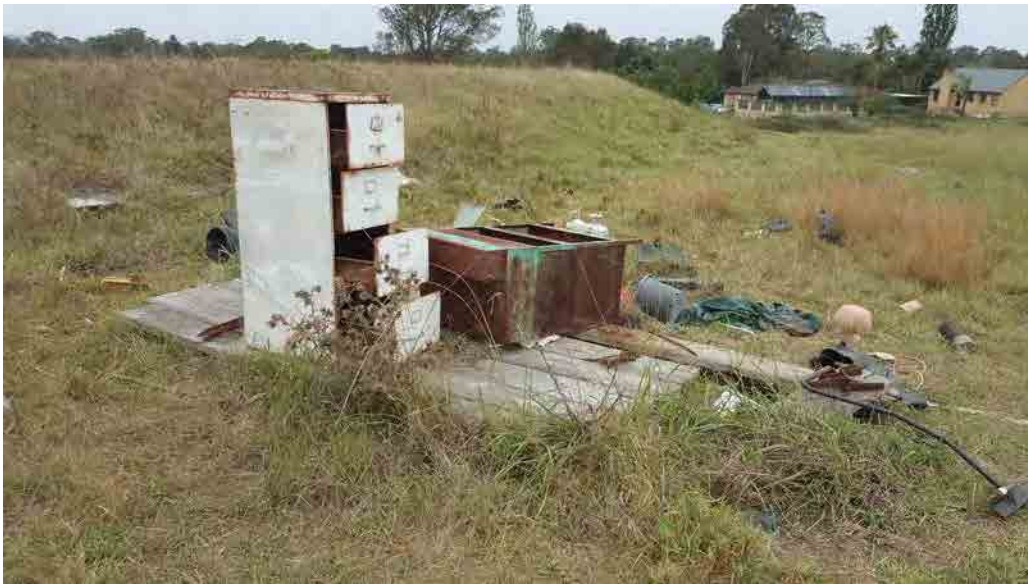
Photograph 7 – Metal furniture and timber visible next to dam near centre of 1000 Picton Road
