Preliminary Environmental Site Assessment – With Supplementary Soil and Groundwater Sampling

West Schofields Part Precinct
Schofields NSW 2762

CSR Ltd C/- Calibre Consulting

July 2016

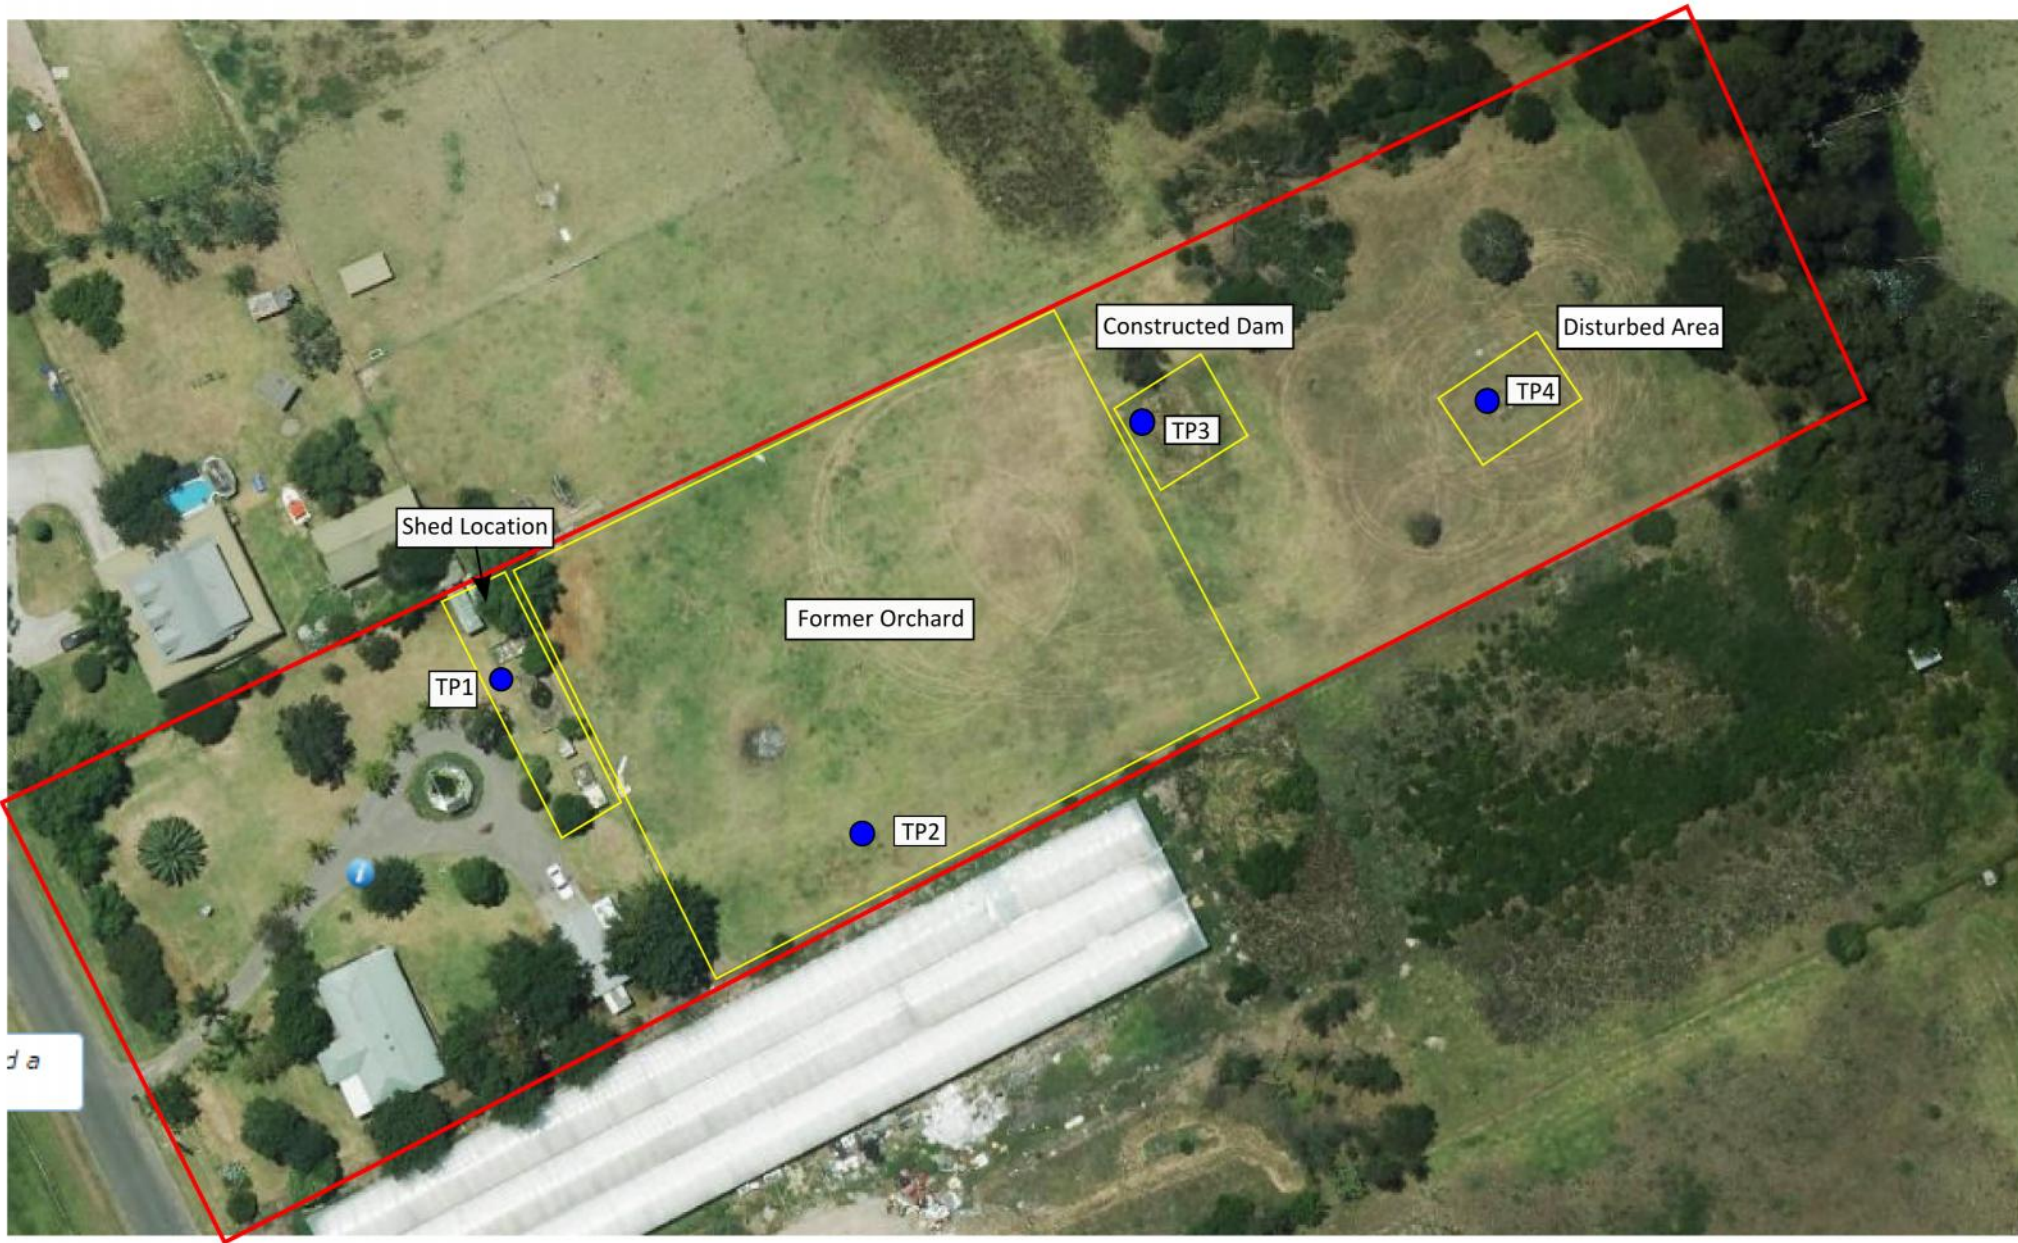
FIGURE 4 – PROPERTY A – SITE LAYOUT WITH SAMPLING LOCATIONS

Property A on Lot 10 DP12076, located within AEC 7, housed a residential weatherboard dwelling with several sheds, aviaries, and a fenced pond. The rear of the property was an open paddock with a dam and bund in the middle of the paddock and remnant vegetation bordering Eastern Creek. No asbestos was identified on the exterior of the sheds and dwelling present. The banks of the dam appeared to be constructed of material generated during the construction of the corresponding dam, with no foreign materials noted on the surface of dam banks. No obvious surface staining, odours, imported fill materials, dangerous goods or items of heritage or archaeological significance were observed across the property during the inspection. A large shed was present on the neighbouring property to the south. Evidence of machinery was observed, however no further evidence of chemical storage could be visually identified during the inspection.

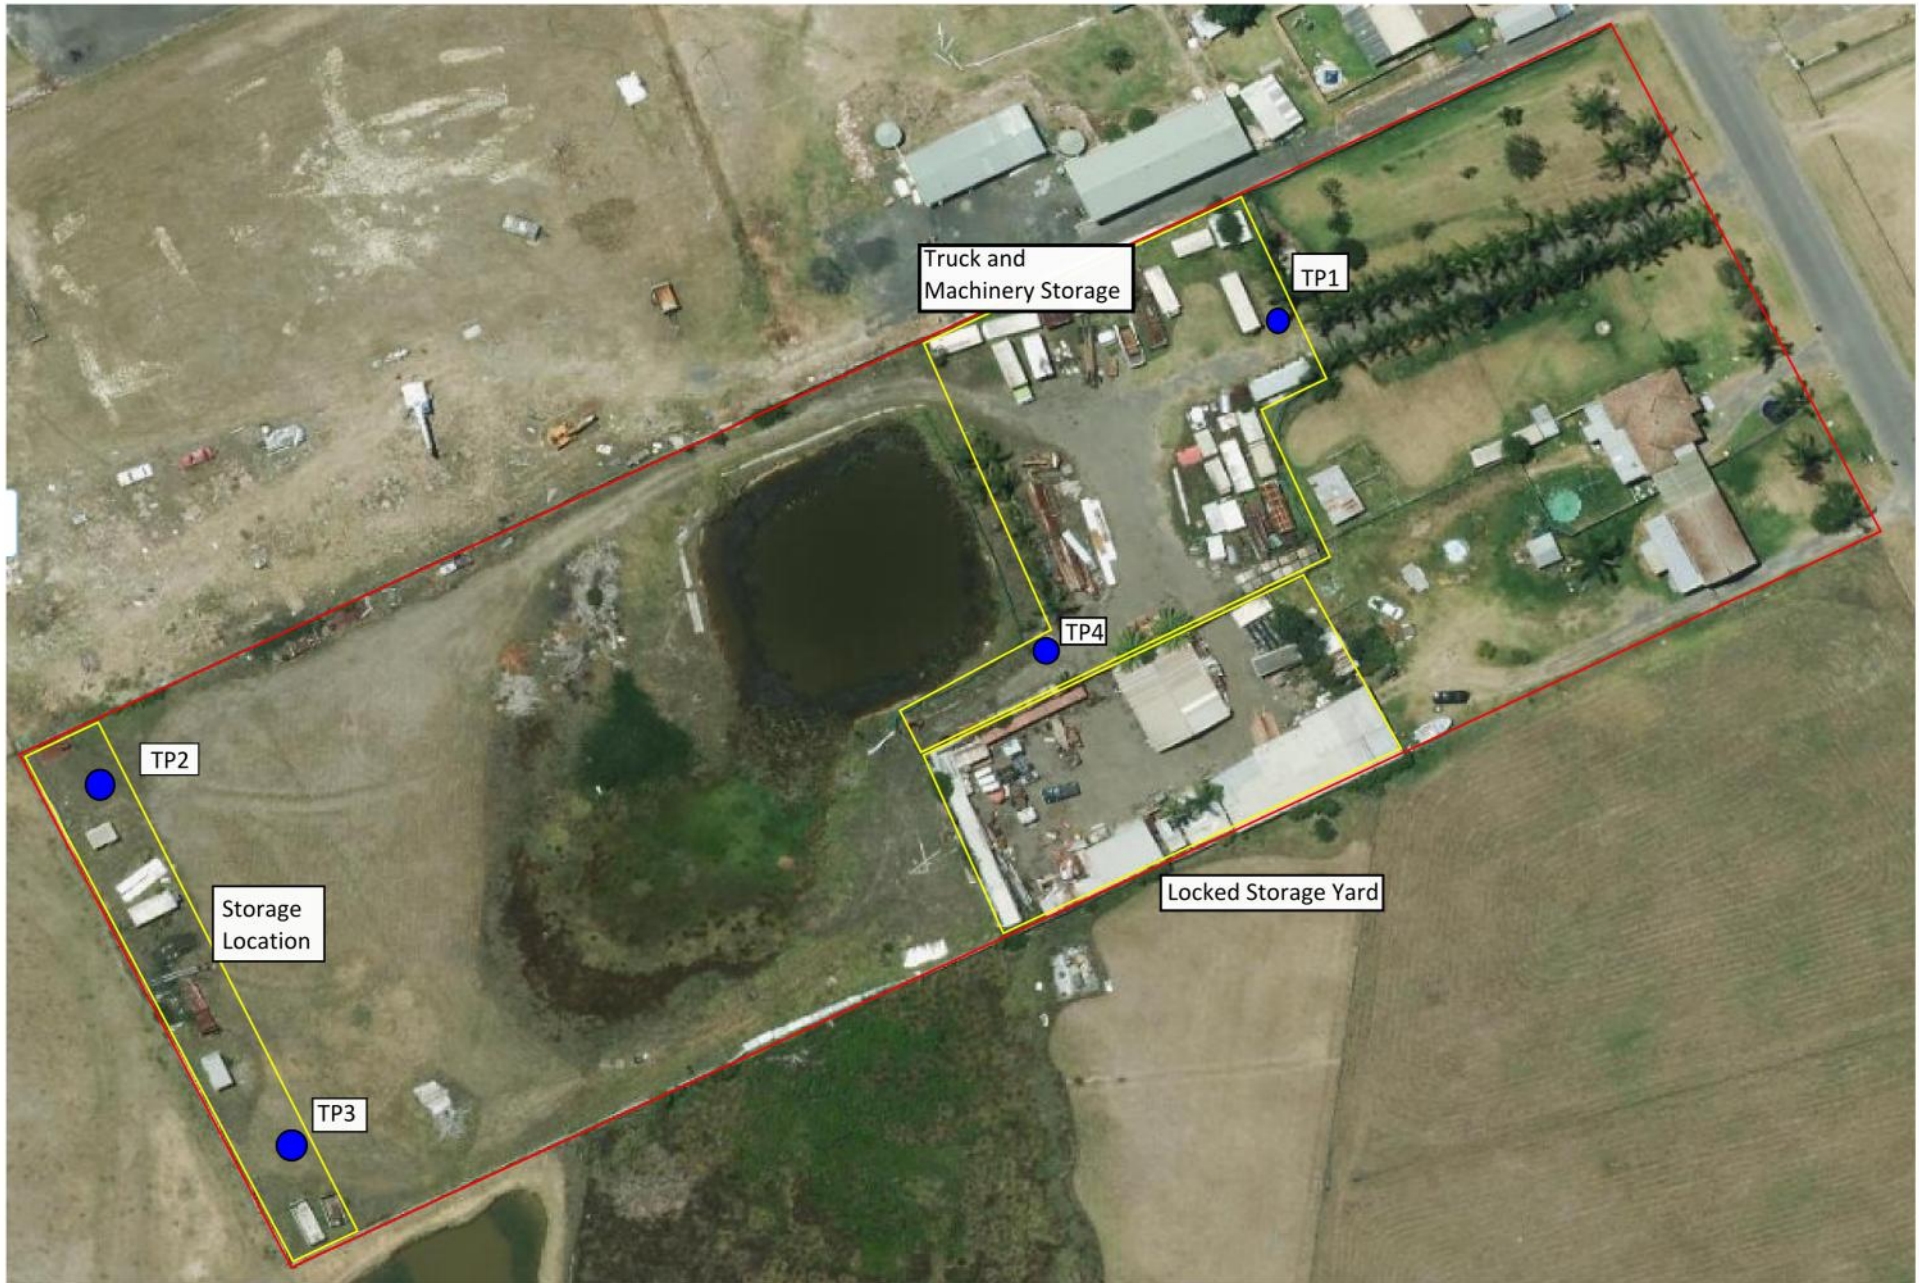
FIGURE 6 – PROPERTY C – SITE LAYOUT WITH SAMPLING LOCATIONS

Property C on Lot 52 DP12076, located within AEC 3, housed a residential dwelling at the front of the property with possible asbestos cladding. The house appeared to be in good condition externally. Maintained gardens surrounded the house and the driveway. In the centre of the property was a storage yard for trucks and machinery. Minor evidence of staining was observed below the trucks during the Site inspection. One test pit was excavated in this location (C-TP1). A locked compound contained additional machinery which was inaccessible during the Site inspection. One test pit was excavated external to the compound adjacent to some machinery (C-TP4). The rear half of the property contained an open paddock with a large dam. At the rear of the property were several storage containers and items of machinery. Two test pits were excavated in this location (C-TP2 and C-TP3). No areas of bulk filling were observed during the test pitting investigation.

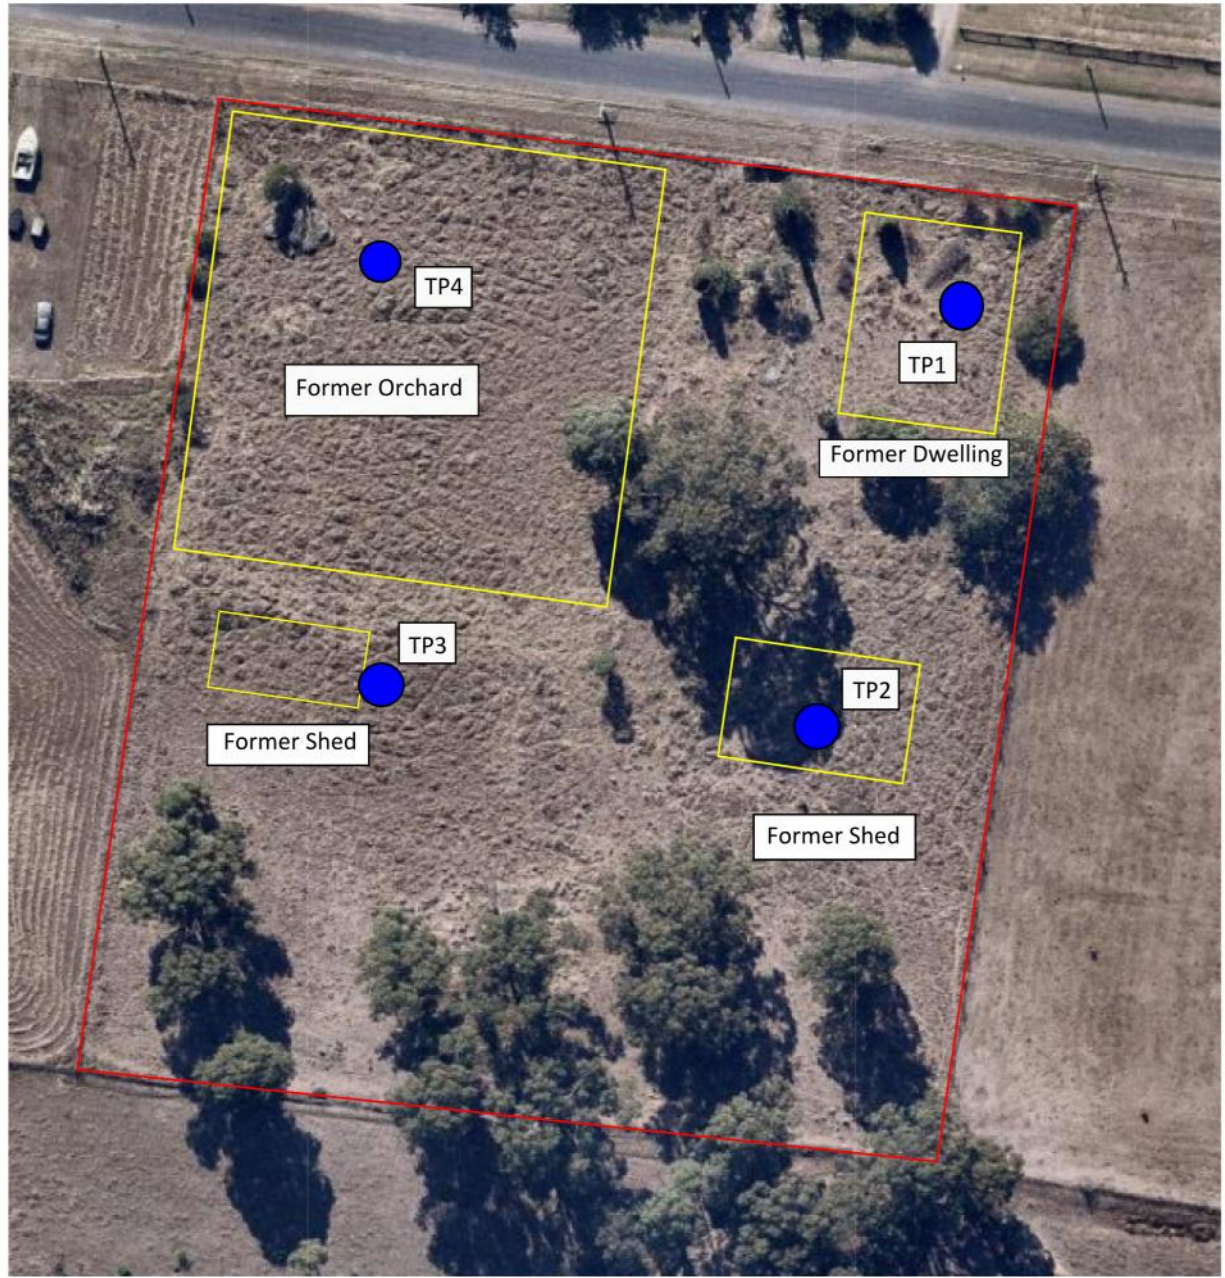
FIGURE 7 – PROPERTY D – SITE LAYOUT WITH SAMPLING LOCATIONS

Property D on Lot 25 DP12076, located within AEC 8, contained an open paddock with remnant vegetation and dense high grasses. A dwelling was removed from the northeast portion of the property in 2014. No evidence of asbestos was identified in the footprint of the previously removed dwelling. One test pit was excavated in this location. Soils were observed to be light brown sandy soils to 0.4m below ground level (bgl) with natural clays below. The previous location of the shed south of the main dwelling had one test pit excavated with natural clay soils observed from 0.4mbgl. Although some rubbish and concrete was observed on the surface no evidence of bulk filling was observed. One test pit was also excavated southwest of the previous primary dwelling location directly adjacent to a concrete slab from the base of a previously demolished shed. Light brown silty soils were observed to be a similar consistency to the main dwelling location with natural clays from 0.3m bgl. The previous orchard location south of the demolished dwelling was also inspected with one test pit excavated with no evidence of fill soils identified. No further evidence of areas of fill were identified during the site inspection.

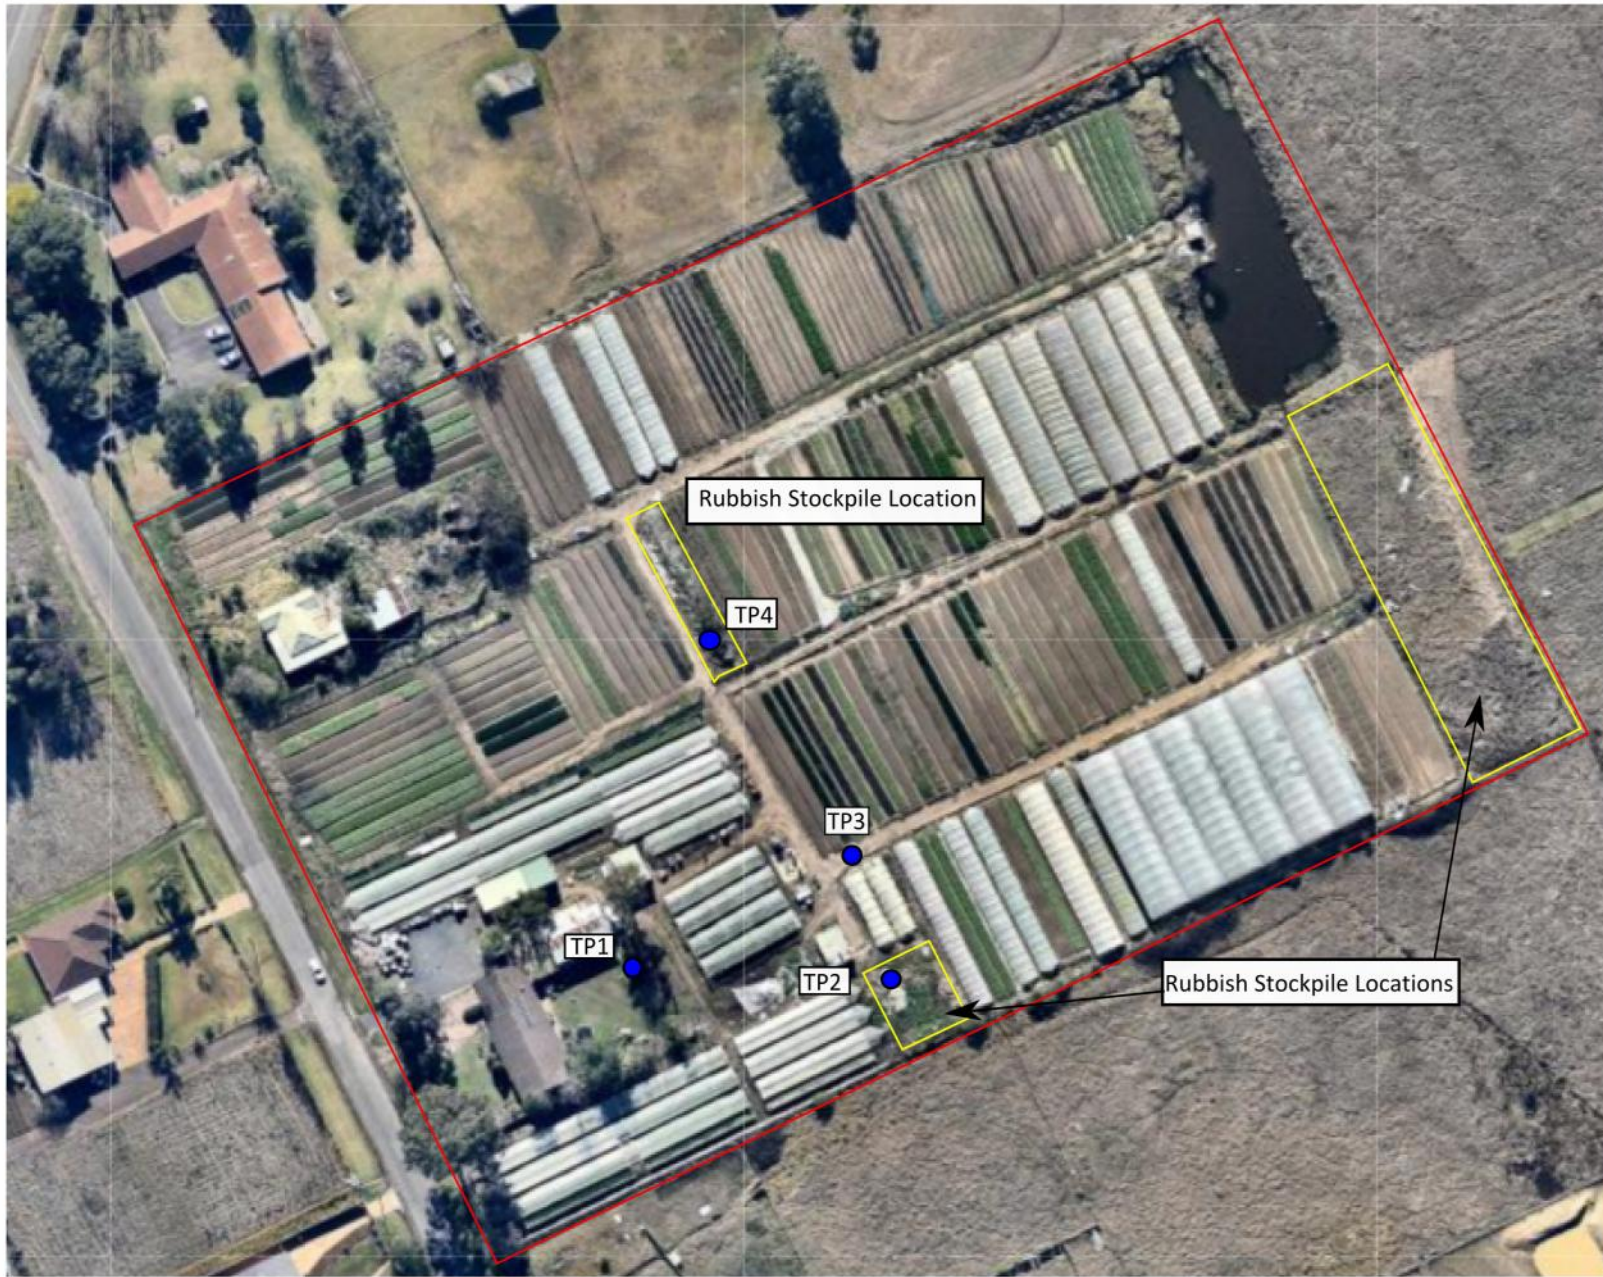
FIGURE 8 – PROPERTY E – SITE LAYOUT WITH SAMPLING LOCATIONS

wide containing unconsolidated rubbish and building materials was in this location. Asbestos fragments and sheeting were observed within the stockpile during the site inspection. Chemical containers were also observed within the fill materials. The rear of the property had previously been identified as a potential area of investigation during the aerial photography review, however this area was inaccessible by the backhoe during the site inspection.

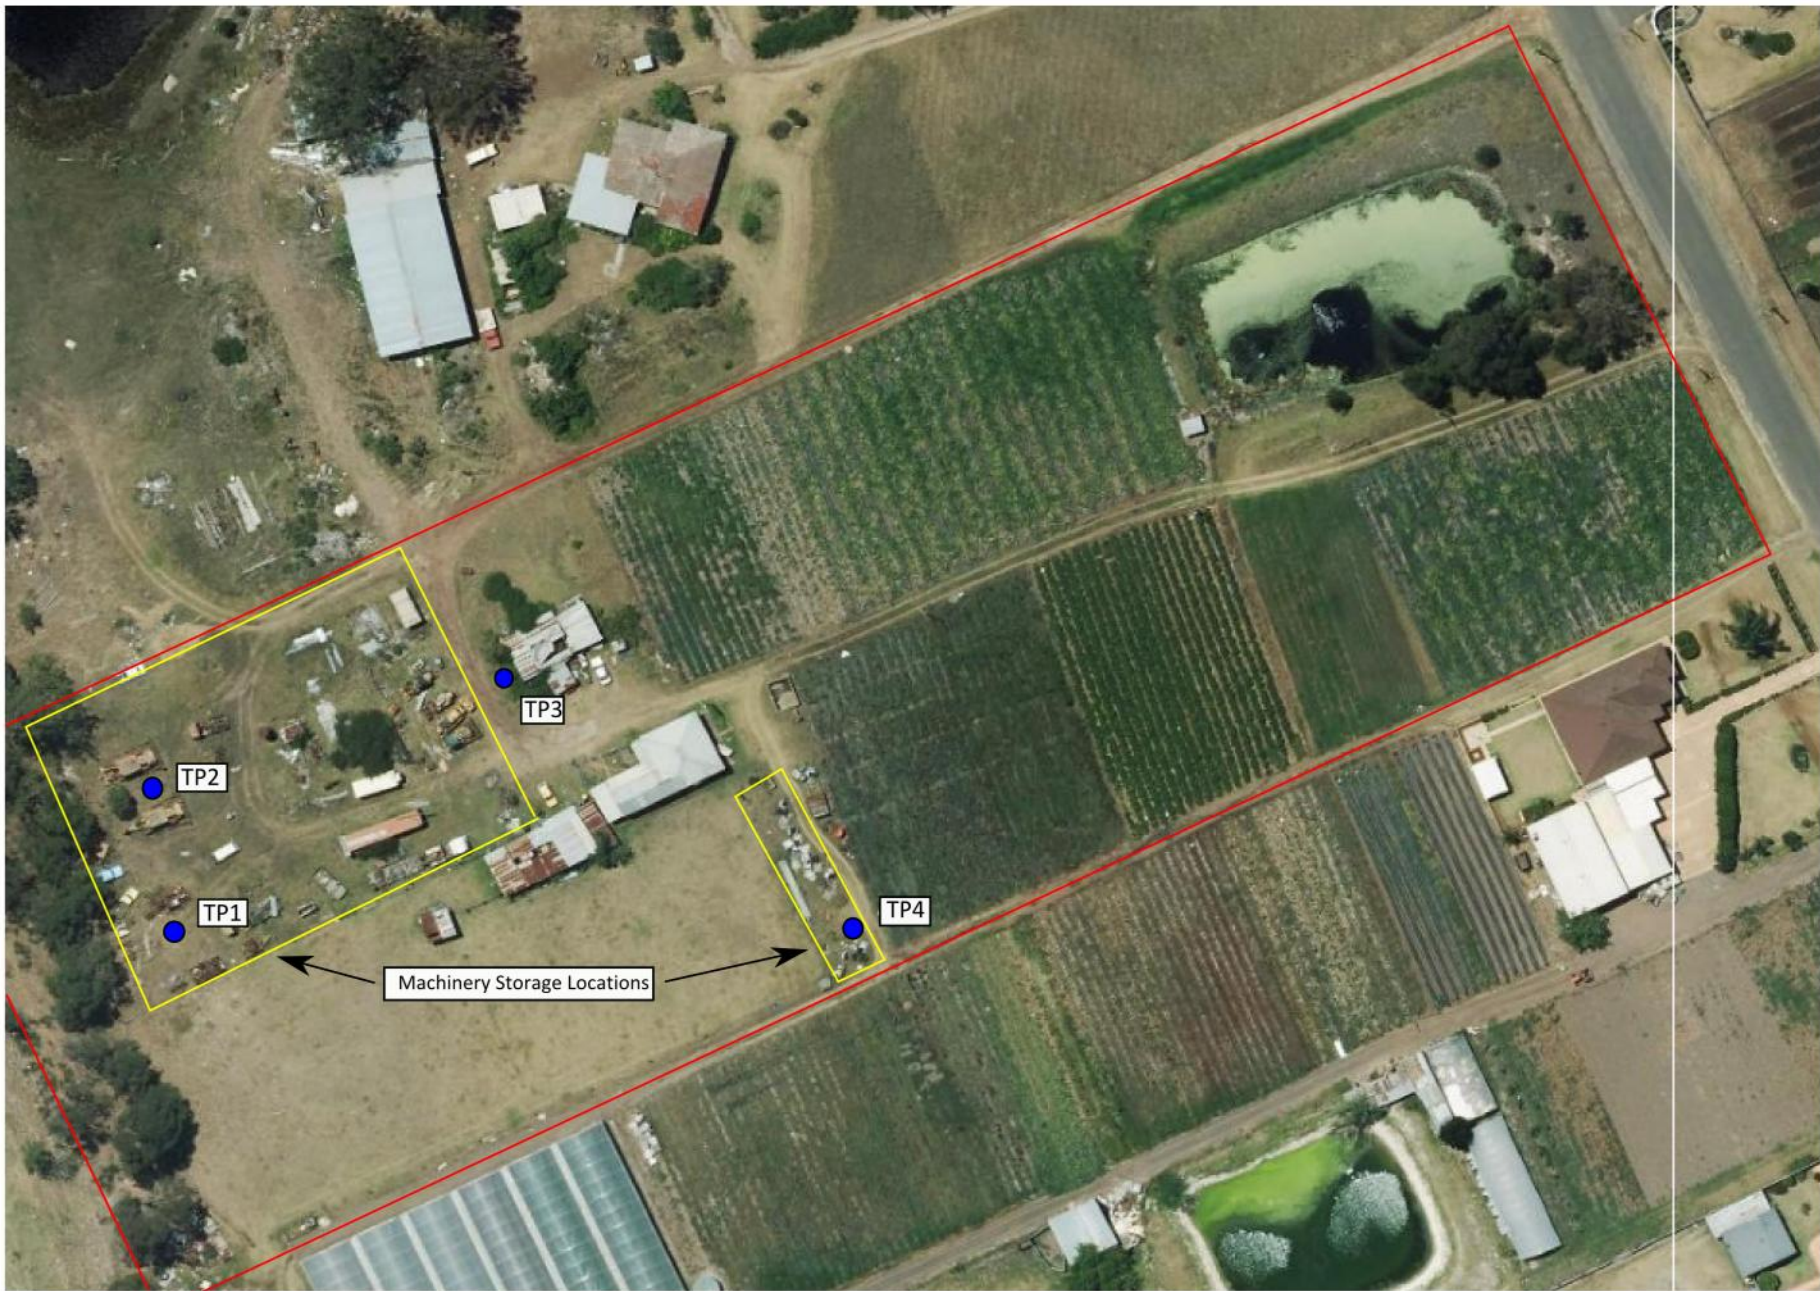
FIGURE 9 – PROPERTY F – SITE LAYOUT WITH SAMPLING LOCATIONS

Property F on Lot 34 DP12076, located within AEC 9, contained a market garden and dam within the eastern half of the property. No evidence of rubbish in fill soils were observed on the external surface of the banks surrounding the dam. A dwelling and two sheds, all containing possible asbestos cladding were located in the central section of the property. Several items of machinery and excavation equipment were located in the centre and western section of the property. Stained soils were observed in several locations in this area surrounding the machinery. The remaining area of the property was sparsely vegetated with tall grasses. Four test pits were excavated on the property. F-TP1, located in the western portion of the property contained red silty soils to 0.2m bgl with natural red clays from 0.2 m. Asbestos fragments were also observed on the ground surface surrounding the test pit. No areas of fill were identified surrounding the test pit location. F-TP2, located within the machinery storage area contained some stained brown silty soils with inclusions of building rubble to 0.5m bgl. Potential hydrocarbon contamination was observed surrounding the test pit. F-TP3, located directly adjacent to the northern shed on the property was observed to contain silty topsoil to 0.3m with natural red clays from 0.3m. Several lengths of asbestos pipe were also observed in this location. The cladding on the adjacent shed was observed to be in poor condition. F-TP4, was located southeast of the main dwelling adjacent to the market garden. Some machinery was also located in this location. The material consisted of dark brown topsoil to 0.3m bgl with natural orange and grey mottled clays from 0.3m. No other evidence of fill areas were observed during the site inspection.

- Removal of asbestos fragments found on the ground surface on Property F (within AEC 9) should be undertaken by a licenced asbestos removalist. The area will then need to be validated by a licenced asbestos assessor;

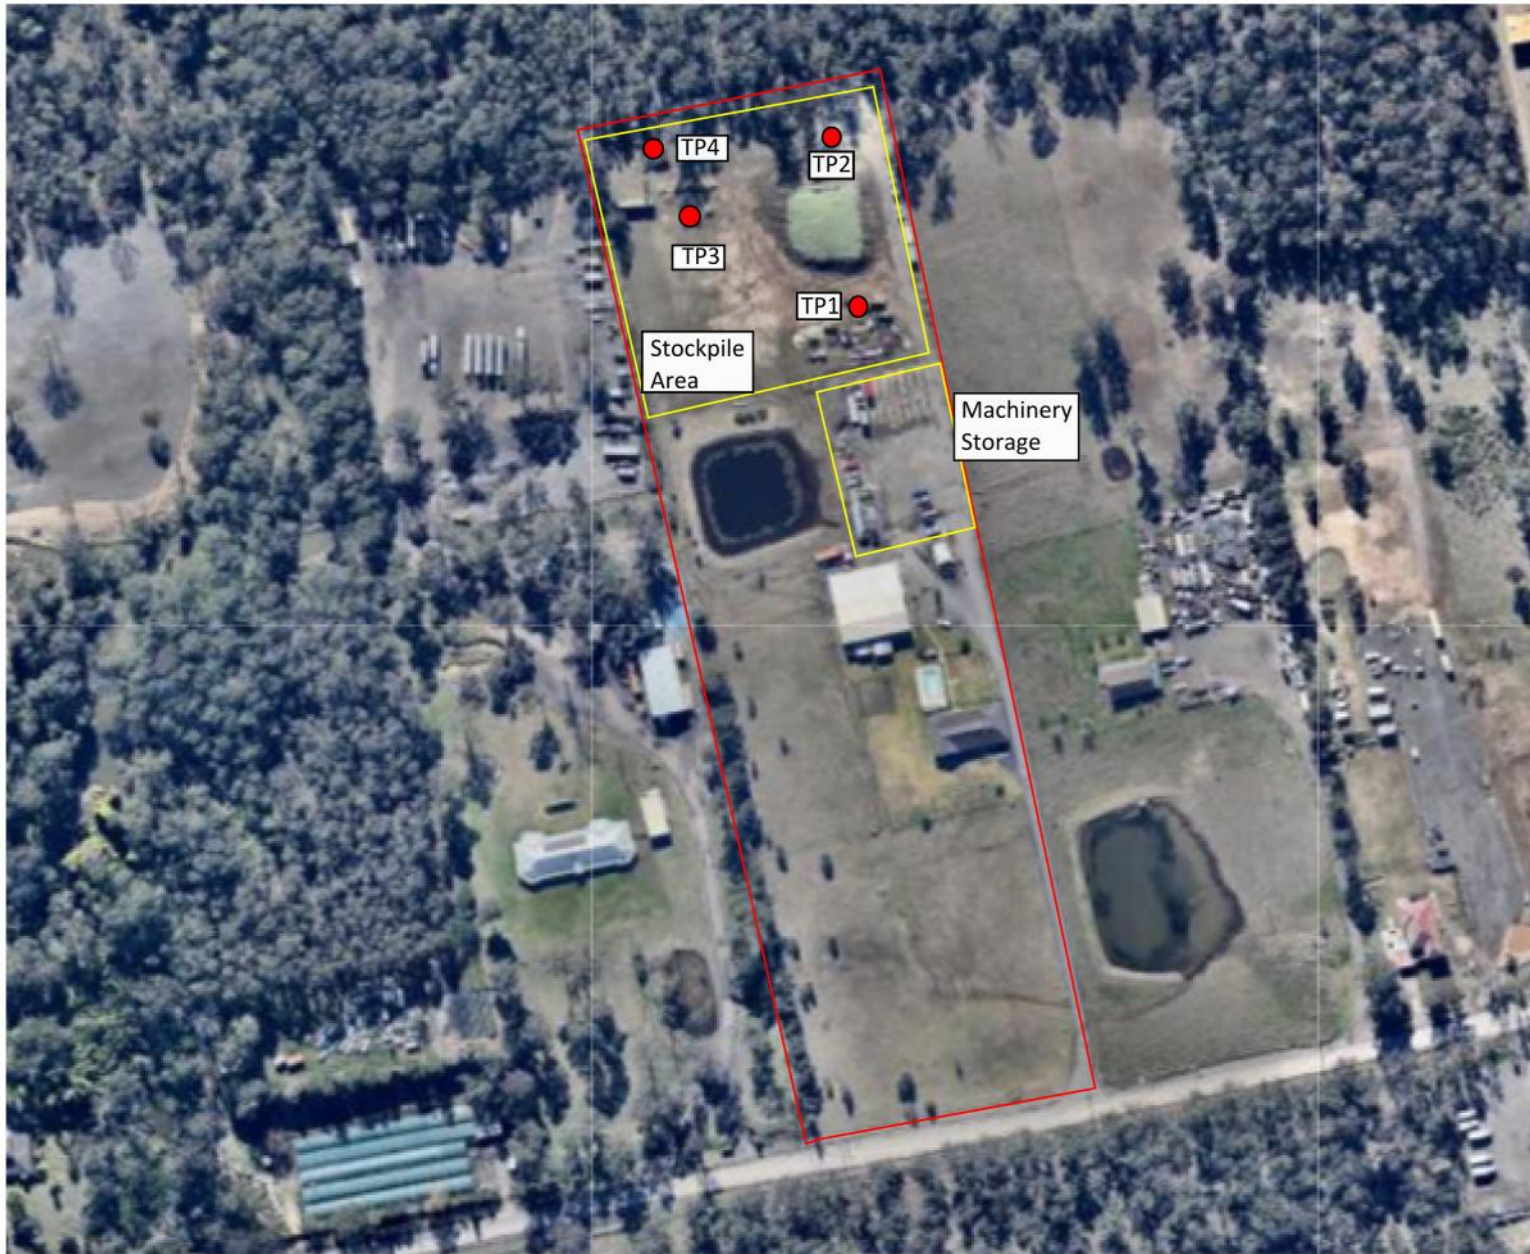
FIGURE 10 – PROPERTY G – SITE LAYOUT WITH SAMPLING LOCATIONS

Property G on Lot 9 DP17048, located within AEC 4, contained a trucking and storage business. The front section of the property contained an open horse paddock with remnant vegetation bordering the property to the west. The main dwelling on the property is constructed of brick and tile with a large storage shed located behind it. A long asphalt driveway leads to a trucking storage yard with two 27,500L above ground diesel storage tanks (ASTs). The ASTs were in good condition and housed within a walled compound. No evidence of spillage was evident at the time of inspection. Several trucks, storage containers and items of machinery were present within the bitumen driveway and gravel storage yard. Surface staining was evident in several locations throughout the driveway and yard area consistent with its land use. The large storage shed was unable to be accessed at the time of inspection. Four test pits were excavated at the rear of the property within an area of historical stockpiling and machinery storage. G-TP1 was excavated in a grassed area next to a stockpile of sand, building rubble and steel. The stockpile was situated on natural red clays below 0.2m bgl. A large stockpile of dark brown silty clay material approximately 600m³ in size appeared to have no inclusions

and could possibly have been excavated material from the Site. G-TP2 was excavated at the rear of the property directly adjacent to a stockpile of mixed clays. The stockpile was inspected by the backhoe and no inclusions were observed in the top 0.5m excavated. G-TP3 was excavated into a stockpile on the western side of the rear yard. Six small stockpiles were located in this area with inclusions of bitumen, concrete and steel. Some small fragments of fibrous cement material were observed in the yard that were confirmed to contain no asbestos. G-TP4 was excavated at the very rear of the property within an area housing vintage trucks in a state of disrepair. No evidence of hydrocarbon staining was observed surrounding the vehicles.

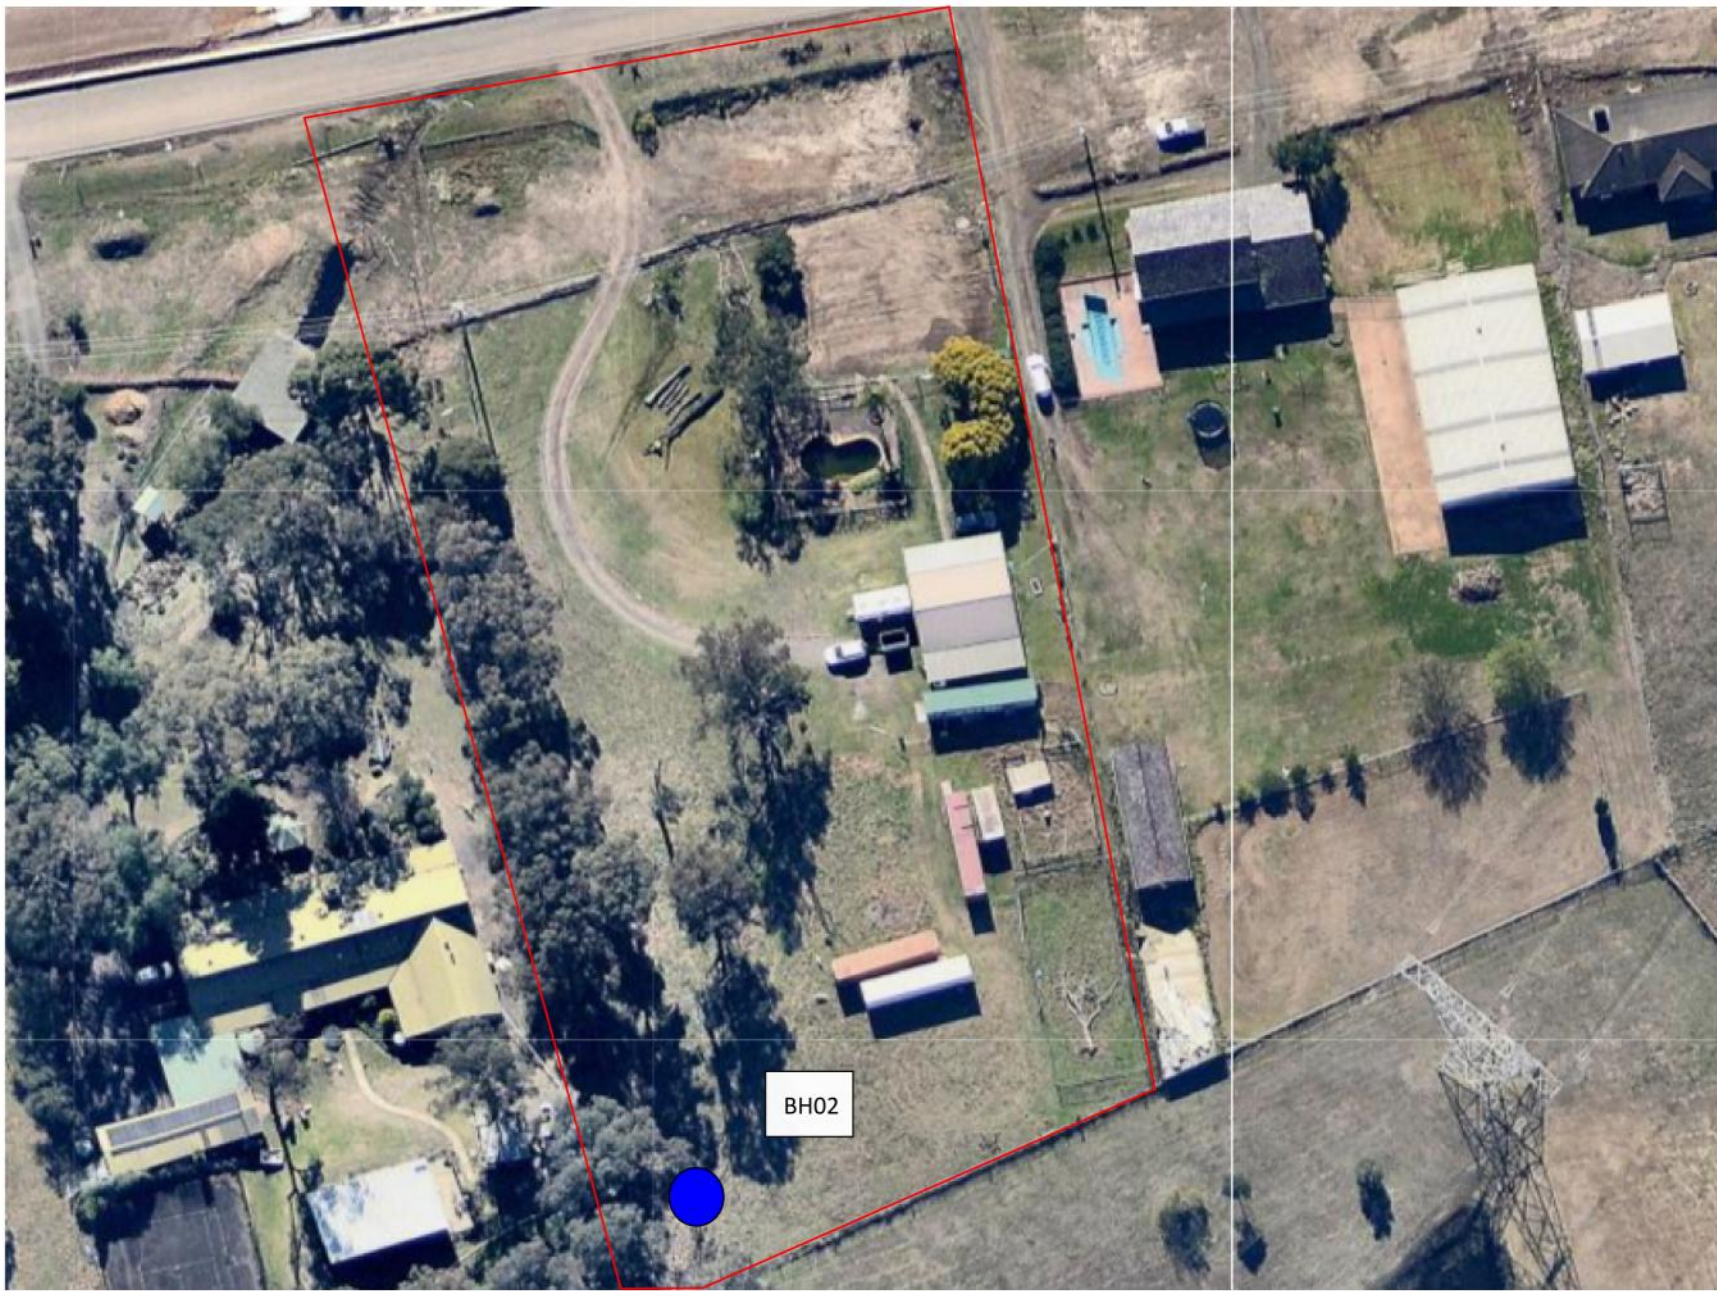
FIGURE 11 – PROPERTY H – SITE LAYOUT WITH SAMPLING LOCATIONS

- Test Pit Location
- AEC From Aerial Photograph Review
- Property Boundary

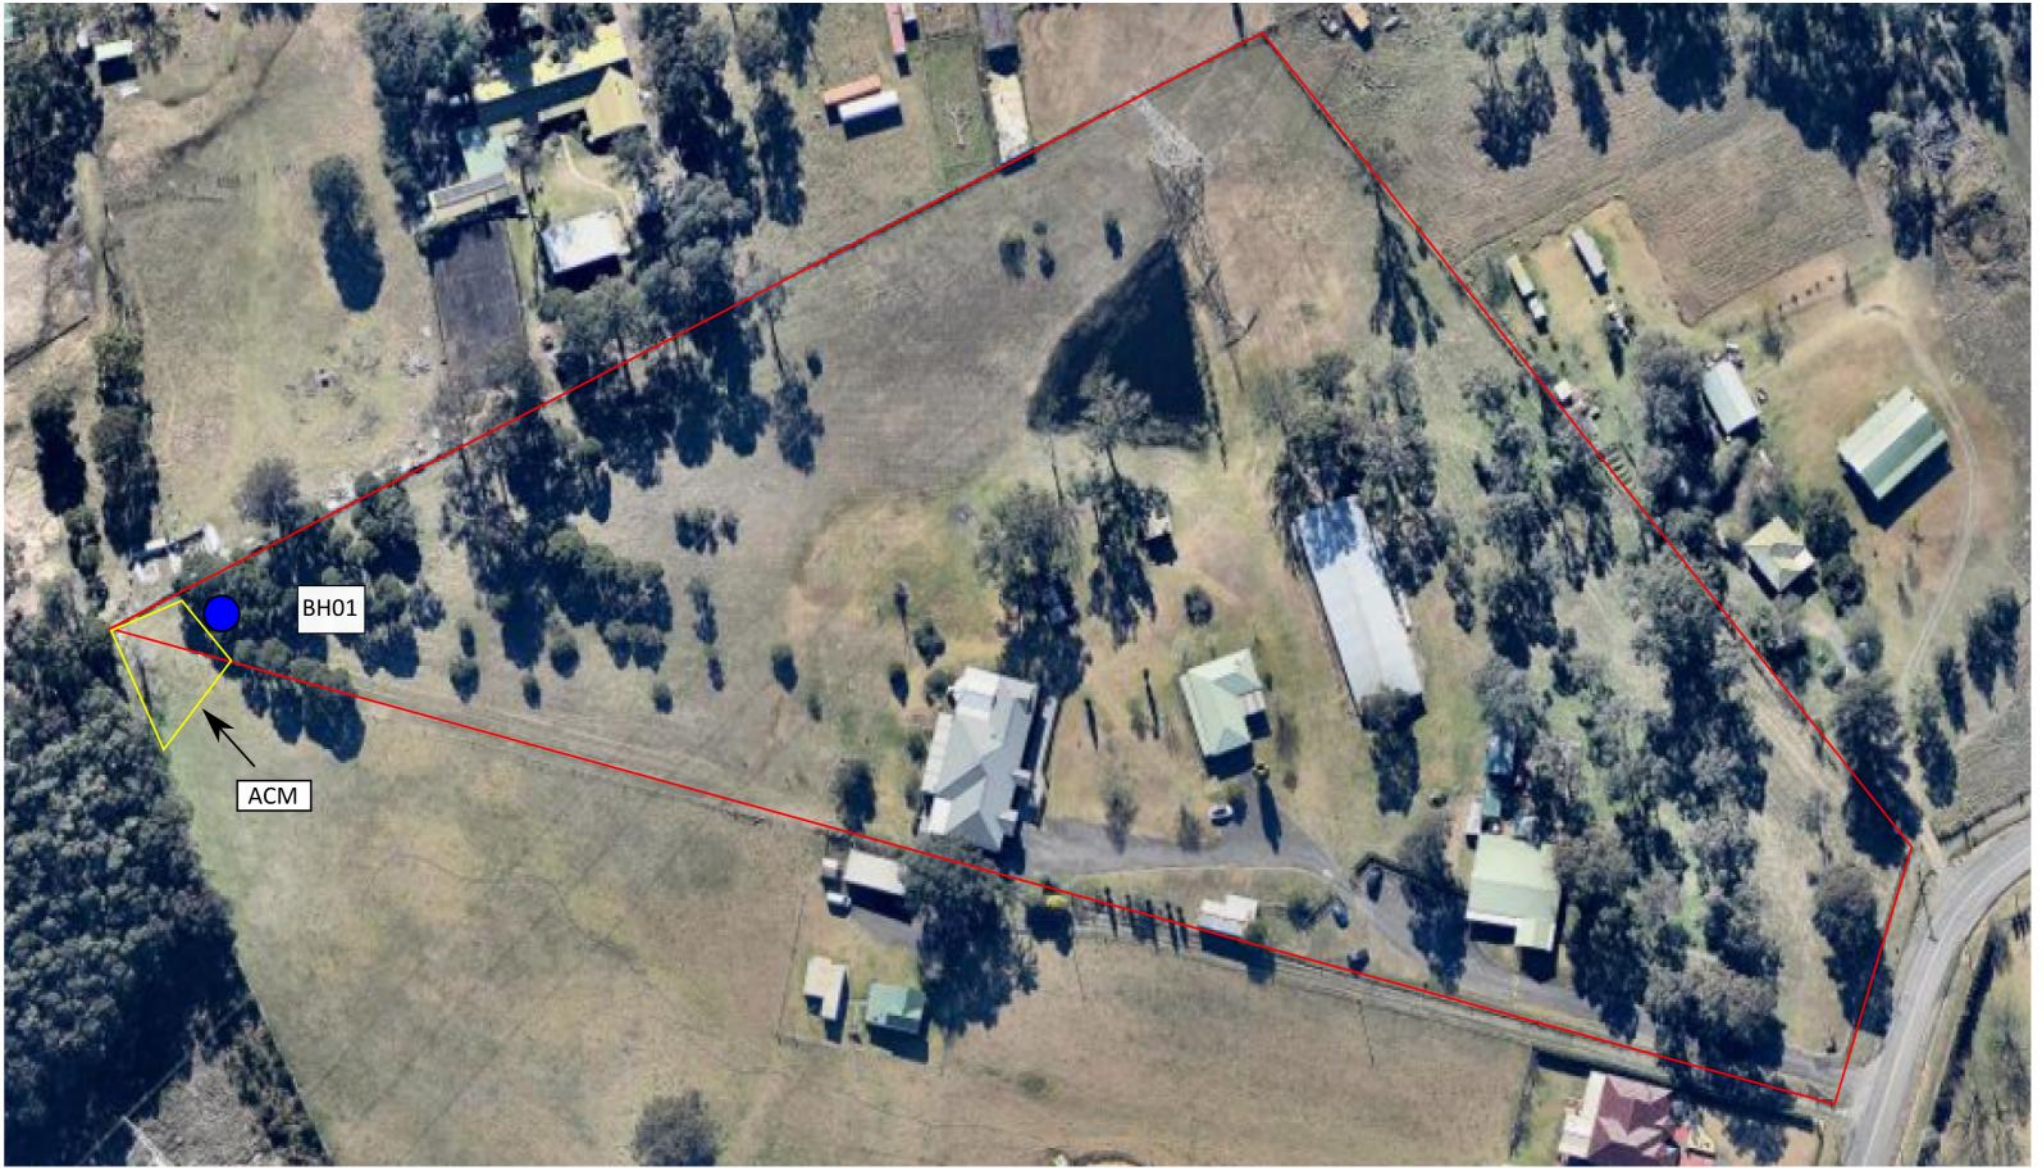
FIGURE 12 – PROPERTY I – SITE LAYOUT WITH SAMPLING LOCATIONS

Property I on Lot 37 DP12076, located within AEC 11, contained a child care centre within the front section of the property. A bitumen driveway serviced both the child care centre and the primary residence. Remnant bushland was scattered throughout the property. A large storage shed was observed east of the primary residence with a constructed dam at the rear of the property. No evidence of asbestos was observed on the surface of the previously removed sheds near the main residence. One borehole was augured, with a groundwater monitoring well installed, at the rear of the property. Soils included dark brown topsoil to 0.3m bgl with clays to 1.5m bgl and underlying shales to 1.0m bgl. Fragments of asbestos were observed on the surface near the boundary of the property with 8 Durham road near the well installation location. There was a greater concentration of fragments and evidence that supports the prior removal of a structure within the 8 Durham Road property.

- The asbestos fragments found on the found surface on Property I and on Lot 36 DP12076 (within AEC 11) should be further investigated to determine the extent of the asbestos in the underlying soils;
- The crushed building material paths on Property E (within AEC 13) should be further investigated to determine the extent of the Asbestos Containing Material (ACM) present within the path network of the market garden;
- The rubbish stockpile on Property E should be spread out and hand-picked by a licenced asbestos removalist. The area will then need to be validated by a licenced asbestos assessor.

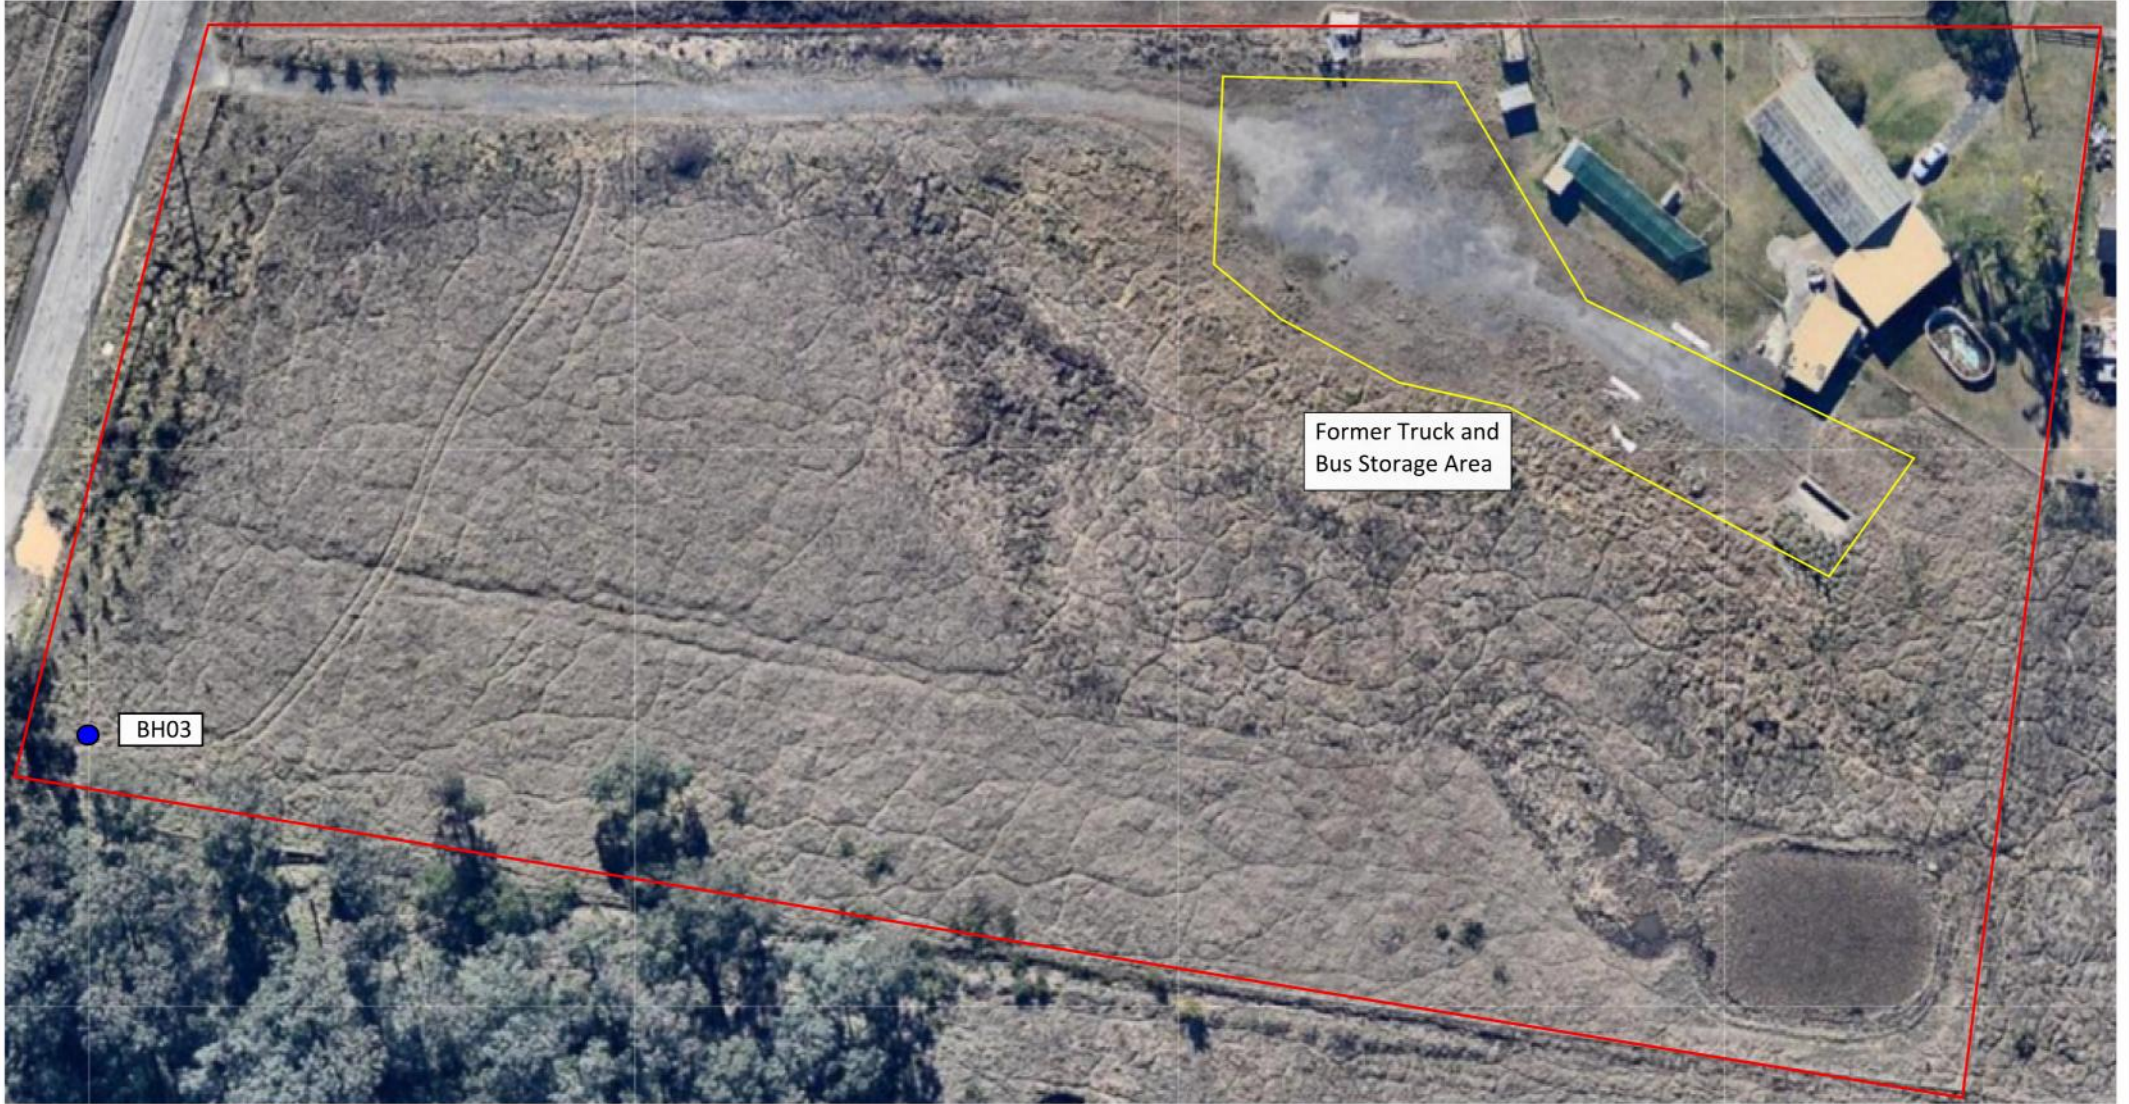
FIGURE 13 – PROPERTY J – SITE LAYOUT WITH SAMPLING LOCATIONS

Property J on Lot 28 DP12076, located within AEC 2, contained a fibrous cement (FC) sheeted dwelling with an FC sheeted outhouse. There was a pool at the rear of the main dwelling, a paddock to the side and rear of the dwelling and rows of olive trees fronting Meadow Road. No evidence of staining was observed in the area previously utilised to store buses and trucks on the property. A constructed dam was located in the southeast corner of the property. One borehole was augured, with a groundwater monitoring well installed, at the rear of the property. Soils included silty clay topsoil to 0.3m bgl with clays to 3.5m bgl and underlying shales to 7.0m bgl.
