ACT Heritage Council

BACKGROUND INFORMATION Glenburn Precinct (Blocks 16, 30, 60, 71–73, and 94, Kowen)

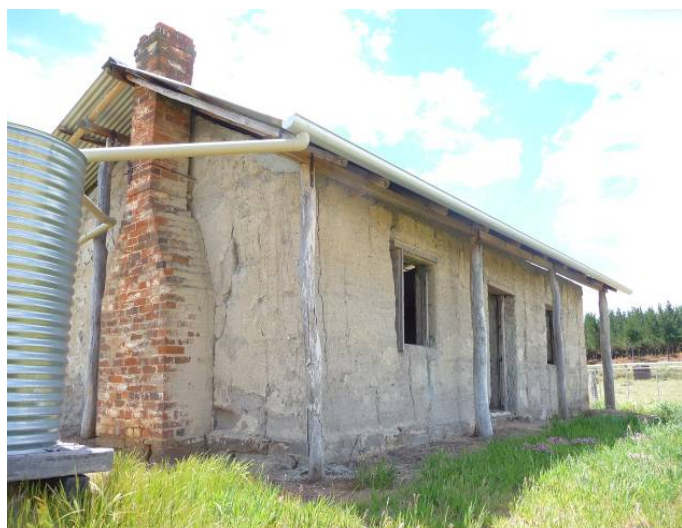
Figure 3 Glenburn Homestead Pisé Cottage southeast facade (ACT Heritage 2013)

The walls of the pisé structure are original; approximately 30cm thick and have been rendered. The walls were originally covered in a lime render, but it has weathered across most of the surfaces, exposing the pisé matrix underneath. The exposed pisé reveals the impressions left by the formwork during construction. The largest cracks in the walls have occurred where the different sections join each other as the construction method leaves these areas as weak points. The footings for the walls are local rock laid in a single random rubble course with soft local sand cement.

The southwest and southeast walls have suffered extensive weathering at their bases and as a consequence threaten the stability of the structure. An example of this extreme deterioration can be seen at the base of the southeast wall where deterioration of the pisé matrix has caused complete penetration into the interior. The floor, originally wooden on stumps (Appendix A) is of earth throughout, which has recently been topped up with about 15cm of decomposed granite gravel. A brick chimney and internal fireplace are in the centre of the southern wall. The internal fireplace is open and the bricks have been whitewashed. Two pieces of iron support an archway of brick above the opening. Holes at either side above the fireplace indicate there was probably a mantle shelf in place but it no longer exists. The windows are timber framed, although there is no glass or covering remaining. There was a verandah along the southeastern facade of the building, but all that is left are some remnant posts or depressions to indicate where they once were.

Commonwealth funding in 2009 allowed a major conservation project to be undertaken at the Glenburn Homestead. The Pisé house had bulges in the walls corrected and major cracks filled in. The walls were then braced with metal rods and capped with concrete. The slab hut had a significant lean corrected, footings stabilised with concrete, an internal metal bracing structure erected and several timbers replaced. (Roberts 2010)

Although the structure is at present stable, it cannot be said that it is in good condition. During the restoration program a large crack from top to bottom of the northern wall was braced with a metal tie and the western and eastern walls have been braced to stop outward leaning using a series of wire and rod ties. Even though this has supported these walls and the structure as a whole for 26 years, there is an urgent need to protect against the basal erosion of the southern corner wall sections of the building. These are slowly but relentlessly being eroded away. Additionally, while previous conservation works were done with the best intentions, the use of stiff concrete and metal rods within the pisé matrix may cause differential movement between the different materials and is likely to exacerbate existing faults.

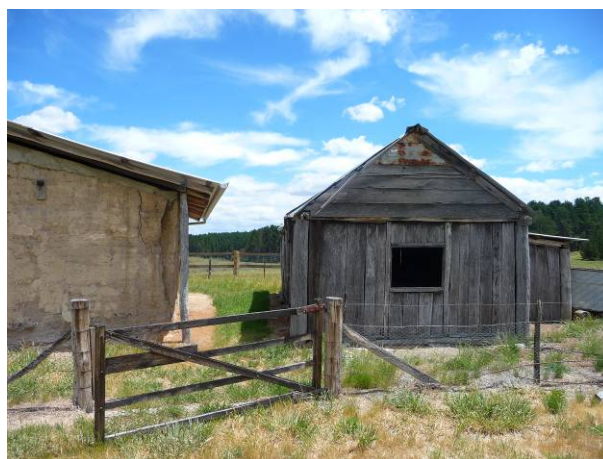
Figure 4 Glenburn Homestead Slab Cottage (ACT Heritage 2013)

The roof is constructed of sapling bush poles with sawn joists supporting corrugated iron roofing. It is assumed that the original roof cladding was corrugated iron due to the spacing of the ceiling joists, and at the time of its construction corrugated iron was becoming a popular building material. It is likely that this was the material used. The floor is of timber planks replaced during the restoration programme. The windows are timber framed with a mixture of adze-cut and newer sawn wood. The machined wood sections were added during conservation works. Glass fragments indicate the presence of glass windows, which are no longer in position.

The fireplace and chimney is located on the southwest wall. It is made out of sandstock brick and joined by the same type of soft mortar that was used for the stone footings of the pisé house. The materials are of a low quality with many of the bricks being poorly fired and crumbling and the mortar has weathered away, creating large gaps and significant cracking through the structure. The top of the chimney has previously fallen and the bricks have been collected and piled within the fireplace.

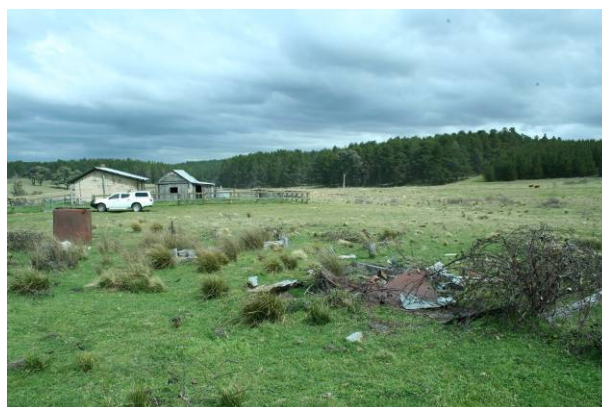
Figure 5 Glenburn Machinery Shed remains in the foreground with pisé and slab cottages in the background (ACT Heritage 2014)

The Glenburn Hay/Machinery Shed and Yards Site is located about 30 metres to the north-east of the Glenburn Homestead. Little of the structural fabric remains. It was described by Futter in his 1914 valuation of the property as slab walled with an iron roof, measuring 54'x12' (Appendix A). Today, the machinery shed location is marked by a small scatter of metal parts, fragments of the wooden structure, and stone and bricks scattered about. Among the ruins of these structures are a metal 19th century ships tank, a rusted bed frame, a metal trough and sheets of flat and corrugated iron.

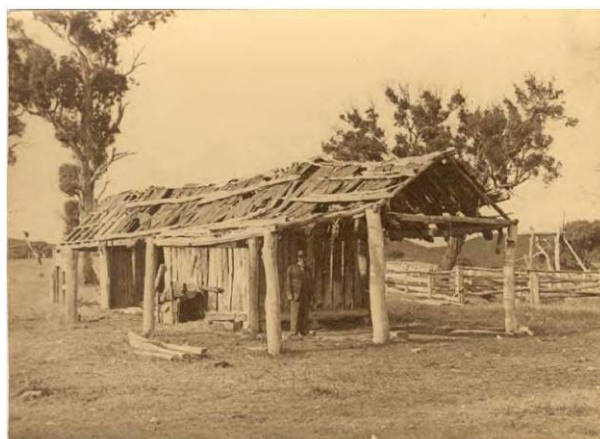
Figure 6 Glenburn Machinery Shed in 1947 (source Arthur Wilson, from McAlister 2007: 15)

Figure 6 shows the wooden slab structure in a dilapidated state by 1947 (Photo by Arthur Wilson in 1947 with James Edmonds standing in front of the still standing shed, from McAlister 2007: 15). The shed is supported on a series of large bush pole posts set in a 2x4 pattern, with a lean-to extending the western side of the shed. There are two mature trees in the background which are no longer extant. The date of construction for the shed is unknown, but the 1947 photograph shows that it had a bark roof. The 1913 valuation by Moriarty and the 1915 disposal schedule both describe this building as having a bark roof (McAlister 2007: 21).

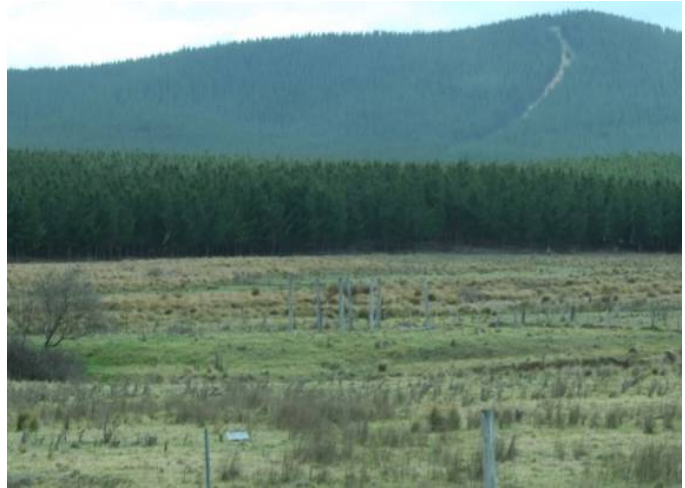
Figure 7 Glenburn Hayshed remaining posts (ACT Heritage 2014)

younger than the Machinery Shed near the Glenburn Homestead based on its condition at the time of their survey. By 2011 there was very little left of the structure and the upright posts were leaning badly, with two having fallen completely. The Friends of Glenburn engaged in conservation works and all the posts have been re-erected and straightened. There is a remnant post and rail fence to the north west of the shed ruin. A field mower is located near the hayshed site, on the same side of an existing fence as the shearing shed.

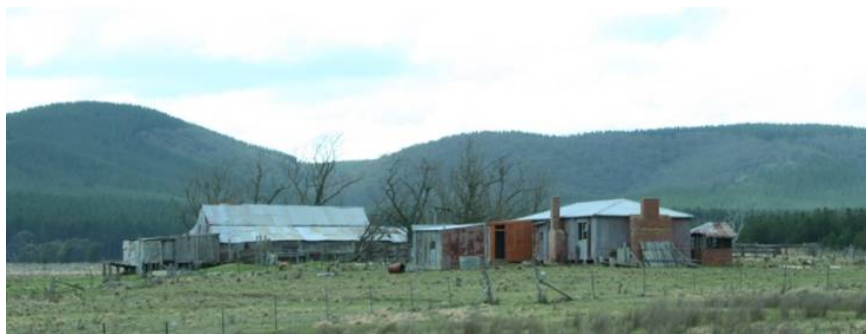
Figure 8 Glenburn Shearing Complex. Shearers' Quarters are in the foreground and the Woolshed in the background. (ACT Heritage 2014)

Most of the present structure and associated sheep dip and yards are of later construction. The shed is a wood slab building that has been constructed in several phases and has been subject to continual repair and maintenance resulting in a mixture of original and later materials, including adzed and machined timber as well as bush pole piers.

The quarters have been abandoned for several years and are now in a very poor state of repair. Several windows and door locks have been damaged and there is smoke damage to internal walls and ceilings, most likely caused by occasional squatting. It should also be noted that the building may not be sound and entering could be dangerous.

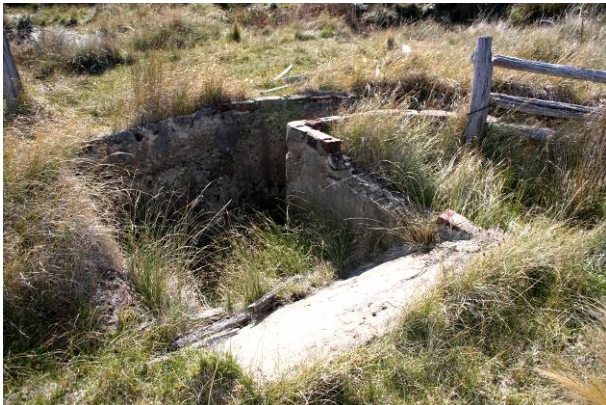
Figure 12 Sheep Dip and Yards (early 20th century) detail of the dip ramp (ACT Heritage 2015)

The sheep dip and yards are located 500m to the west of the woolshed, at the confluence of Glenburn Creek and a smaller tributary. Built by the early 20th century and improved in 1940, the dip and yards presumably ceased being used after the new dip was built adjacent to the shearing complex c.1945 (McAlister 2007: 23). The sheep dip is dug into the ground and lined with brick that has been rendered. The sheep dip and yards are a good example of the use of local materials to build rural structures that have been sited to take advantage of water sources as well as the higher, rocky ground adjacent to the site to help the sheep dry without creating muddy patches.

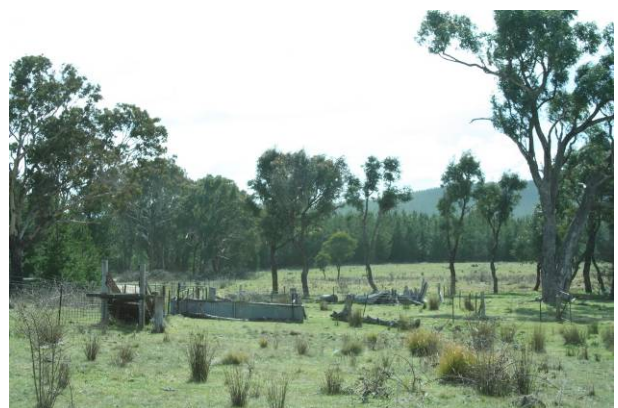
Figure 11 Sheep yard and Loading Ramp (ACT Heritage 2014)

The sheep yards, built in the 1980s by Ken McInnes, are a continuation of the pastoral use of the place and demonstrate changes in farming practices. They consist largely of recycled materials, demonstrating the resourcefulness that is a hallmark of Australian rural properties.

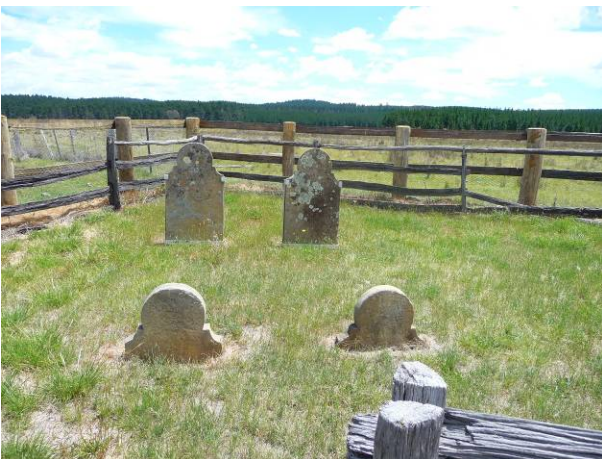
Figure 15 Colverwell Graves (ACT Heritage 2013)

The small graveyard has at least two and possibly five burials associated with it. It is situated on an area of high ground above Glenburn Creek surrounded by grassland in the central region of the valley. The yard is enclosed by a post and rail fence of approximately 8 x 7 metres. The post and rail fence had previously been in an advanced state of deterioration before conservation in 2005, which included the erection of a second, outer fence. There are two carved headstones and two footstones within the graveyard belonging to the two Colverwell children who were accidentally drowned in the creek in 1837. The headstones had fallen from their original upright positions with the gravestones falling carved face uppermost and as a consequence weathering and lichen encrustation caused some deterioration of the inscriptions. The headstones were conserved and cleaned and then re-erected with aluminium supports during the 2005 conservation program.

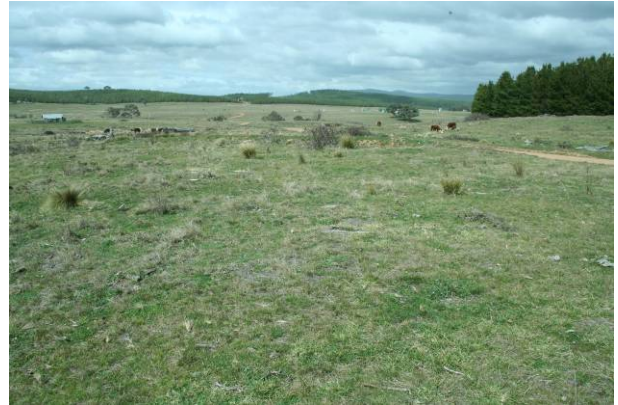
Figure 16 Charcoal Kilns remains (ACT Heritage 2014)

The remnants of charcoal kilns are situated near the northwest corner of the precinct. Surface remains of nine kilns are still visible as small clusters of blackened bricks and earth. The kilns had a circular concrete base of ~4.5 metres in diameter with a slightly raised border on the rim and were arranged in pairs. The brick walls from the kilns, which would have been built on the raised borders, have been removed (Bulbeck and Boot 1990:26).

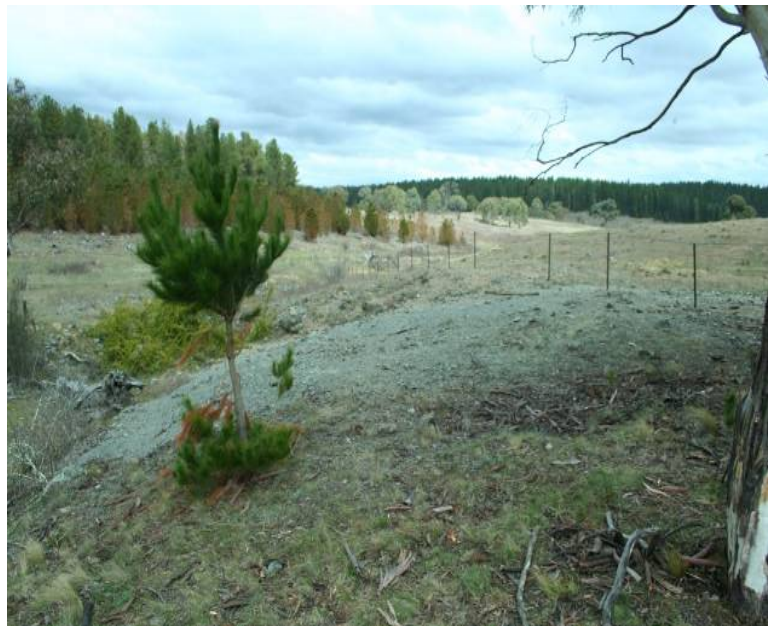
Figure 17 Glenburn Copper Mine (ACT Heritage 2014)

Within the boundary for the original Portion 1 (currently Block 72) there is an area containing a spoil heap of blue-grey gravel in the southeast of the Precinct, 500m east of Collier's Homestead Ruins, noted by Moriarty's valuation (Appendix A) as a former copper mine. Copper mining is a hard rock process that requires crushing of ore and processing on a large scale, so it is likely that the area is a test pit, or a small sample that was mined to see if it would be worthwhile to establish mining operations proper. While the area may have been in the Gundaroo Goldfields area, it is not too far from the copper/gold/zinc/silver mines at Captains Flat to the south for someone to think it worthy of testing. This appears to be the case as evidenced by the neighbouring Portion Plan 20 (cited in McAlister 2007: 26) which includes a note in 1882 for a mineral lease (minerals other than gold or coal) by JB Thompson Jnr, J J Wright, J Kinsela and JB Thompson Snr which was refused.

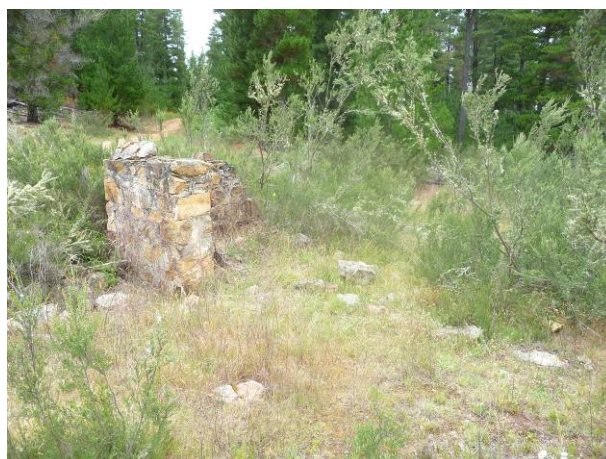
Figure 21 Argyle Homestead Ruins (ACT Heritage 2014)

The only remains of the Argyle Homestead Ruins are the corner of a fireplace made from roughly dressed and coursed stone. Bulbeck and Boot (1990: 36) note that there were several depressions marking out post holes, indicating that the building was wood and measured roughly 11.5m x 6m. McAlister (2007: 34) argues that it was built by Luke Colverwell Jnr sometime after 1891 as there was no mention of the house in the census of that year so it must post-date Colverwell's purchase of the land.

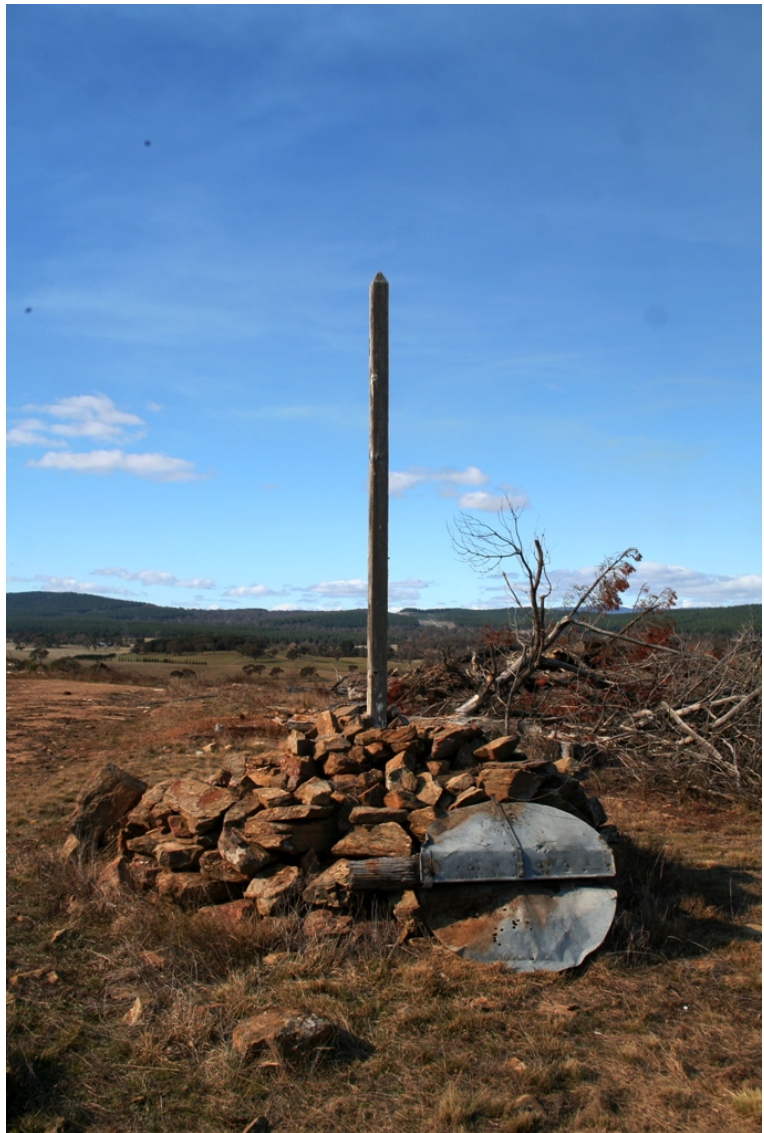
Figure 22 Atkinson Trigonometrical Station facing east. (ACT Heritage, 2015)

The cairn sits atop a primary survey mark and the pole and vanes sits atop of this mark. The mark itself is rarely accessed, instead the vanes are used for sighting towards the Trig or one of the nearby recovery marks (one or more survey marks that are offset from the Trig station) are used to set up equipment directly.
