Beveridge North West Precinct Structure Plan Area

Site Suitability Assessment

Project no: VW07335
Document title: Desktop Environmental, Hydrological and Geotechnical Assessment
Document no: VW07335_RPT_FINAL
Revision: Final V4
Date: July 2014
Client name: Metropolitan Planning Authority
Client no: VW07335
Project manager: Corey Bannister
Author: William Rodger / Ci Wang / Amanda Woodman / Tara Smith
File name: I:\VWES\Admin\Administration\GeoEnvironmental\Environmental_Management\B-
ProjectsProposals\Projects\Beveridge NW Site Suitability
Assessment\Deliverables\Desktop Assessment\VW07335_RPT_FINAL.docx

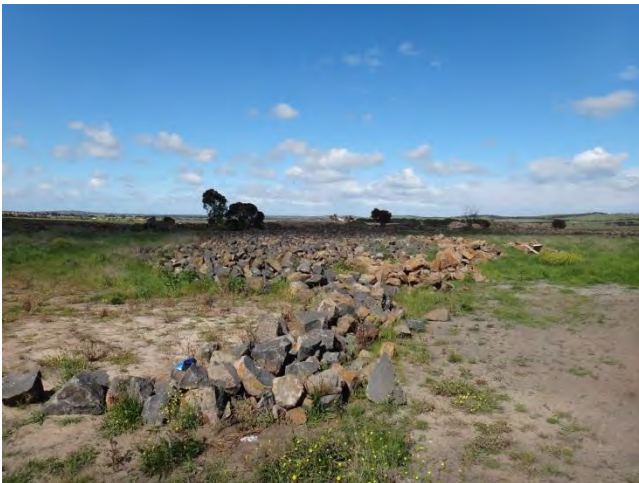
The site inspection confirmed the above in part, with rock outcropping (basalt) observed across the study area as well as eroded alluvial deposits along creek. These are illustrated in the images below.

Plate 5.1 : Basalt quarried from a site to the south of the PSP Plate 5.2 : Eroded deposits of silt along the Kalkallo Creek

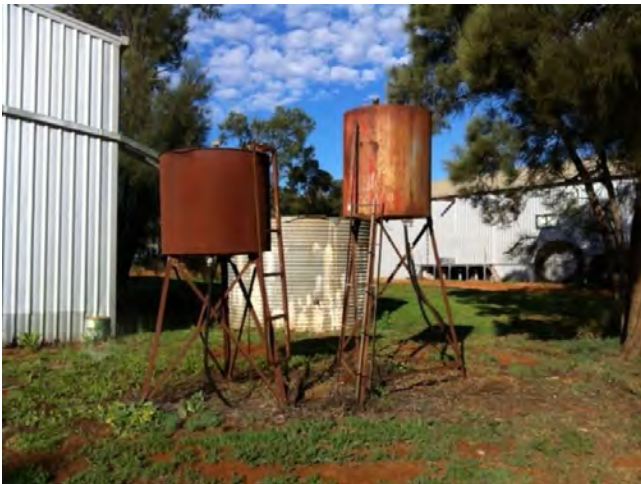
Plate 7.1 : Example of above ground storage tank

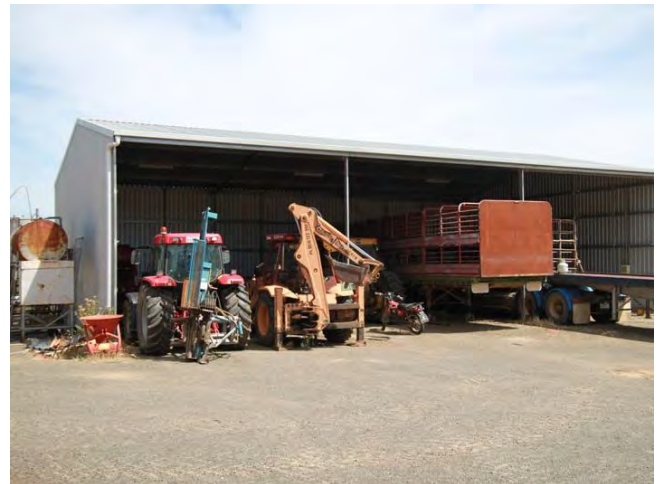
Plate 7.2 : Example of typical farm machinery shed

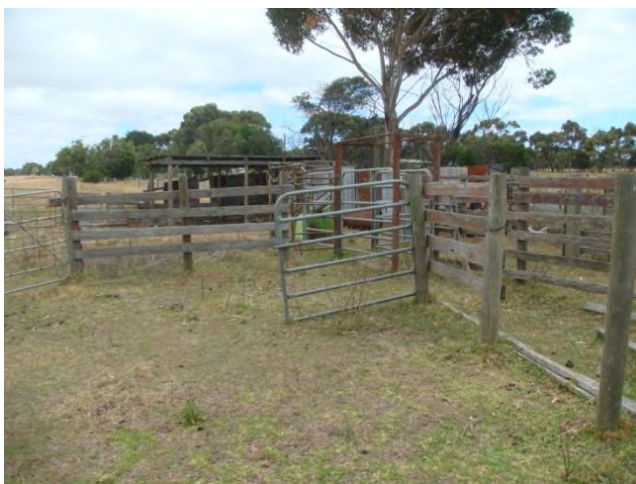
Stockyard structures were frequently noted across the PSP study area, typically close to the main farm homestead. These are used to hold livestock prior to loading on to trucks and typically form a number of small timber enclosures. These occasionally include small covered sheds used for storage purposes.

Plate 7.3 : Example of a stockyard structure

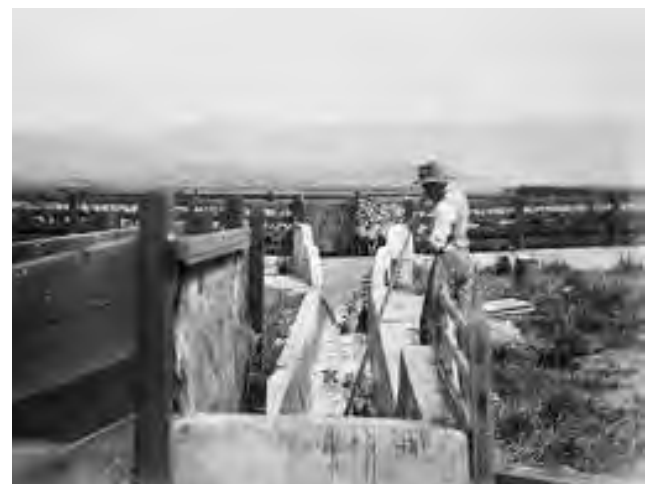
Contamination of soil and groundwater can result from the above activities as the liquid formulation either leaks from defects in the dipping infrastructure (be it a permanent sheep dip or mobile trough) or drains from sheep while they are retained in the holding enclosures after dipping is completed.

Plate 7.4 : Example of typical sheep dip

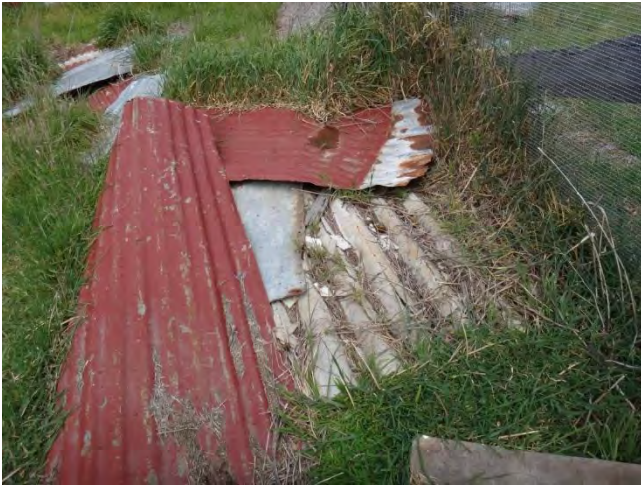
Plate 7.5 : Potential asbestos cement sheet at property 2

- Completion of a hazardous materials assessment for properties 2 and 22 to confirm not only the extent of potential asbestos containing materials and lead based paints, but to identify controls that should be implemented during future development to prevent exposure by site workers or future users of the site. *Timing: It is recommended that this task be undertaken to coincide with the cessation or scaling down of current site operations at these sites and prior to the commencement of the proposed development and construction works.*

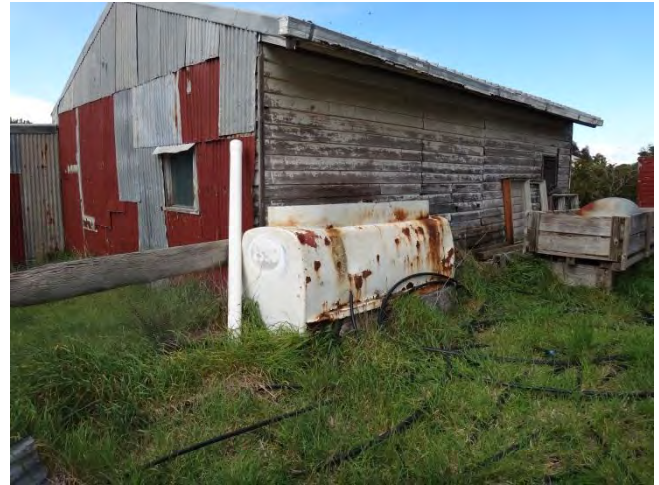
Plate 7.6 : Fuel storage tank at property 2

- Assessment of potential contamination associated with general agricultural land uses around the homesteads of properties 2, 6 and 22. These sites are likely to present the greatest potential for contamination, albeit likely a small number of localised areas (i.e. around septic tanks, fuel storages, stockyards etc.). This process may be best undertaken through the preparation of a Sampling, Analysis and Quality Plan (SAQP) followed by a Phase 2 Environmental Site Assessment (which may include targeted sampling of soils and groundwater). *Timing: It is recommended that this task be undertaken to coincide with the cessation or scaling down of current site operations at these sites and prior to the commencement of the proposed development and construction works.*

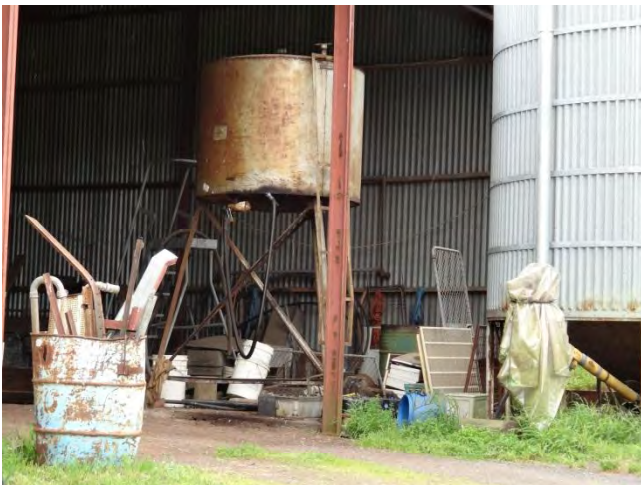
Plate 7.7 : Above ground diesel storage tank at property 6

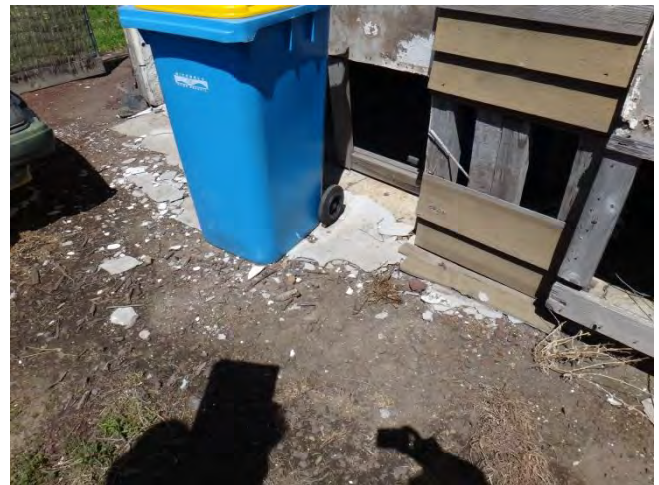
Plate 7.8 : Potential asbestos cement sheet at property 22

22	Farm buildings including stockyard and residence	Soil and groundwater	TPH and metals around farm buildings as well as herbicides, insecticides and fungicides around stockyards. Nutrients and biological contaminants around septic tanks. Potential asbestos also observed as well as possible lead based paint.	Farm residence as well as sheds and associated infrastructure. The sheds themselves were in varying conditions, some extremely dilapidated. Some potential asbestos fragments were also observed around one of the buildings. The paint on the timber was also flaking heavily (potentially lead based paint given the likely age of the building). No fuel storage was noted on site with the exception of an LPG cylinder supplying the house. A diesel fuel tank was observed on the back of a ute, likely used to re-fuel machinery rather than a permanent above/below ground storage tank. An extensive stockyard was noted with cattle crush, although no dipping infrastructure was observed. However, given the presence of a shearing shed it is likely that dipping will have historically taken place. A septic system is also likely present.	M	Targeted investigations around potential contamination sources such as stockyards, septic tanks and around dilapidated buildings where potential asbestos and lead based paint was observed. Hazardous materials assessment to confirm the extent of asbestos and potential lead based paint and management requirements.

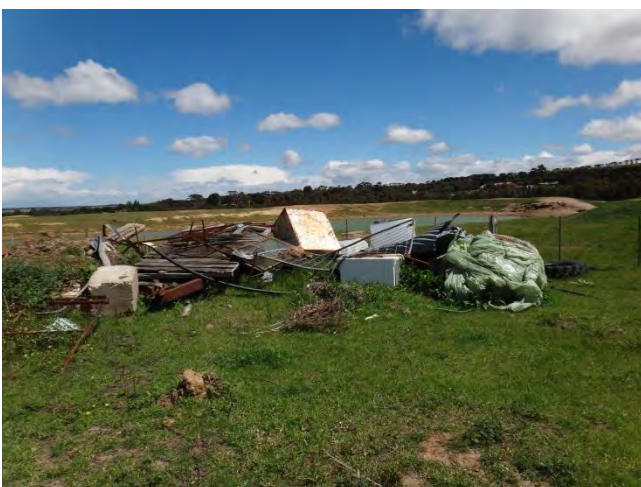
Plate 7.9 : Typical miscellaneous stockpile at property 22

- Classification and appropriate removal (if required) of various stockpiles and dumped materials observed at sites across the study area. This includes subsequent validation following removal. It is noted that sampling of some stockpiles of soil observed may indicate that the material is suitable for re-use as part of future development and as such removal may not be required in all instances. *Timing: This task should be undertaken on a site-by-site basis during future site development.*

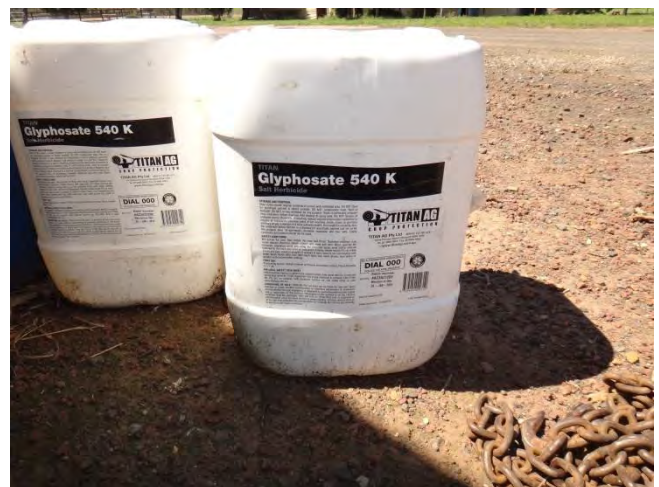
Plate 7.10 : Glyphosate herbicide stored at property 22
