# Mount Martha North Beach Coastal Engineering Options

This document is intended to help visualise the coastal structures discussed in Section 4 of this survey

The following examples are extracts from the Mount Martha North 2017 coastal processes study, plus photos of comparable examples installed at other beaches in Port Phillip Bay. Please consider the impact these options might have on what you value about your use of Mt Martha North beach.

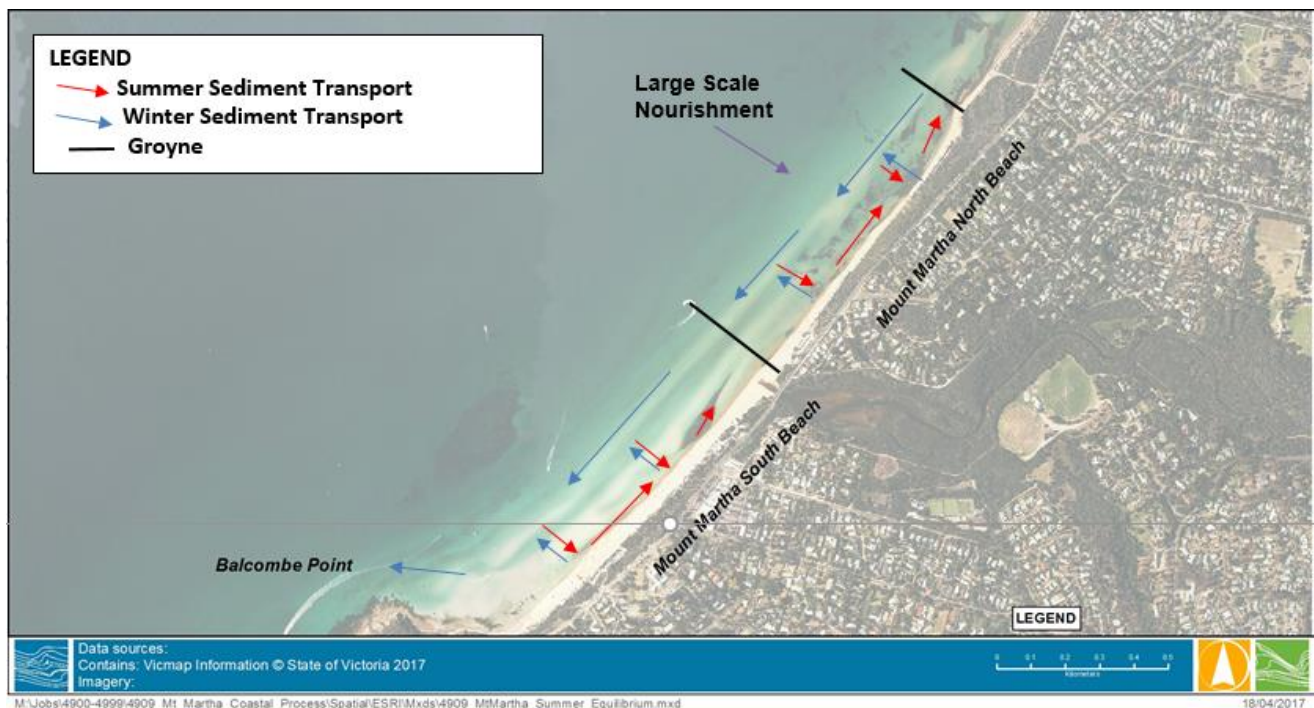
Figure 1: Illustration of large groynes and a large scale renourishment, from Mount Martha North 2017 coastal processes study.

- This option would involve installing a 250–300m long groyne at Balcombe Creek and 200m long groyne at Mt Marth North.
- Coarse sand would be imported to provide large-scale nourishment (approx. 50,000m<sup>3</sup>) for long-term application.
- This scale of renourishment has been carried out previously at Hampton beach (photo shown below).

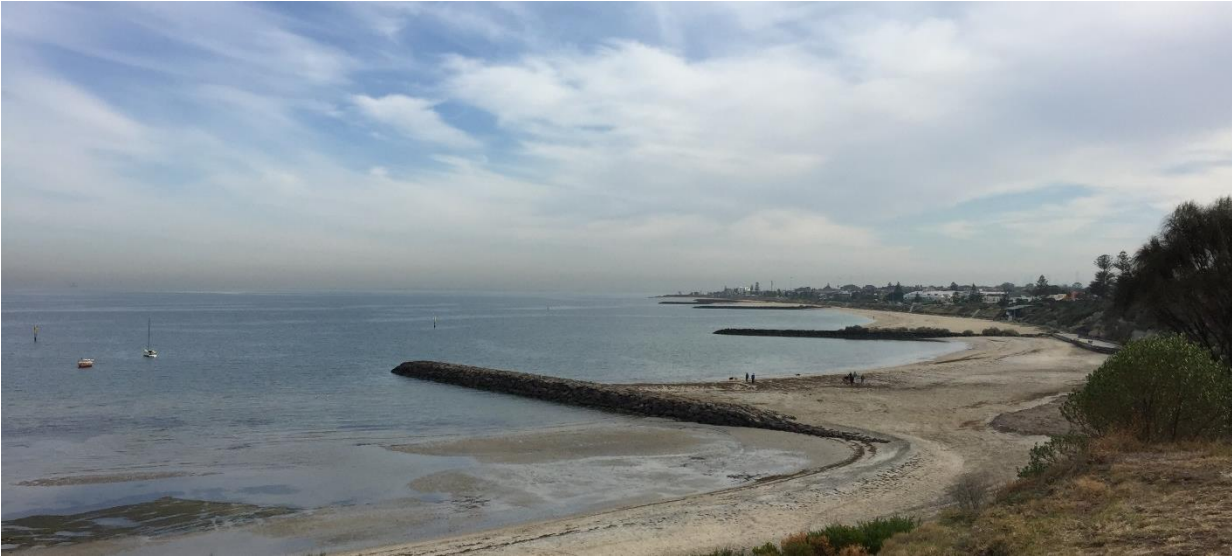
Figure 2: Large groyne installed at Hampton Beach with a large-scale renourishment. This groyne is 143m long, with approximately 50m partially buried. **Groynes at Mount Martha would need to be 1.5–2 times longer.**

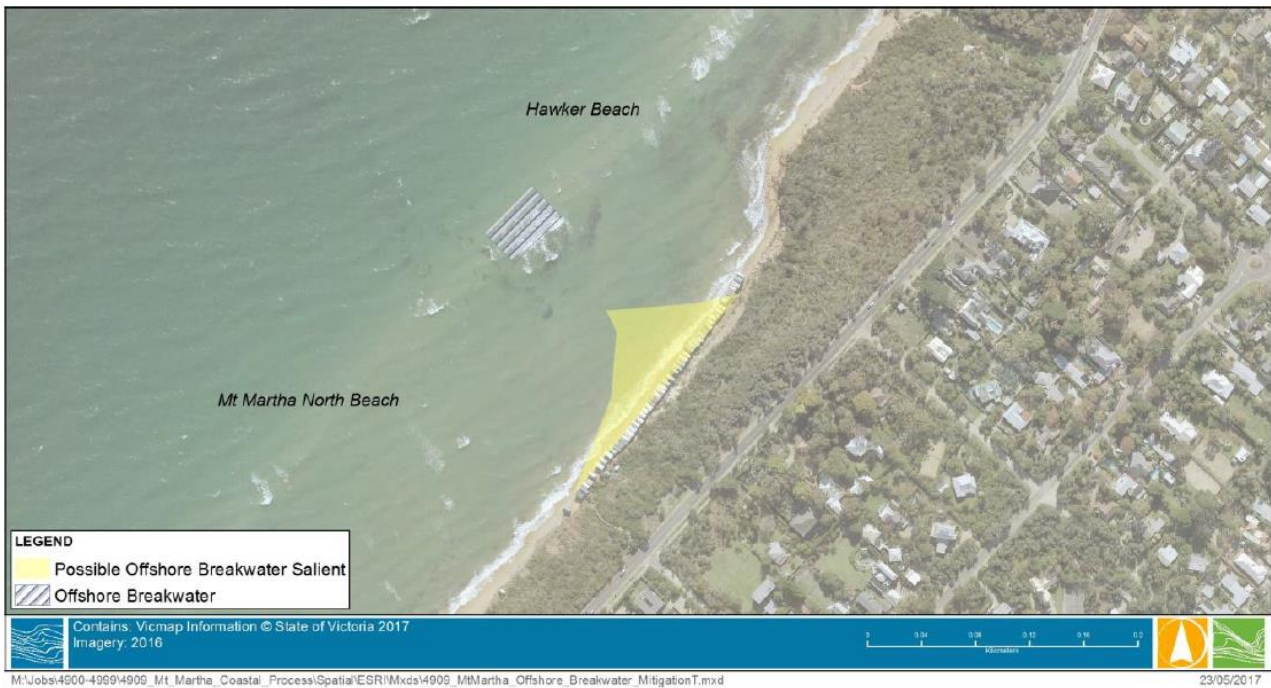
Figure 2: Illustration of large off shore reef and renourishment, from Mount Martha North 2017 coastal processes study.

- Constructing an offshore reef is another option that would be considered a large coastal structure under 4.1.
- This option would aim to produce a salient (detached breakwater) by constructing a large offshore reef
- The location is not ideal for an offshore reef due to the fact an offshore bar already restricts wave action reaching beach.
- If this option is considered for further modelling, Birdrock beach would be considered for the location.

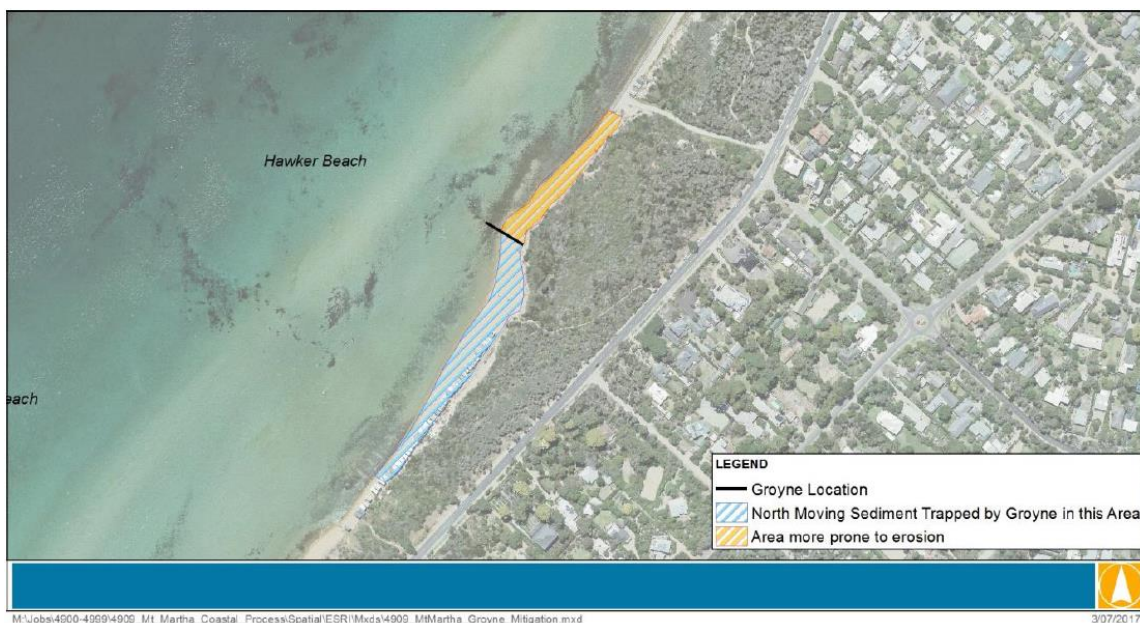
Figure 4: Illustration of sand movement resulting from installing a small groyne combined with a renourishment, from Mount Martha North 2017 coastal processes study.

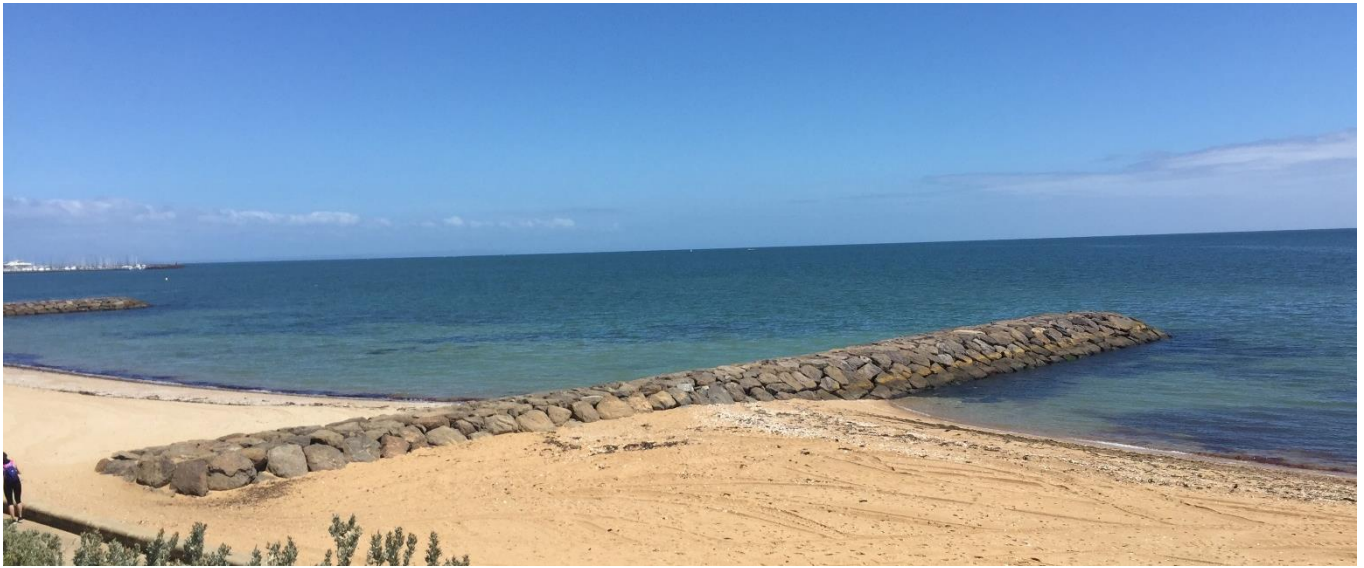
Figure 5: Small groyne (80m long) installed at Brighton beach.

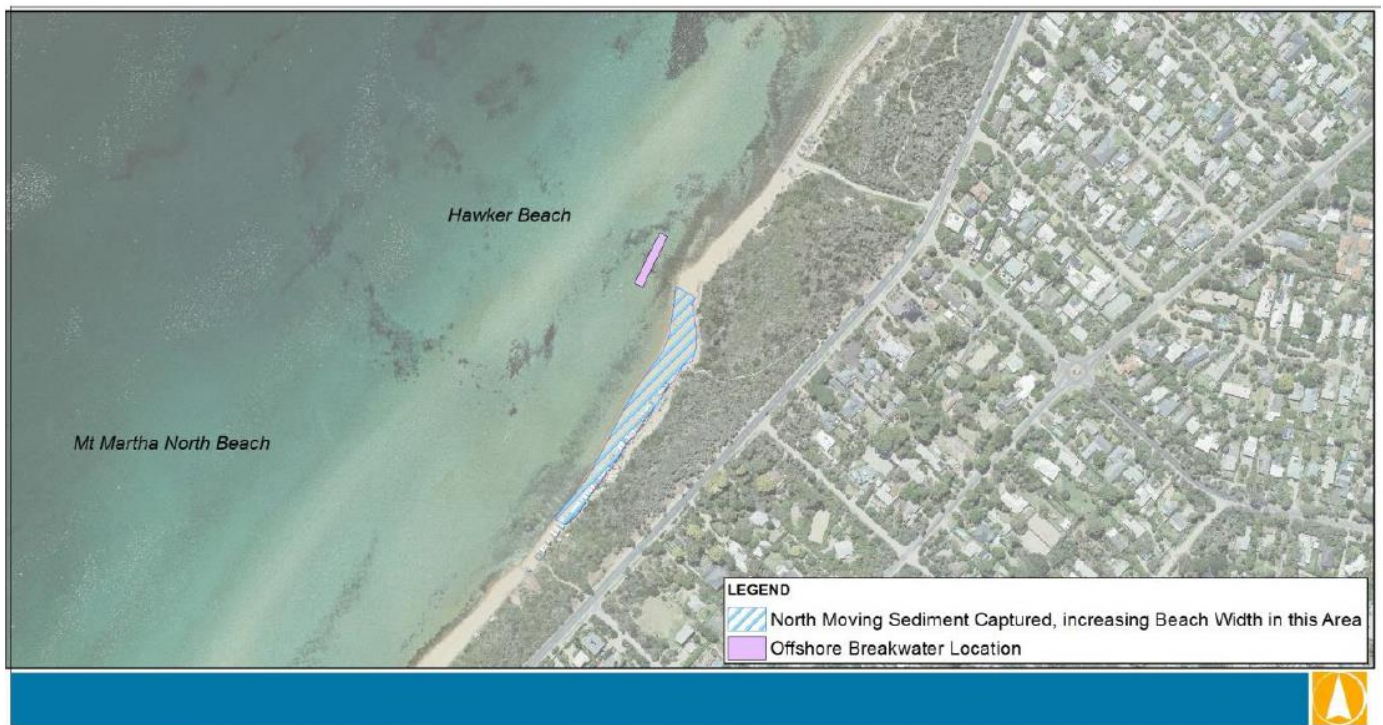
Figure 6: Illustration of small nearshore reef and renourishment, from Mount Martha North 2017 coastal processes study.

- Constructing a small, nearshore reef is another option considered a small coastal structure under 4.1.
- This option would not disrupt recreational activities on beach.

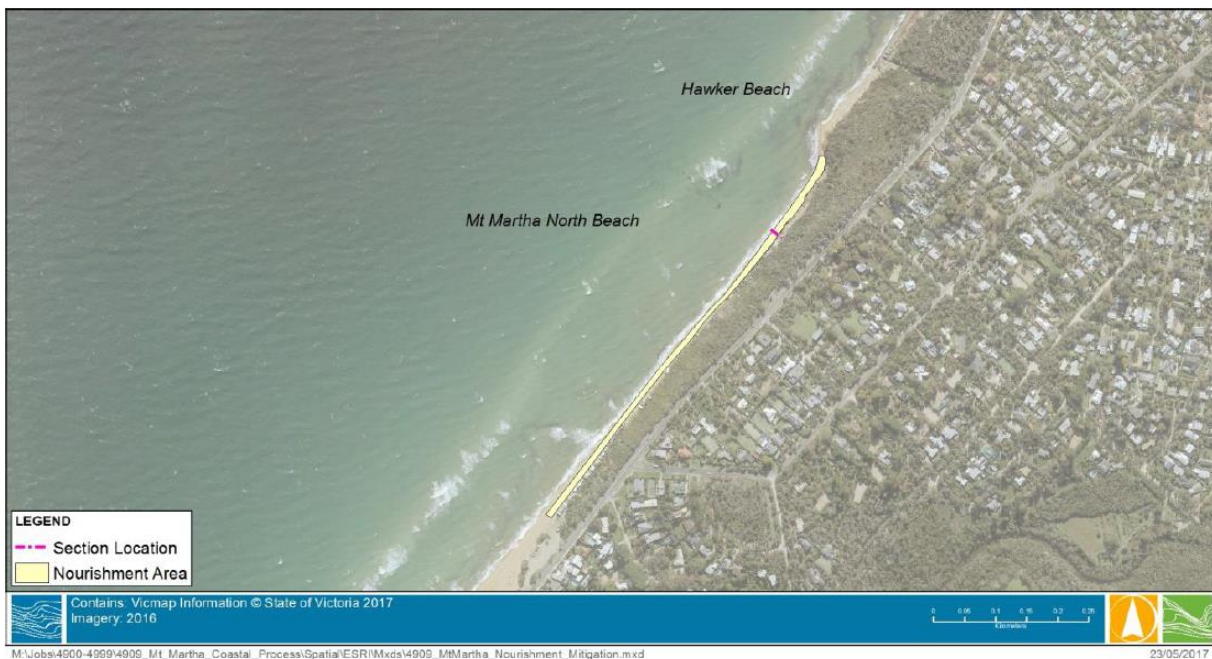
Figure 7: Illustration of renourishment only, from Mount Martha North 2017 coastal processes study.

- Previously undertaken in 2010, 11,300m<sup>3</sup> moved from Mount Martha South to Mount Martha North – lasted three years.
- Modelling suggests a similar remediation but with coarser sand could last longer – however, sea level rise and lack of sediment inflow will continue to pressure coastline. Sea level rise may force beach boxes to require higher floor levels.
