Cultural heritage due diligence assessment for  
an industrial facility at 70 Ordish Road,  
Dandenong South, Victoria

FINAL REPORT

Prepared for SMEC

18 October 2019

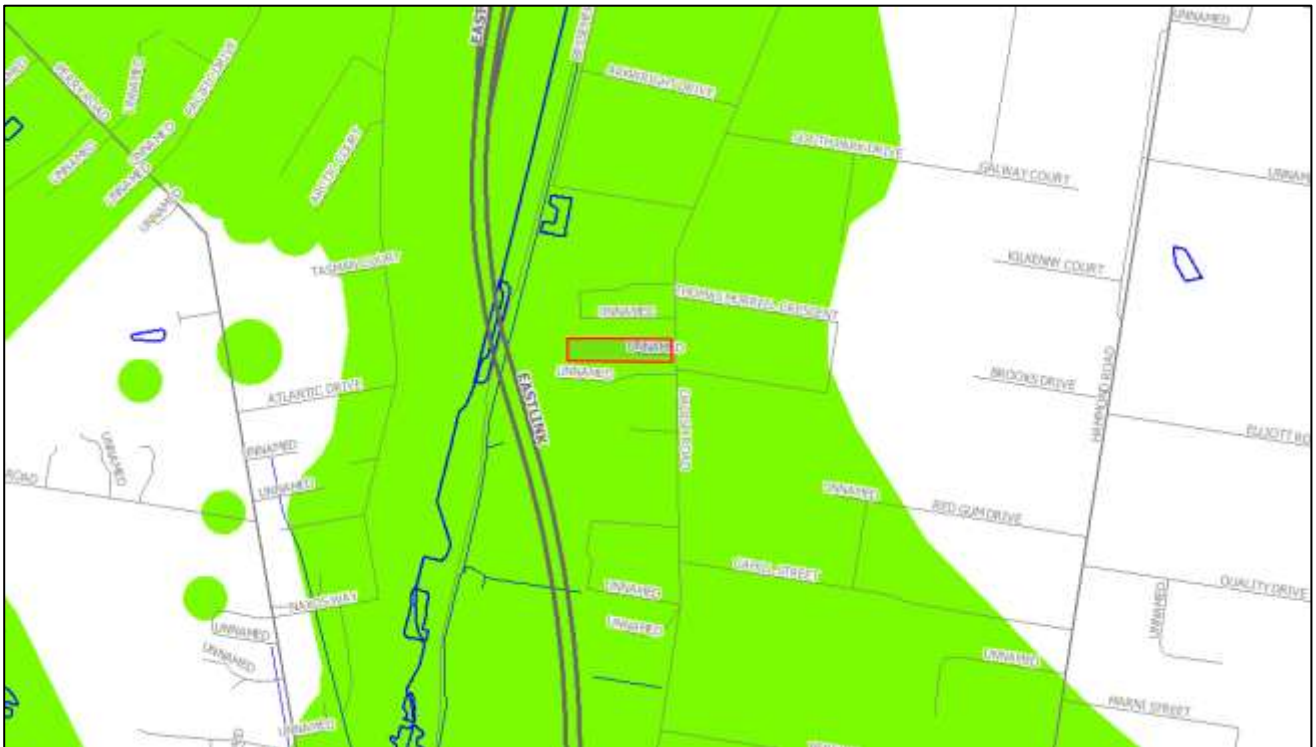
**Figure 2 Study area (red) in an area of cultural heritage sensitivity (green) (GeoVic3, 2018)**

The study area is entirely within the area of cultural heritage sensitivity associated with the Koo Wee Rup Plain, and partially within the area of cultural heritage sensitivity associated with Dandenong Creek, which is located to the west of the property. This is illustrated in Figure 2 below.

Under Regulation 26, waterways listed on the Victorian Geographic Names Register are surrounded by a 200 metre area of cultural heritage sensitivity. The study area is partially within 200 metres of Dandenong Creek.

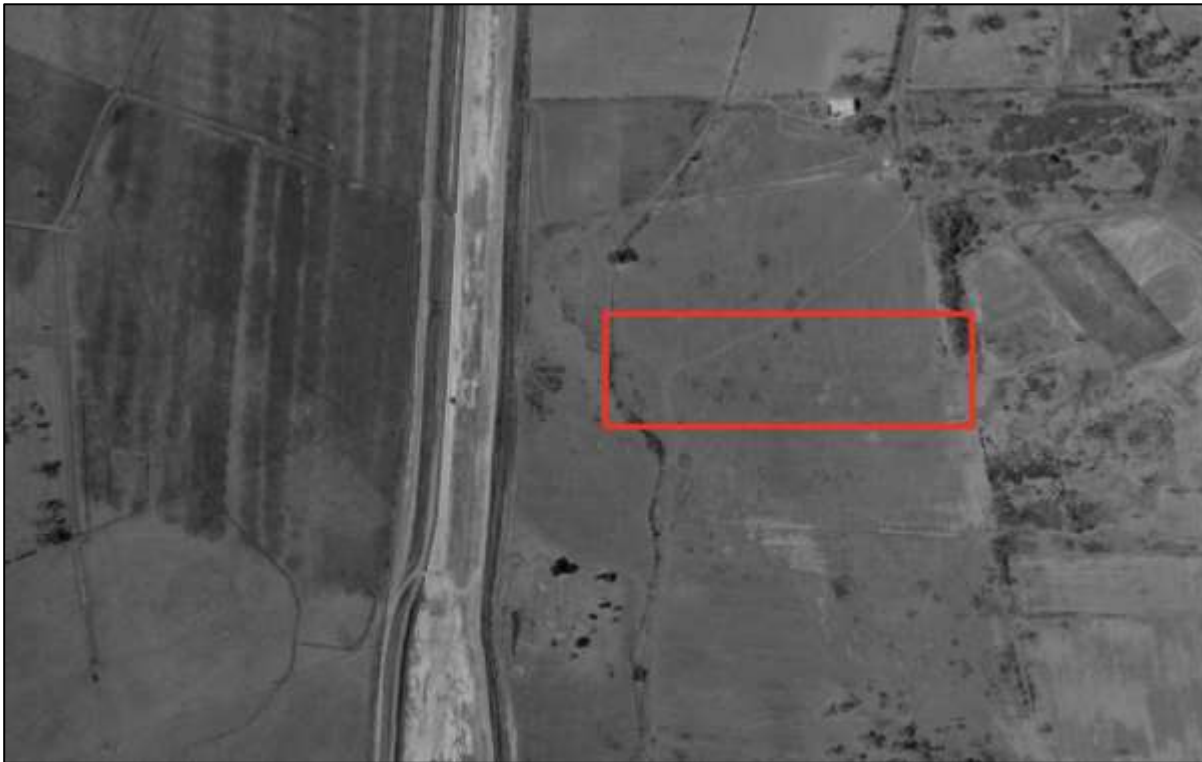
**Figure 3 1968 aerial of study area (red) (State Government of Victoria, 1968)**

Aerials from 1968 (Figure 3) show the study area as cleared land with no signs of infrastructure or other alteration to the land. Ordish Road is established and Dandenong Creek is visible, yet the surrounds feature little other than major roads, paddocks, sporadic vegetation and very few houses. The study area was most likely used for agricultural purposes. A small drainage line is visible parallel to Dandenong Creek, at the western boundary of the study area.

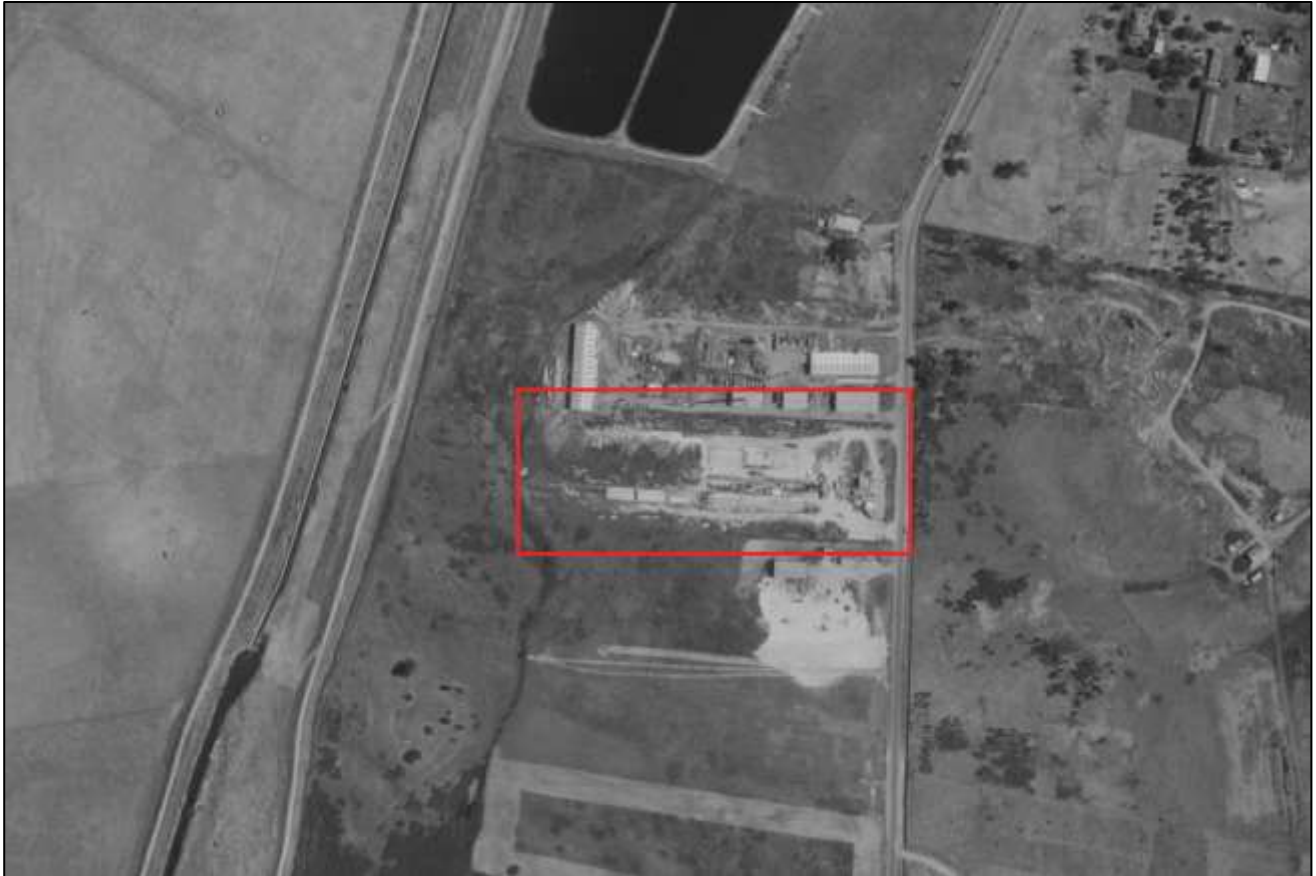
**Figure 4 1977 aerial of study area (red) (State Government of Victoria, 1977)**

The Western Port Foreshores aerial photograph project from December 1977 shows the study area on Run 2, Frame 177 (Figure 4). The aerial shows that the study area and its surrounds undergoing subdivision with the study area property lot being defined among other small divisions to the north and south. The study area has evidence of disturbance across most of the property, with significant ground disturbance associated with the construction of roads and structures, occurring in the eastern section of the property lot.

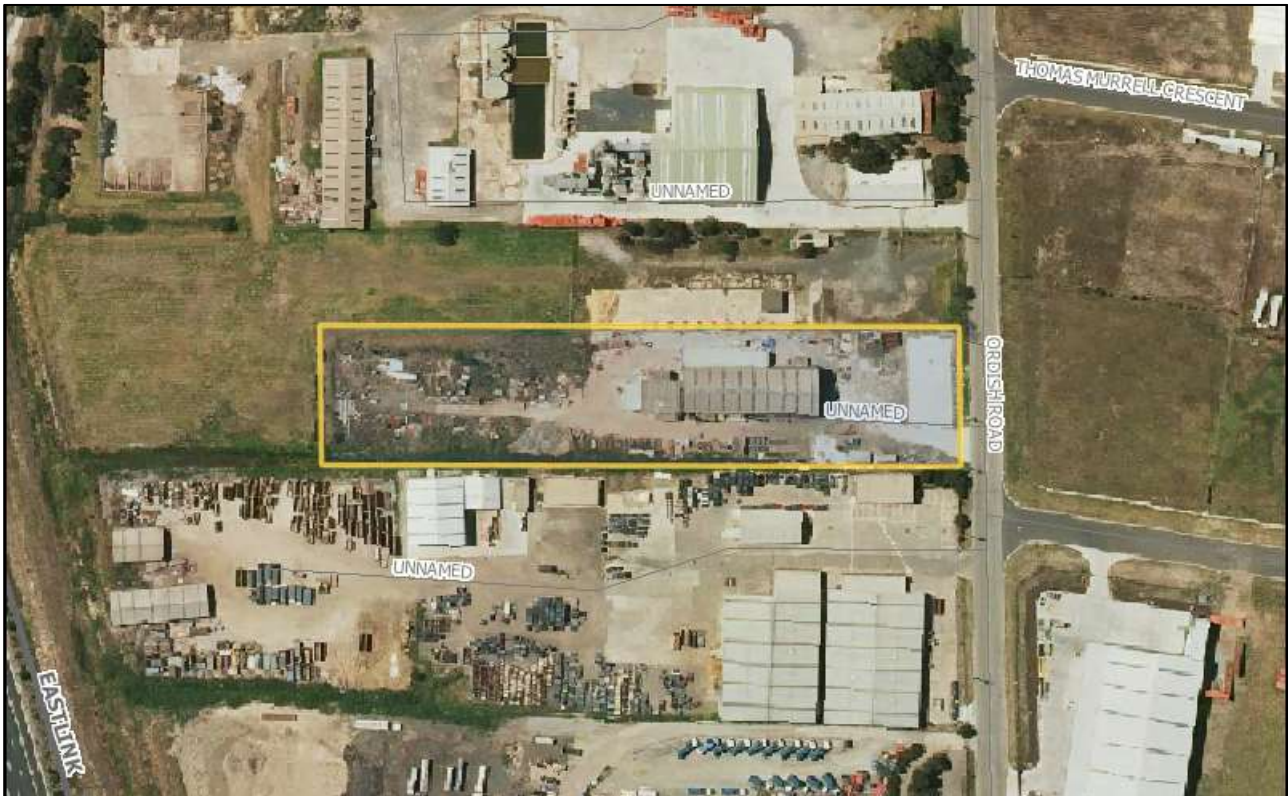
Figure 5 2009 aerial image, study area in yellow (GeoVic3, 2018).

More recent aerial images from 2009 (Figure 5), 2010 (Figure 6) and 2017 (Figure 7) show the recent disturbances to the study area. Figure 5 shows that the large warehouse which currently occupies the land has been constructed which would have occurred sometime since 1977 and significantly disturbed the land on which it was built. The aerial image also shows the cemented carpark and driveway at the eastern end of the property which would have included the grading and scraping of the land to ensure cement was poured over a level surface. A path way is evident at the back of the property with some overgrown vegetation and discarded rubbish.

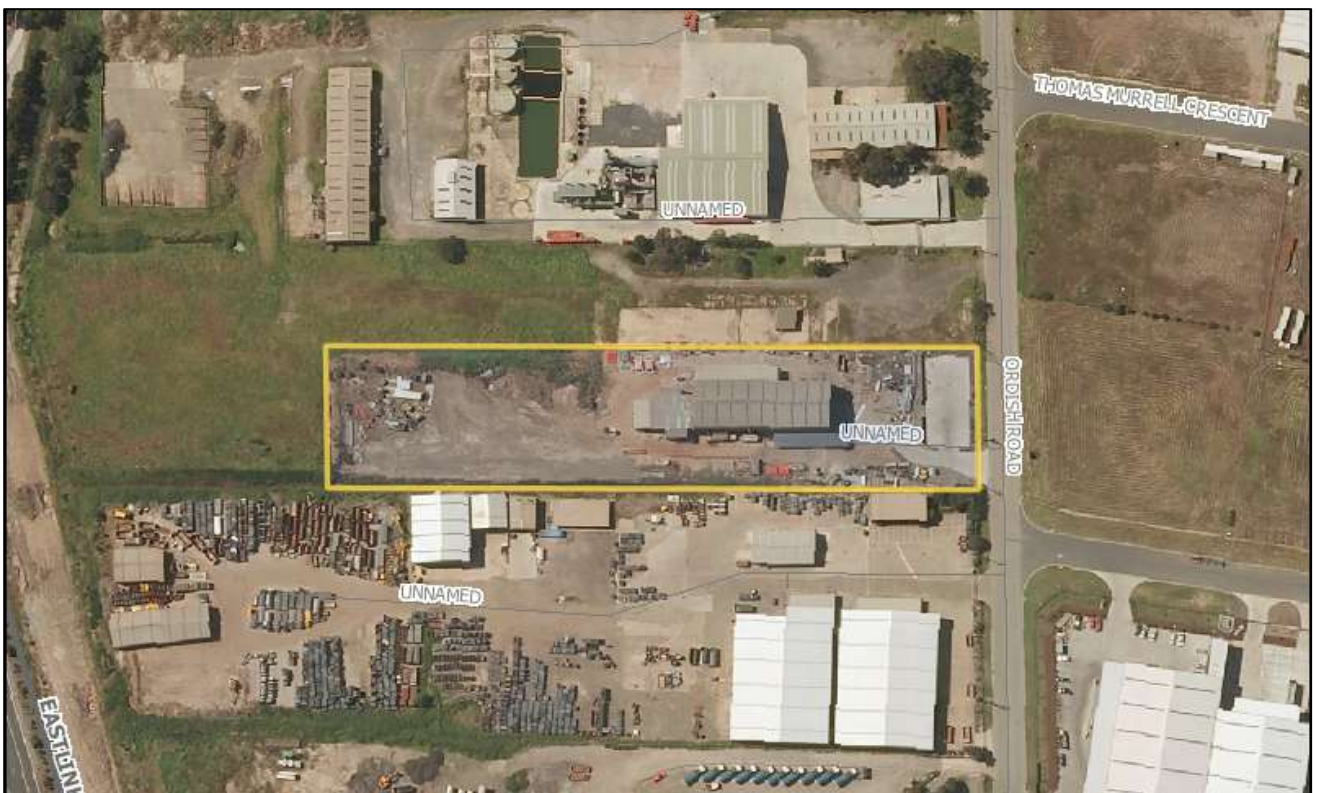
Figure 6 2010 aerial image, study area in yellow (GeoVic3, 2018).

Figure 6 shows little change to the establish structures within the study area but does show a noticeable difference to the western end of the property which appears to have been completely cleared of the overgrown vegetation and grass which would have involved the removal of the topsoil with machinery and is thus considered significant ground disturbance.

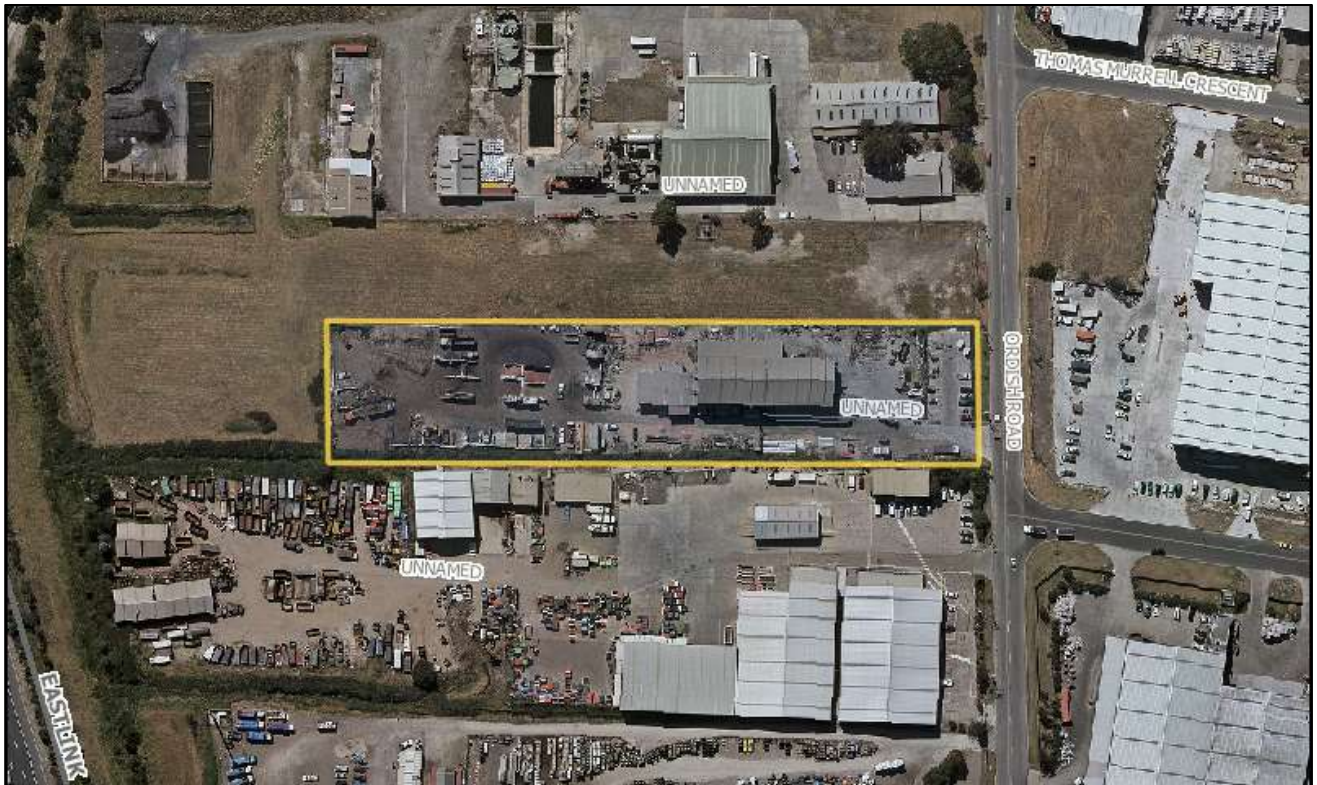
**Figure 7 2017 aerial image, study area in yellow (GeoVic3, 2018)**

Figure 7, the most recent aerial from 2017, again shows little change to the establish structures within the study area yet shows the use of the western end of the study area for the storage of various construction materials and multiple trucks for the transportation of these goods.
