McPhersons Quarry Expansion Proposal Landscape and Visual Assessment: Peer Review

Waikato District Council has engaged Boffa Miskell Ltd to undertake a peer review of the landscape and visual assessment (LVA) prepared by Opus for the proposed McPhersons Quarry expansion.

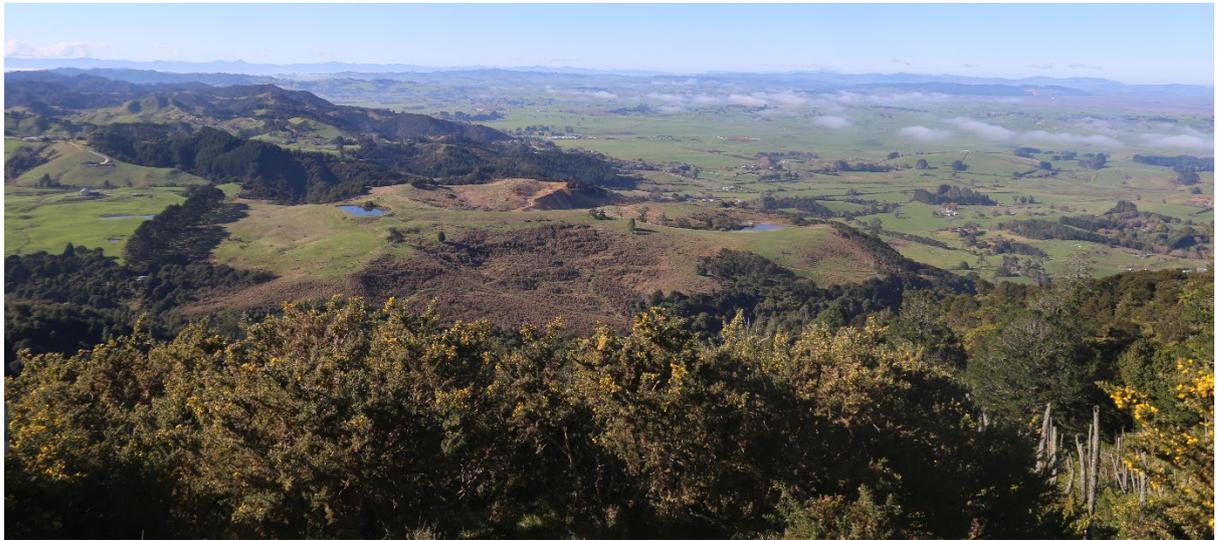
- 8.9 As part of this peer review the Mt William summit and walkway were visited and it is clear that the parts of the proposed quarry extension will be visible. During and after the proposed expansion it may be possible to see further into the quarry floor than currently possible. The section of the walkway closest to the proposed quarry extension and within the Visual Catchment is within thick native bush and does not allow views out. This is misleading in the Visual Catchment Plan without a clear methodology.

View from south east from the Mt William walkway towards the quarry.

- Further explanation should be given to the exclusion of viewpoints from the Mt William walkway and sufficient weight to how significant this is in relation to the number of users, proximity to the proposal and scenic quality of the view.
