**LANDHOLDERS  
DRIVING CHANGE**  
BURDEKIN MAJOR INTEGRATED PROJECT

**LANDHOLDERS DRIVING CHANGE  
LANDSCAPE REMEDIATION  
HALFWAY UPDATE**

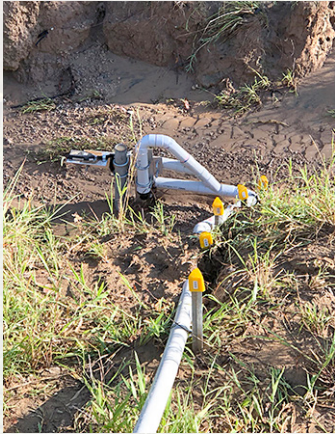
CSIRO water monitoring instrumentation installed at Mt Wickham.

In time, we can expect to see a reduction in the rate of erosion and the concentration of the sediments leaving remediated sites. Water quality and quantity monitoring equipment (installed by CSIRO) are in place at both the treatment and control sites.

This equipment measures water level, runoff volume, turbidity, sediment and nutrient concentration as well as particle size.
