# BURDEKIN MAJOR INTEGRATED PROJECT GULLY MAINTENANCE AND MONITORING PROJECT

## TWO MILE

### SITE FEATURES AND RESTORATION EFFORTS

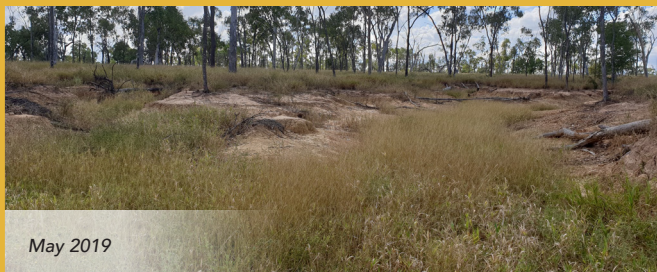
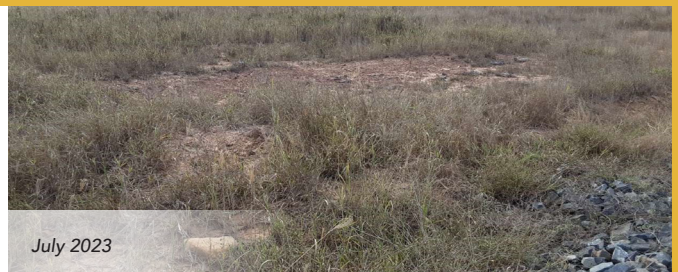
These before-and-after photos were taken near the eastern branch of the gully, looking upslope from within the gully.

The restoration work involved reshaping the gully and rehabilitating the catchment to improve infiltration. Trees were removed to open tunnels, and all nick points in the gully were graded to a gentler slope to promote grass cover to help protect the soil from erosion. The catchment was ripped along the contour to reduce the speed and volume of runoff downslope and to increase grass cover.

After the 2020-21 wet season, Graham was concerned about soil movement upslope from the log pile, where the upper gully head had been reshaped, and the earthworks had “fluffed up” the soil. In October 2021, he constructed two rock weirs (0.3m x 1.5m x ~30+m) above the logs and planted Rhodes grass around the weirs.

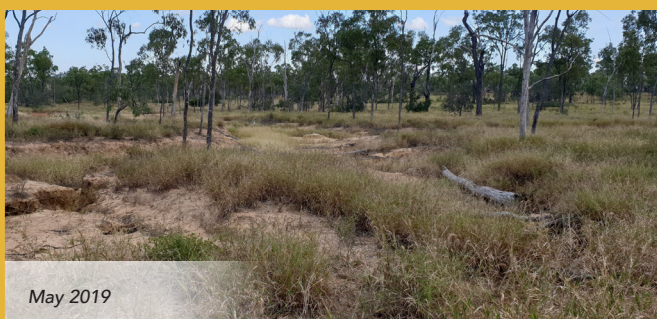
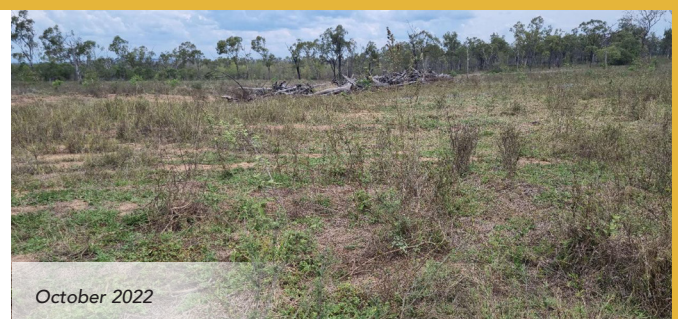
These before-and-after photos are looking downslope from the western branch of the gully.

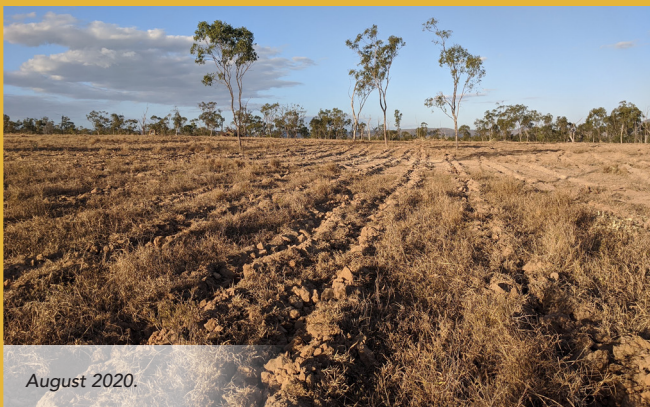
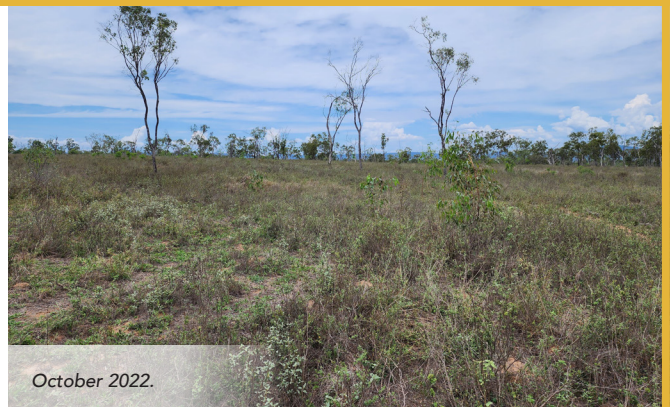
Ripping the slope above the gully reduced surface water velocity, trapped fine sediment, and promoted vegetation growth. The structure of the rip lines is holding up well.

August 2020.

October 2022.

- Ripping the slope above the gully reduced surface water velocity, trapped fine sediment and nutrients, and promoted vegetation growth.
- The structure of the rip lines is holding up well, perhaps because of the clay soil present. It's acknowledged that rip lines don't exist in perpetuity in the landscape.

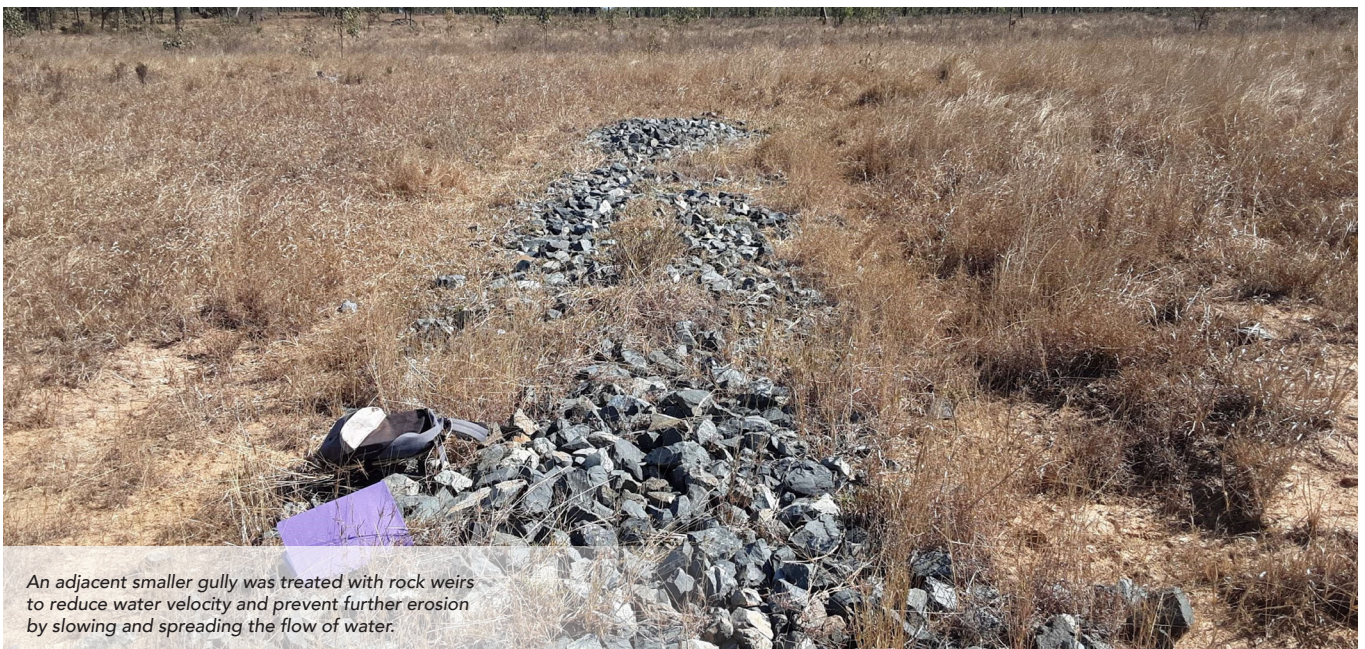
An adjacent smaller gully was treated with rock weirs to reduce water velocity and prevent further erosion by slowing and spreading the flow of water.

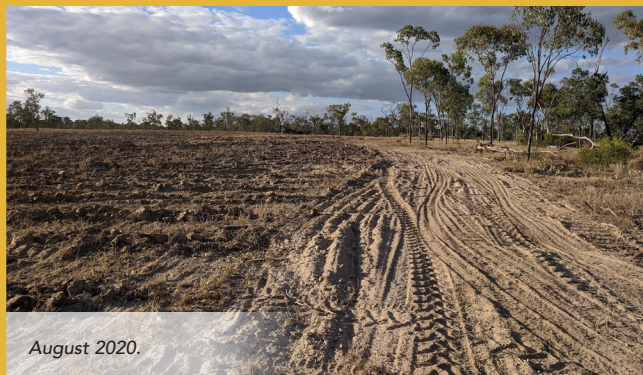
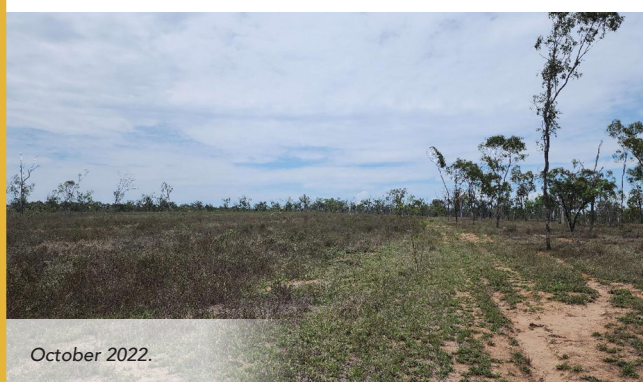
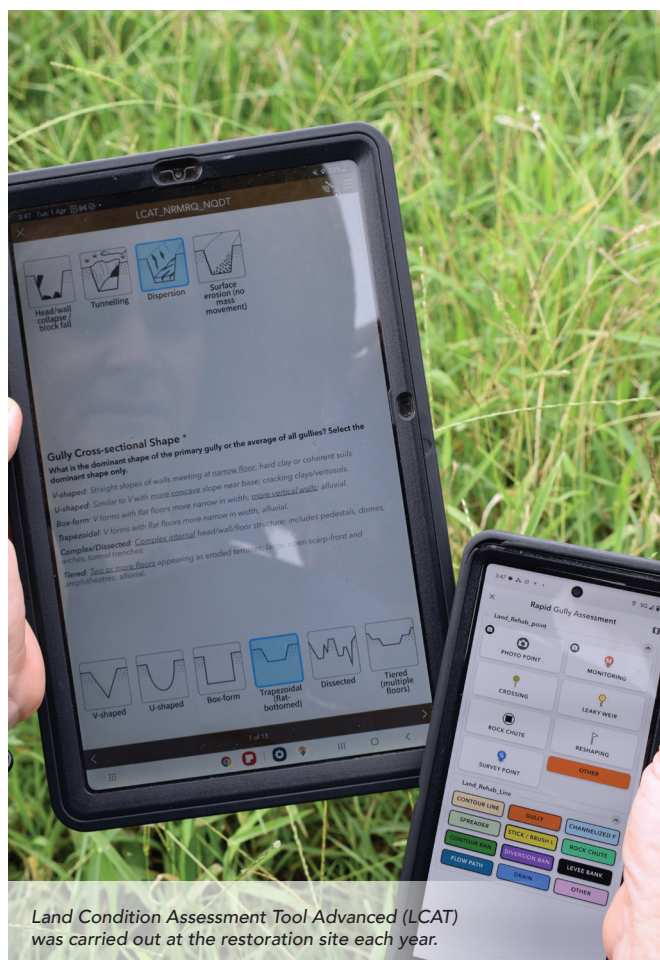
Ripping the slope above the gully reduced surface water velocity, trapped fine sediment, and promoted vegetation growth. The structure of the rip lines is holding up well.

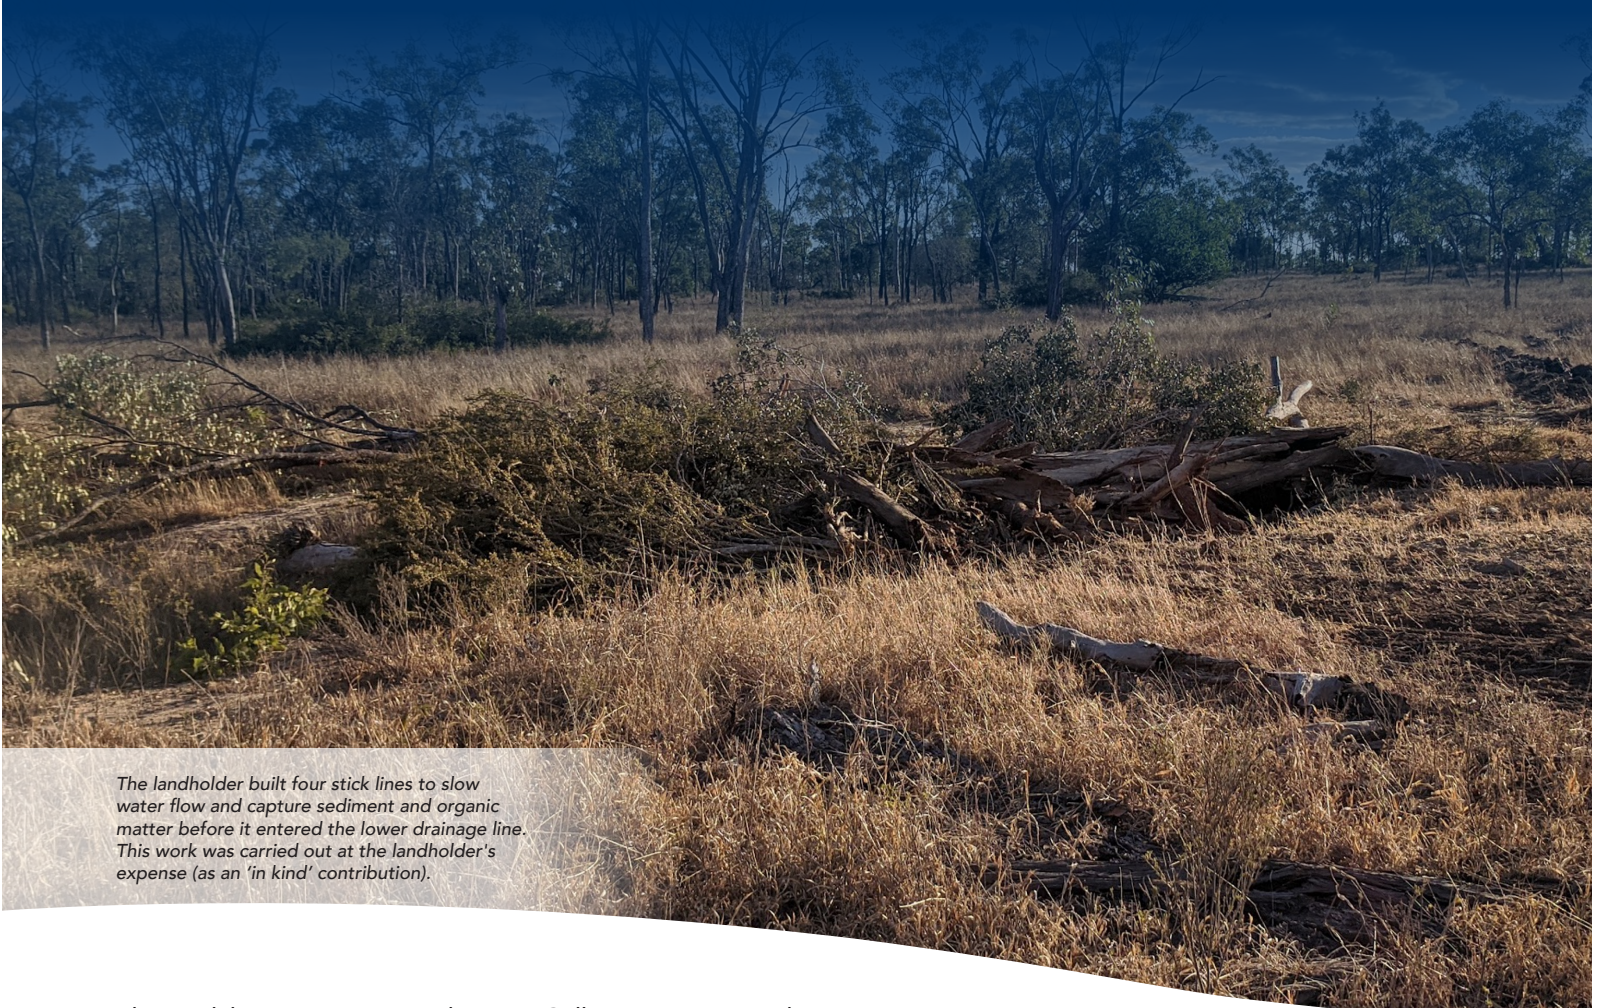
*The landholder built four stick lines to slow water flow and capture sediment and organic matter before it entered the lower drainage line. This work was carried out at the landholder's expense (as an 'in kind' contribution).*

He also built four stick lines below the log pile to slow water flow and capture sediment and organic matter before it entered the lower drainage line. This additional work was designed in consultation with another grazier from the Scottville cluster group,

Barry Collett, who provided the machinery for the job. The work was carried out at the landholder's expense (as an ‘in kind’ contribution). It is believed these structures have played a key role in preventing sharp edges from reforming near the old gully.
