# BURDEKIN MAJOR INTEGRATED PROJECT GULLY MAINTENANCE AND MONITORING PROJECT

## EXEVALE STATION

### SITE FEATURES AND RESTORATION EFFORTS

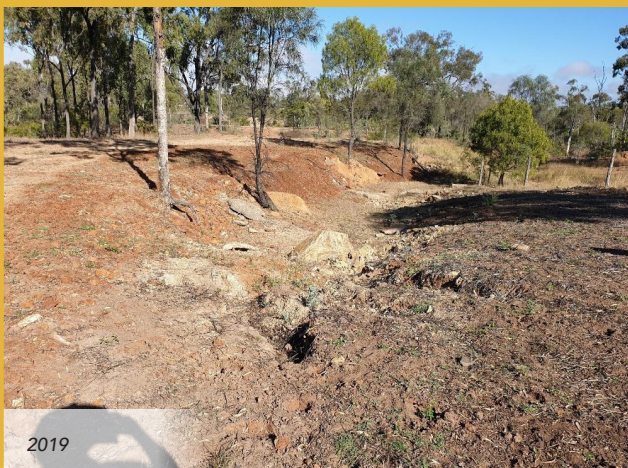
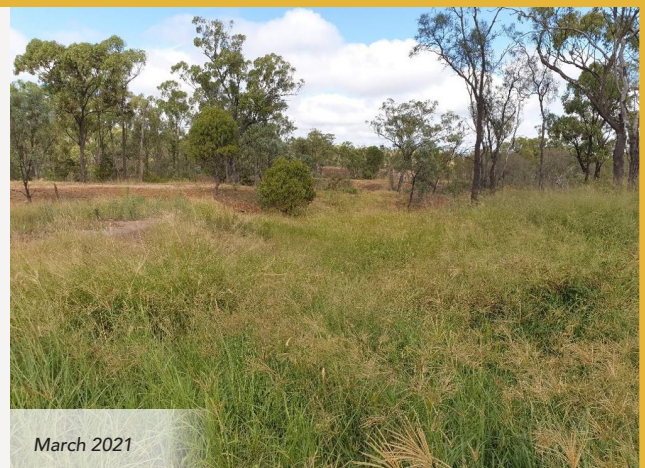
Erosion repair efforts focused on stopping the progression of a two-metre-deep gully at the base of a small hill, where head cuts were slowly advancing upslope. These photos capture the site before remediation and two years later, showcasing the impact of the restoration work.

Given the landholder's previous success in managing other gullies on the property, the same remediation method was employed. Rock was sourced from around the property to fill and line the gully heads. These gully heads were reshaped to a minimum 1:3 slope and seeded. Topsoil and organic matter were added to assist with revegetation.

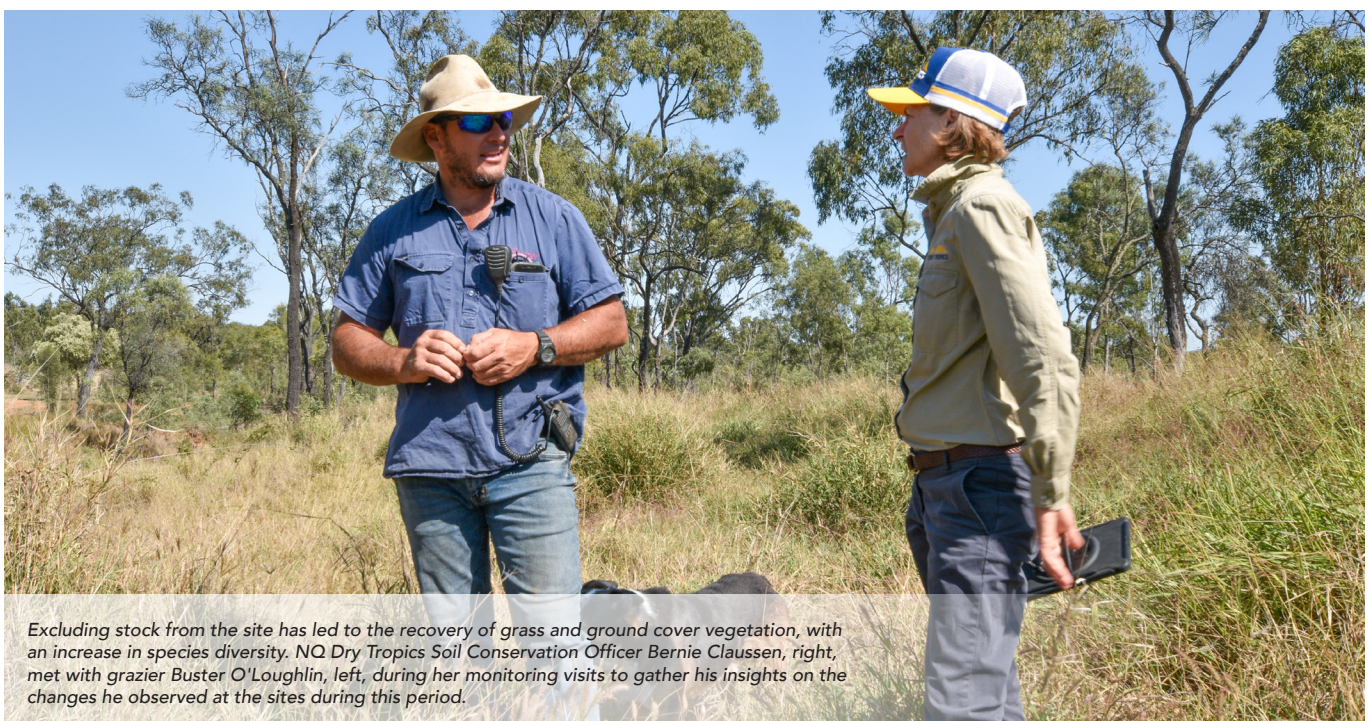
Excluding stock from the site has led to the recovery of grass and ground cover vegetation, with an increase in species diversity. NQ Dry Tropics Soil Conservation Officer Bernie Claussen, right, met with grazier Buster O'Loughlin, left, during her monitoring visits to gather his insights on the changes he observed at the sites during this period.

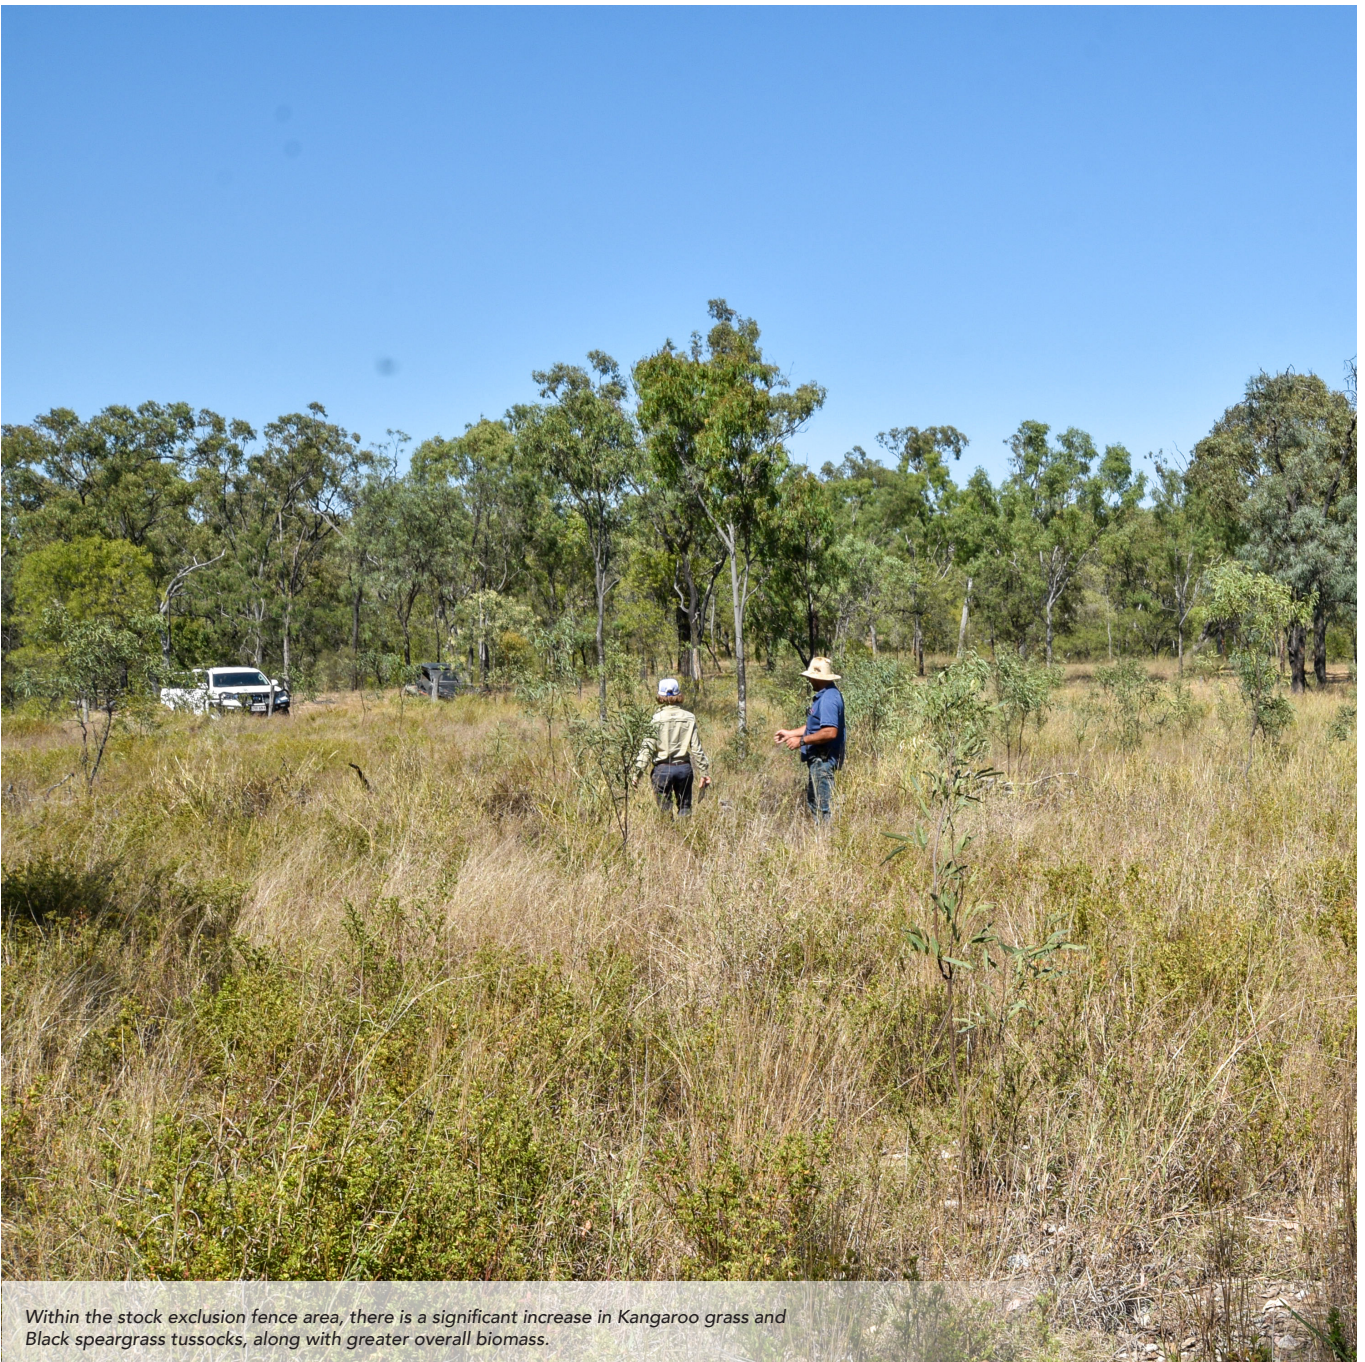
*Within the stock exclusion fence area, there is a significant increase in Kangaroo grass and Black speargrass tussocks, along with greater overall biomass.*

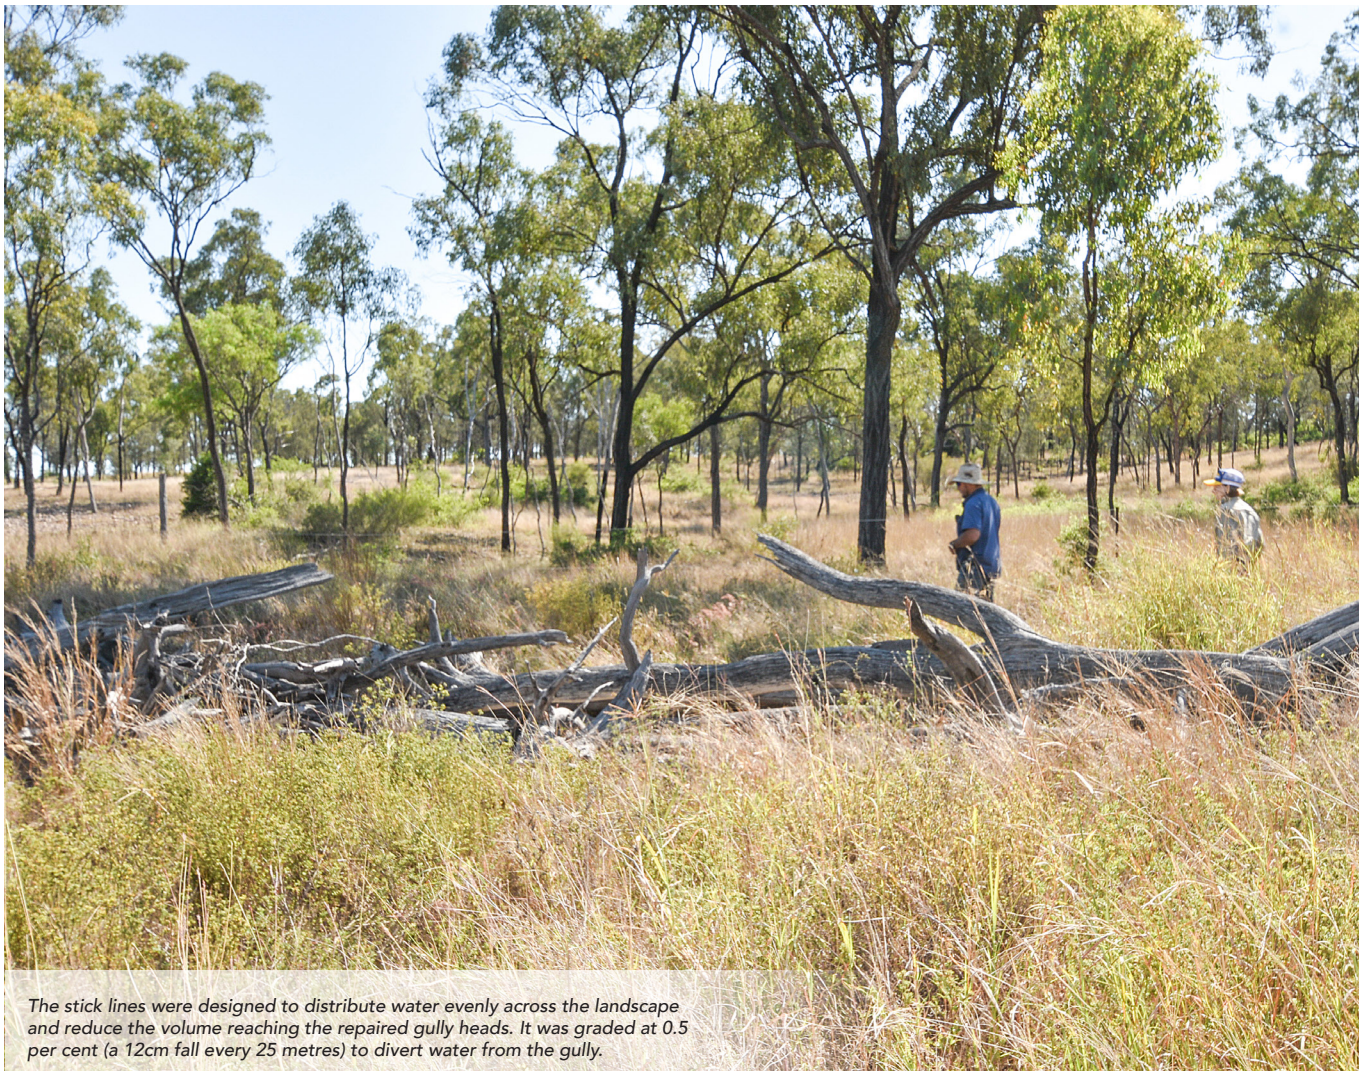
*The stick lines were designed to distribute water evenly across the landscape and reduce the volume reaching the repaired gully heads. It was graded at 0.5 per cent (a 12cm fall every 25 metres) to divert water from the gully.*

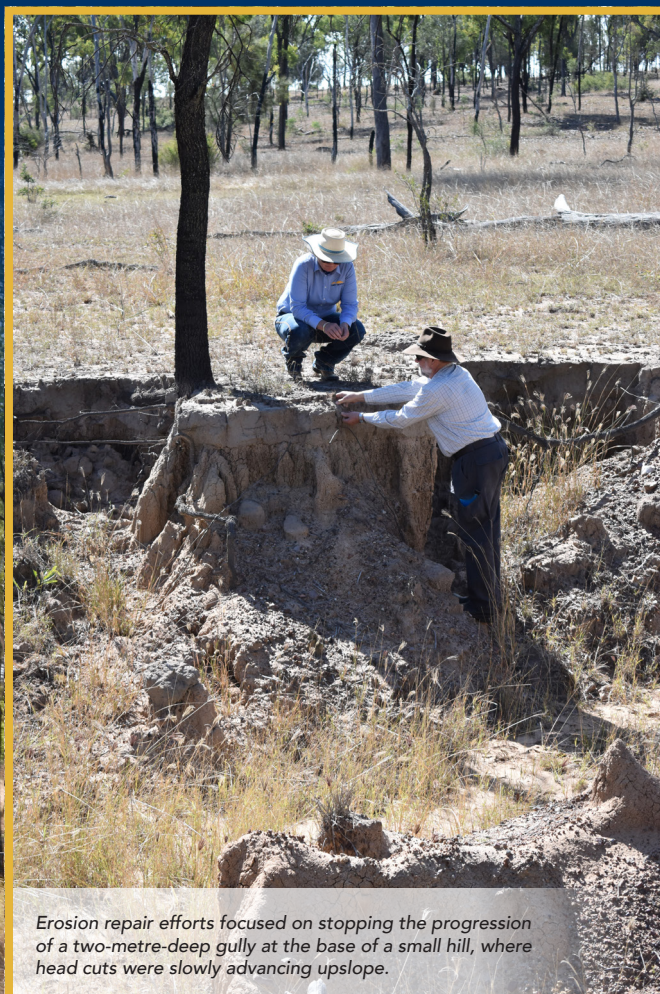
Erosion repair efforts focused on stopping the progression of a two-metre-deep gully at the base of a small hill, where head cuts were slowly advancing upslope.
