# BURDEKIN MAJOR INTEGRATED PROJECT GULLY MAINTENANCE AND MONITORING PROJECT

## MT WICKHAM

### SITE FEATURES AND RESTORATION EFFORTS

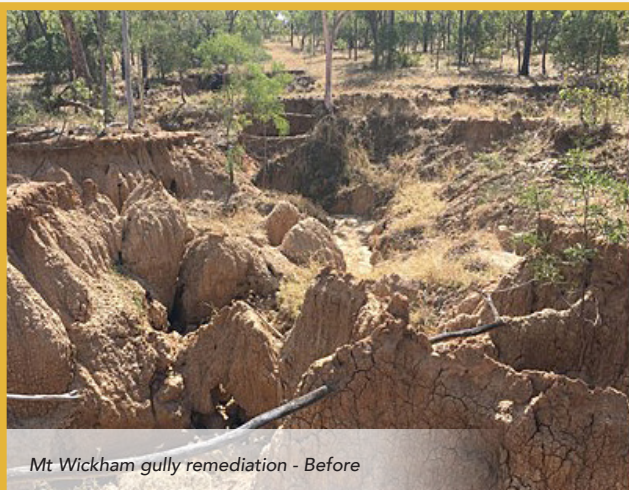
Mt Wickham gully remediation - Before

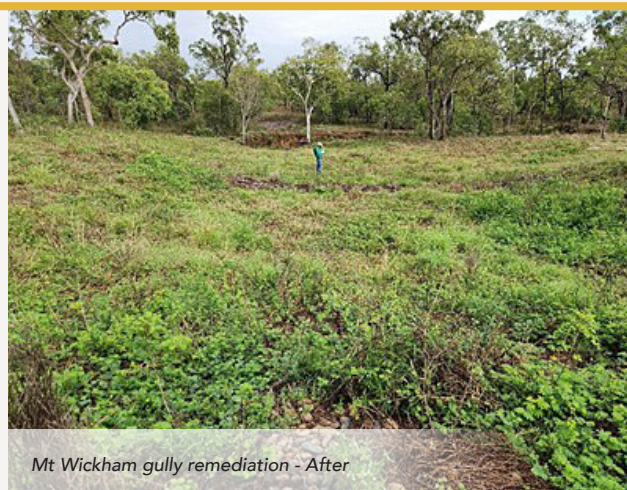
Mt Wickham gully remediation - After

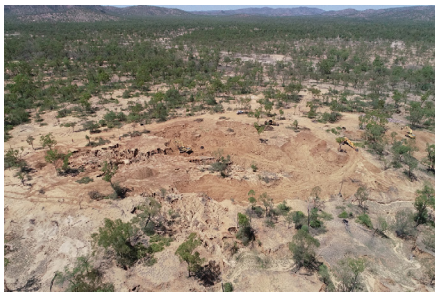
Aerial view of the site during remediation.

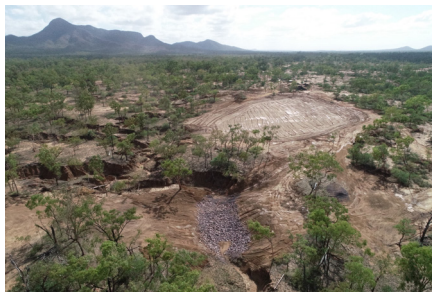
Aerial view of the site right after remediation was completed.

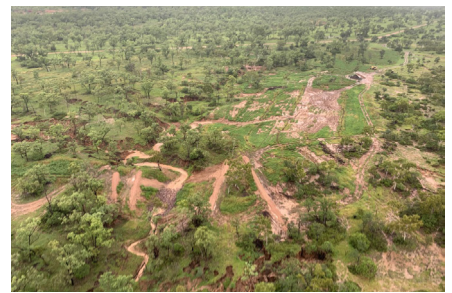
Aerial view of the site weeks later, after more than 300mm of rainfall in a single event.

The works were tested immediately, we got 300mm of rain right after the work was completed, and the remediation held up well. Over a couple of months more than 1100mm of rain was recorded. Of course, some maintenance was needed, but not much. Overall, the work, including the maintenance, is holding up well. It'll be interesting to see how it performs in a few years, and longer term. That's when the experts will have a clearer picture of the treatment's effectiveness.

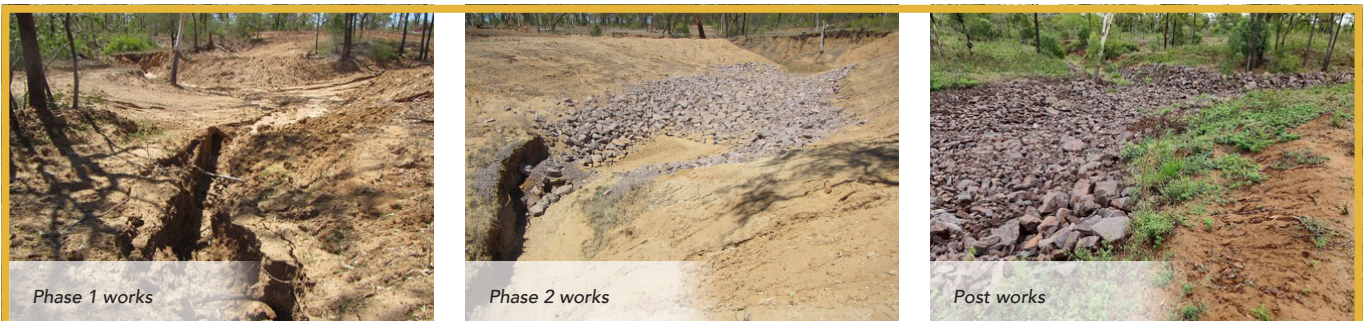
*In the lower sections of the main gully channel, walls were stabilised, and rock structures were installed to slow water flow and reduce erosion. This method provided an effective solution while minimising costs by avoiding the need for extensive reshaping of the entire system. By reducing the water's speed, sediment can settle on the gully bed, helping to establish a new gully floor and reduce upstream erosion.*

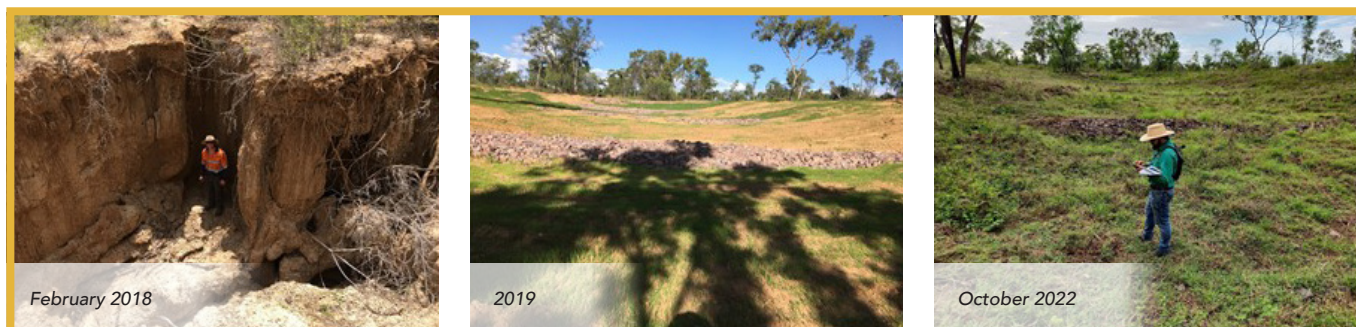
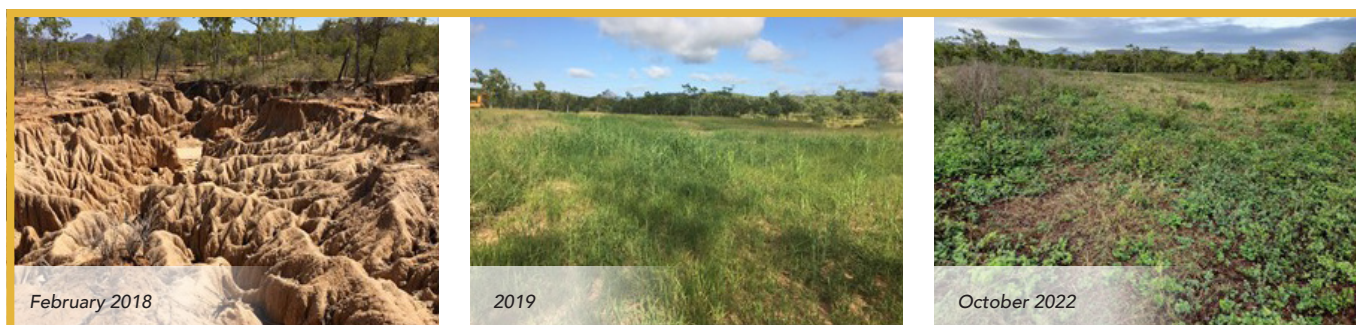
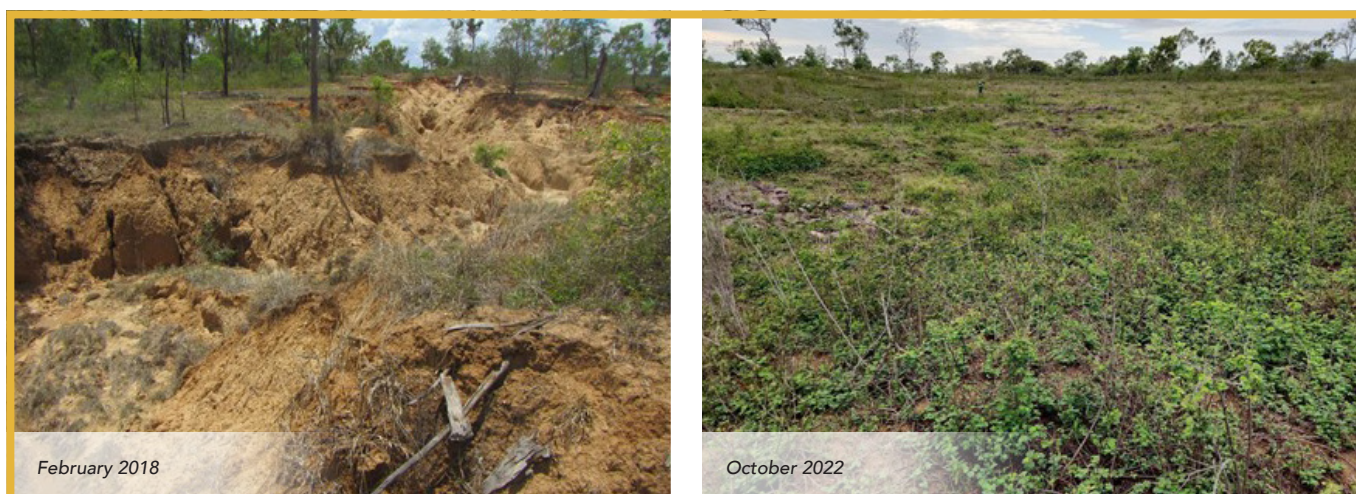
- The Mt. Wickham site required maintenance after the first wet season in 2020 to address rilling and soil movement. Additional maintenance was conducted in 2021 and 2024 to repair ongoing slumping and tunneling, particularly around rock chutes. Without these timely interventions, the site would not be as stable as it is today.

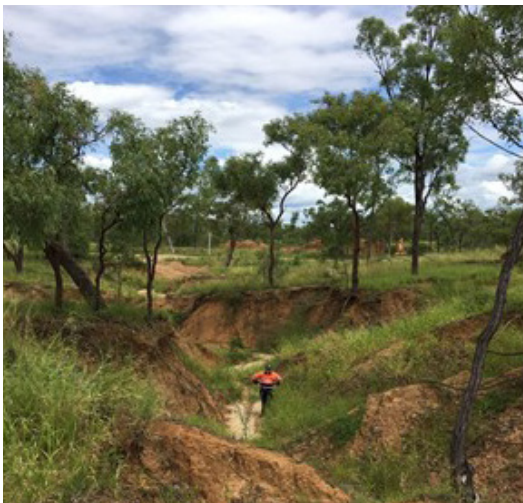
*February 2018*  
The main gully channel before works that drains into Sandalwood Creek and eventually flow into the Bowen River.

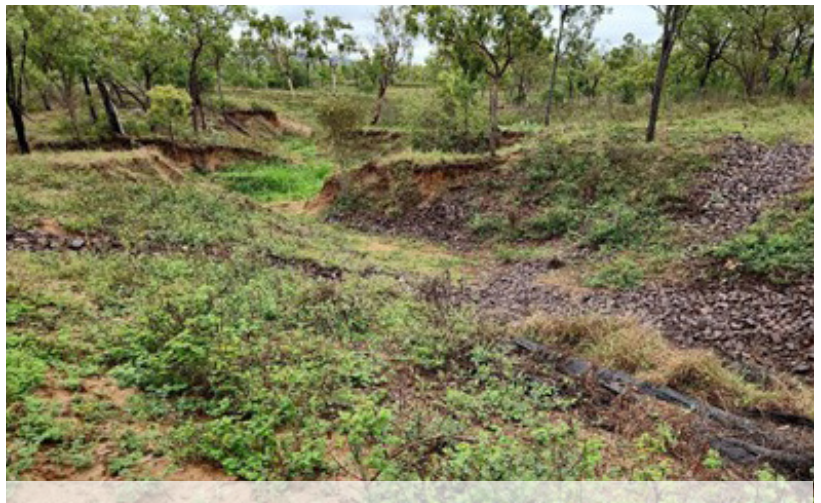
*October 2022*  
In the lower sections of the main gully channel, walls were stabilised, and rock structures were installed to slow water flow and reduce erosion. This method provided an effective solution while minimising costs by avoiding the need for extensive reshaping of the entire system.

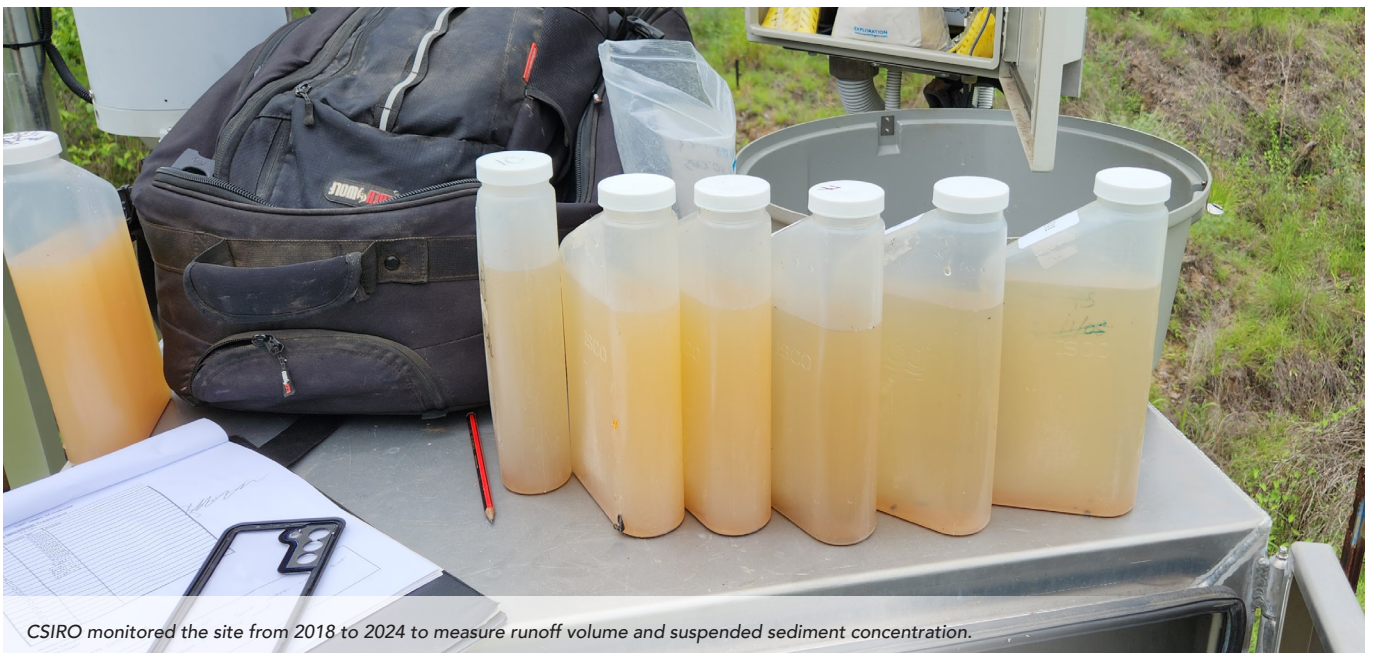
CSIRO monitored the site from 2018 to 2024 to measure runoff volume and suspended sediment concentration.
