# LOGAN CREEK STREAMBANK REHABILITATION

## RESTORING RESILIENCE IN THE BURDEKIN CATCHMENT

The Logan Creek Streambank Rehabilitation project is restoring resilience in the Burdekin catchment through targeted erosion control and riparian restoration works, helping stabilise damaged creek systems while improving water quality and strengthening the landscape for the future.

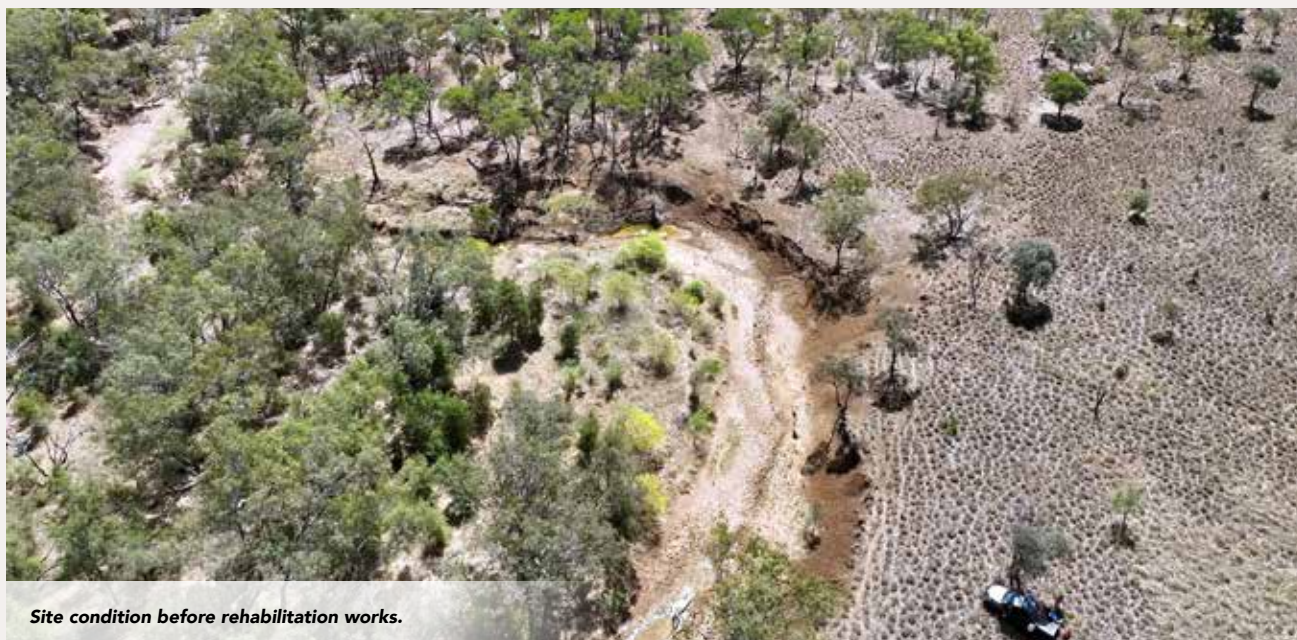
*Site condition before rehabilitation works.*

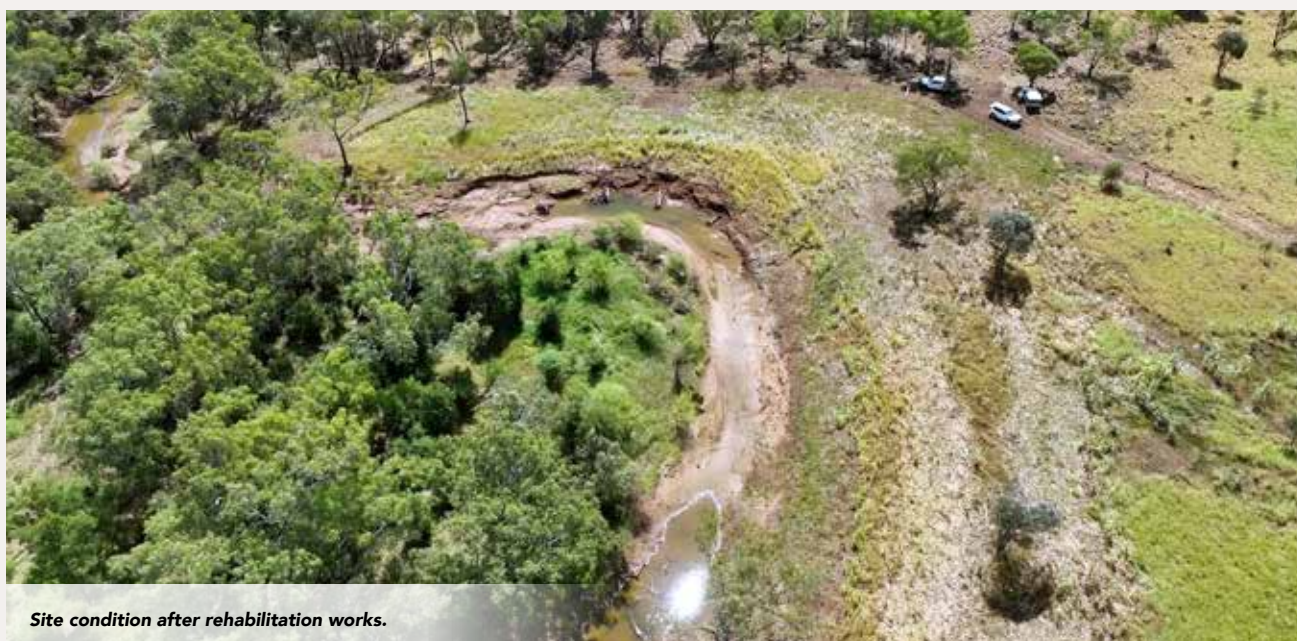
*Site condition after rehabilitation works.*

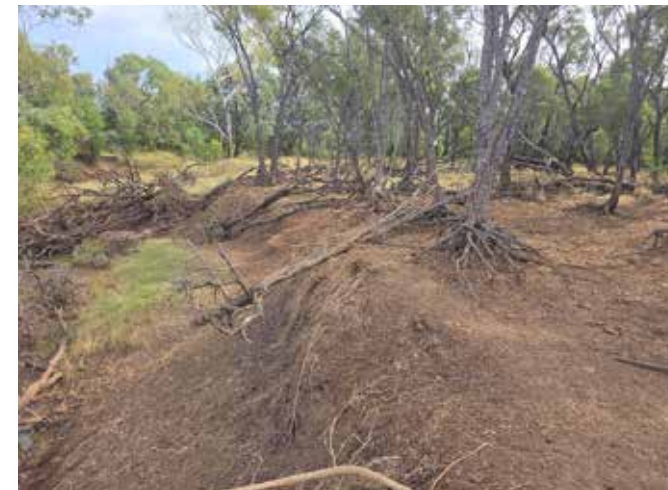
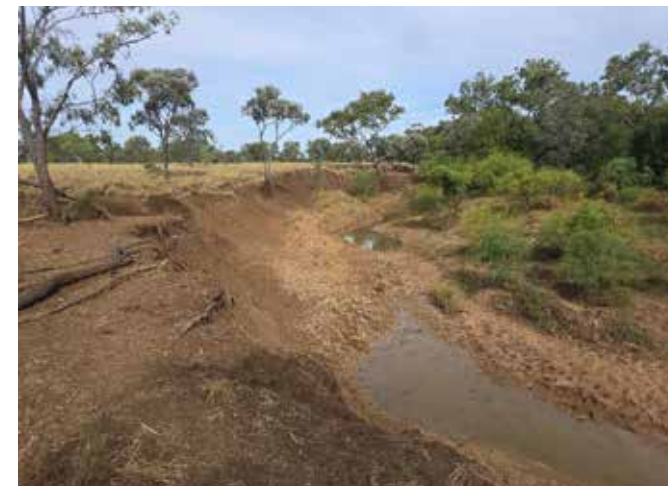
Logan Creek lies within the Brigalow Belt Bioregion, where important remnant Brigalow vegetation lines the creek system. These photos show significant bank undercutting caused by the 2021 flood event and subsequent flows, highlighting the need to protect and restore these valuable riparian ecosystems.

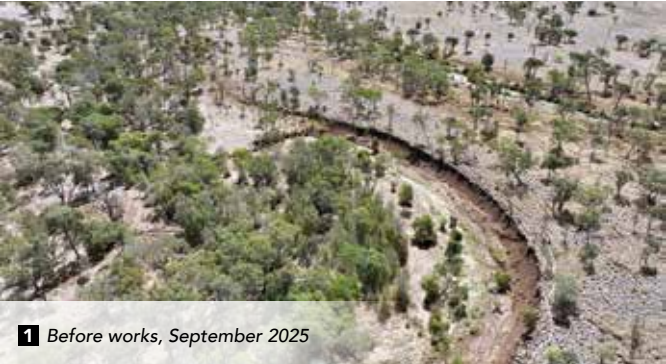
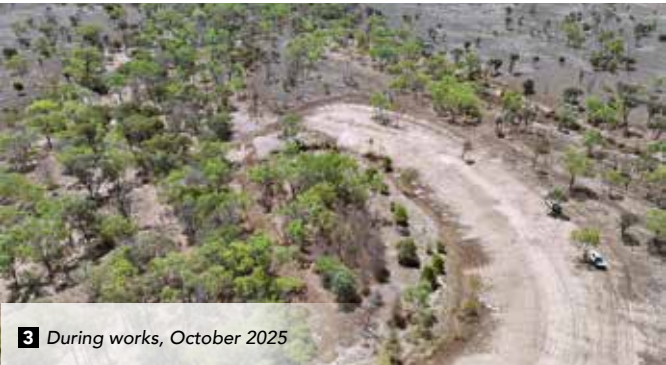
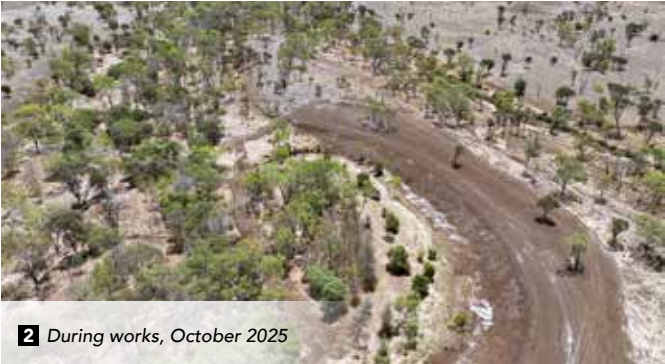
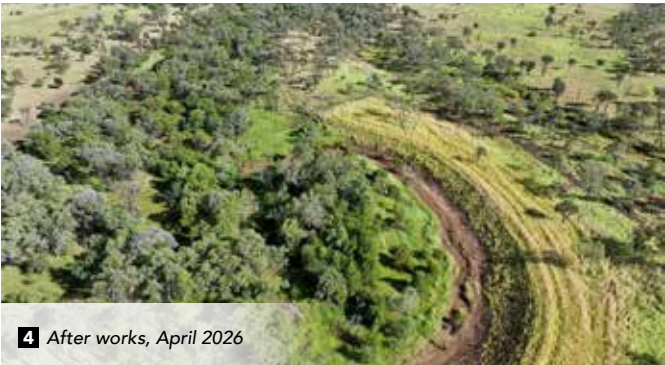
Dooruna Station  
SITE 4

At Sites 4 and 5, more than 150m of severely eroded streambank was reshaped from a steep 1:0.27 slope to a stable 1:3 profile. The banks were seeded with a native mix and fenced to exclude fauna, supporting revegetation and long-term stabilisation.

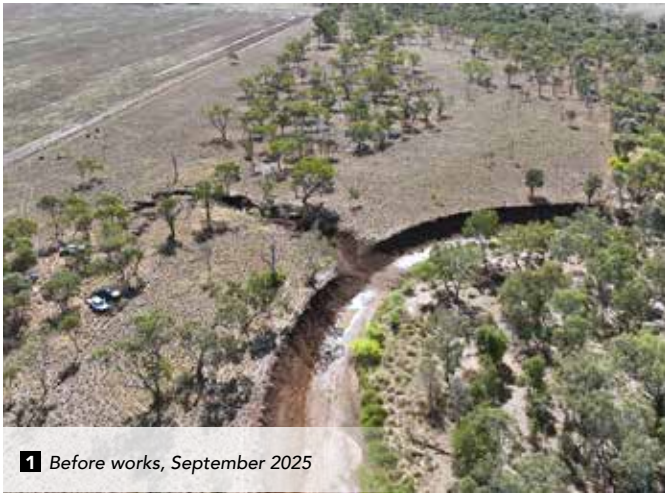
**1** Before works, September 2025

More than 181m of unstable streambank was reshaped to a stable 1:3 slope and revegetated to improve long-term bank stability. Overburden from the works was used to fill an adjacent gully threatening the rehabilitation area.

A rock chute was installed to manage overland flow into the reshaped gully, and fencing was installed to protect revegetation works during establishment.

Soil conditioning helped improve growing conditions, giving plants a better chance of establishing.

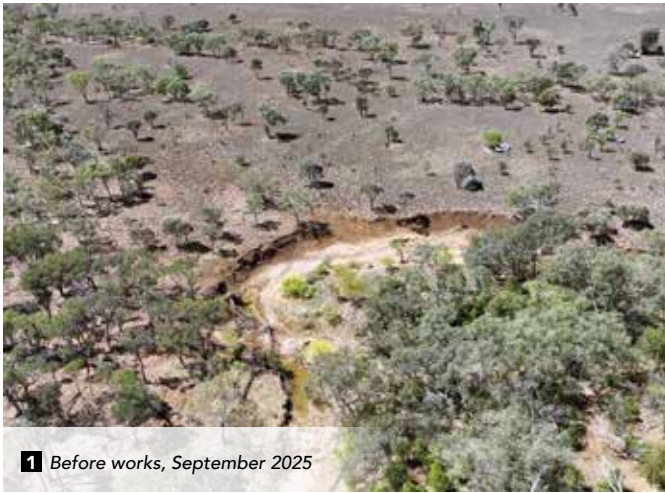
**1** Before works, September 2025

More than 125m of eroded streambank was reshaped to a stable 1:3 slope to improve stability and reduce sediment loss. Lower and upper bank areas were seeded with a native seed mix, with fencing installed to protect revegetation works during establishment.

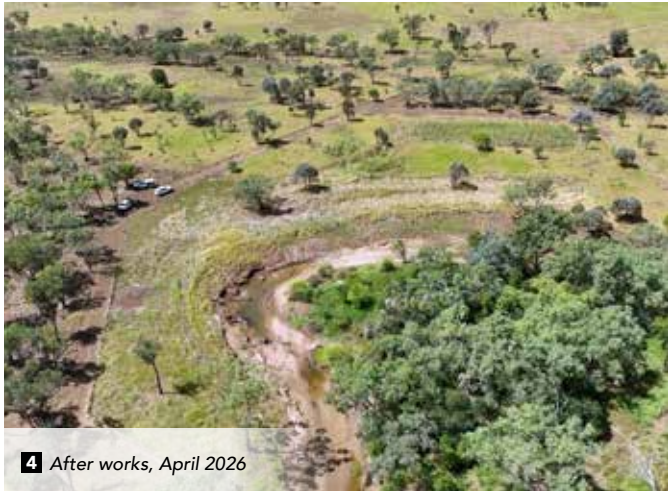
**4** After works, April 2026

Revegetation works have re-established ground cover and initiated natural recovery processes across the site.

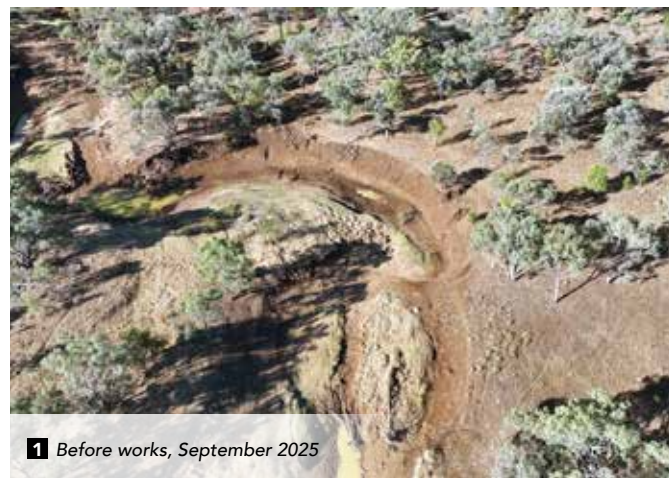
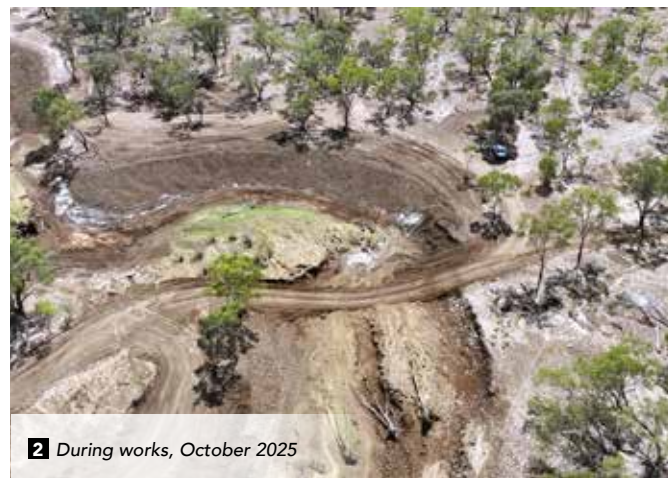
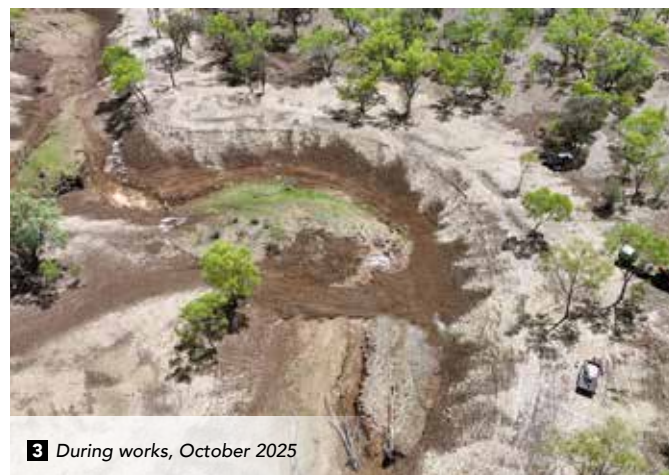
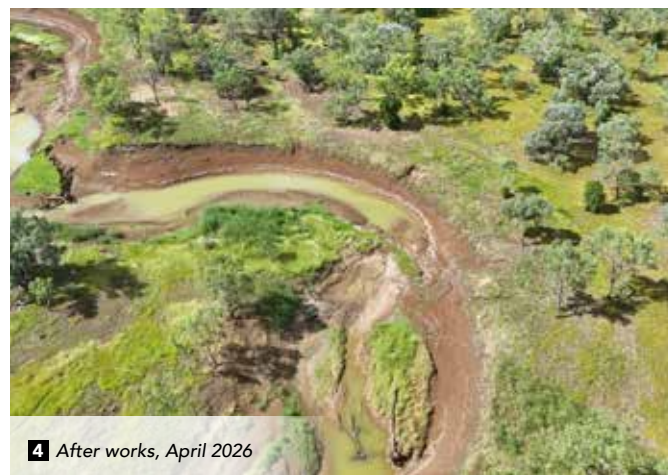
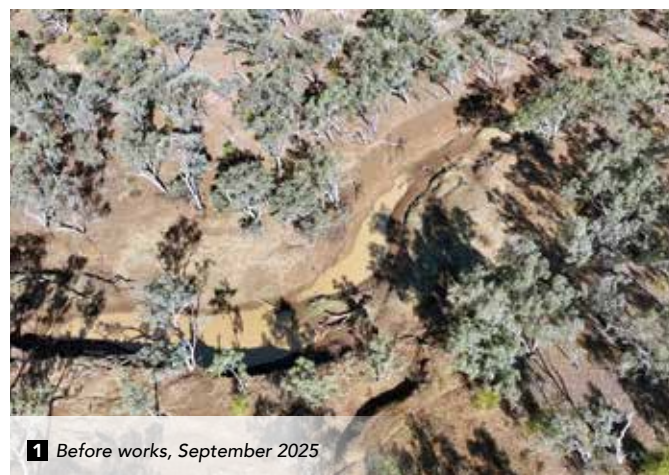
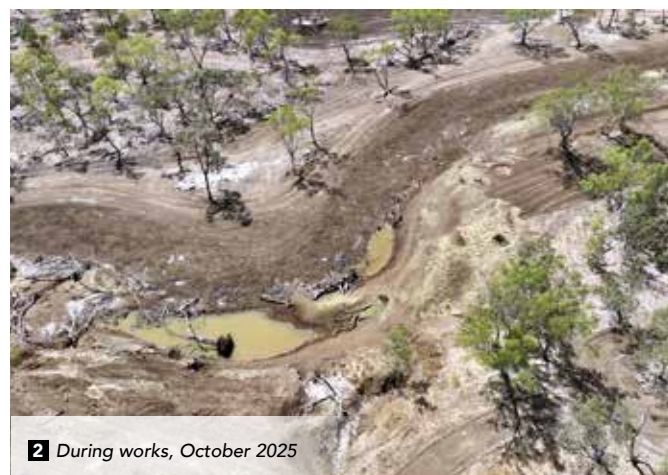
Avon Downs Station  
SITE 8

Site 8 represented one of the largest treatment areas, more than one kilometre of actively eroding streambank was reshaped to a stable 1:3 slope and revegetated to improve long-term stability.

The original 263m treatment area was extended after Sites 1, 2, 3 and 9 were deemed unsuitable for repair works. Rehabilitation priorities were identified using a Digital Elevation Model (DEM) of Difference (DoD), which measures changes in land elevation over time by comparing two topographic surveys to identify areas of erosion, deposition, and volumetric change.

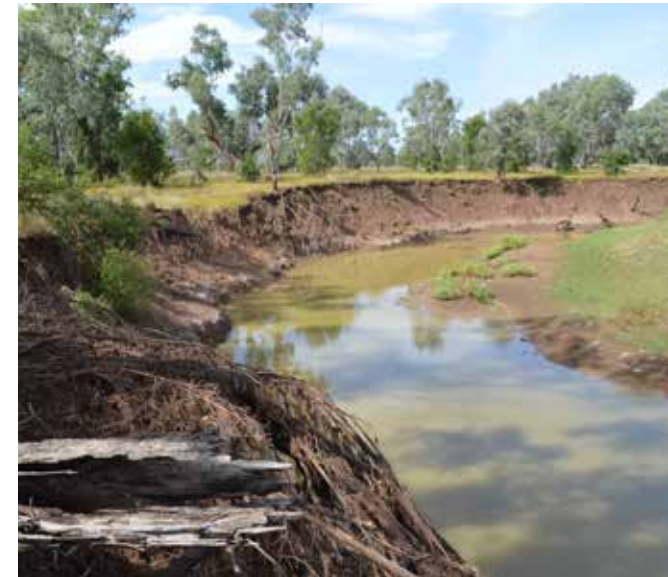
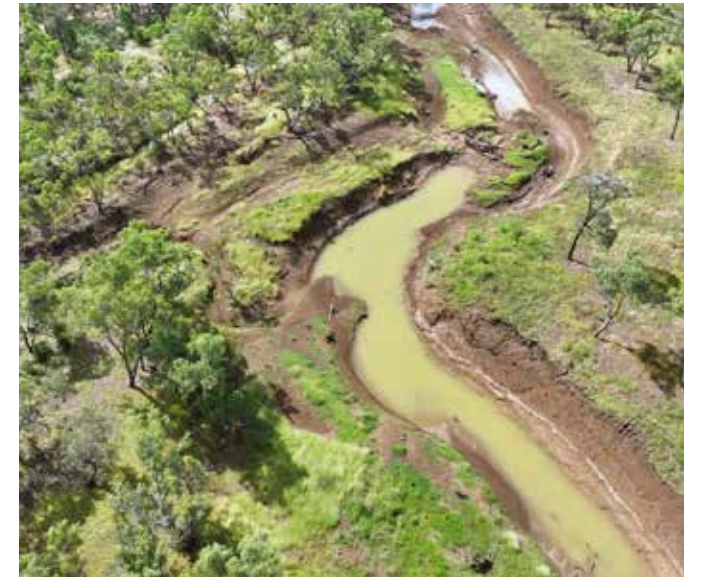
These photos show the transformation at Site 4 following rehabilitation works.

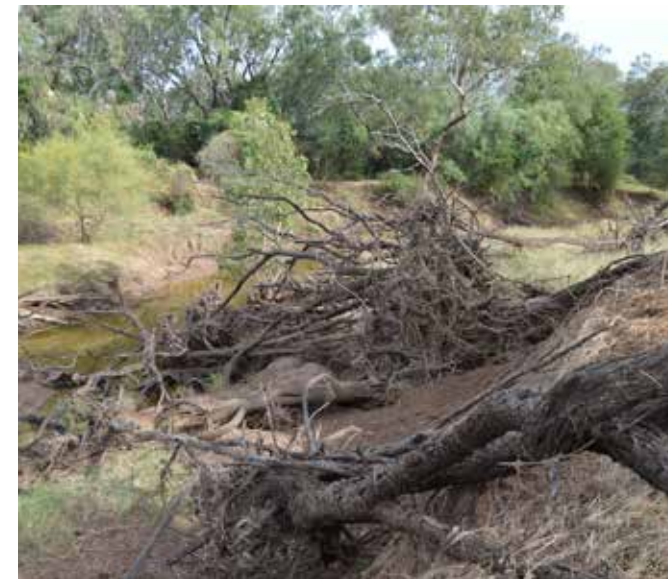
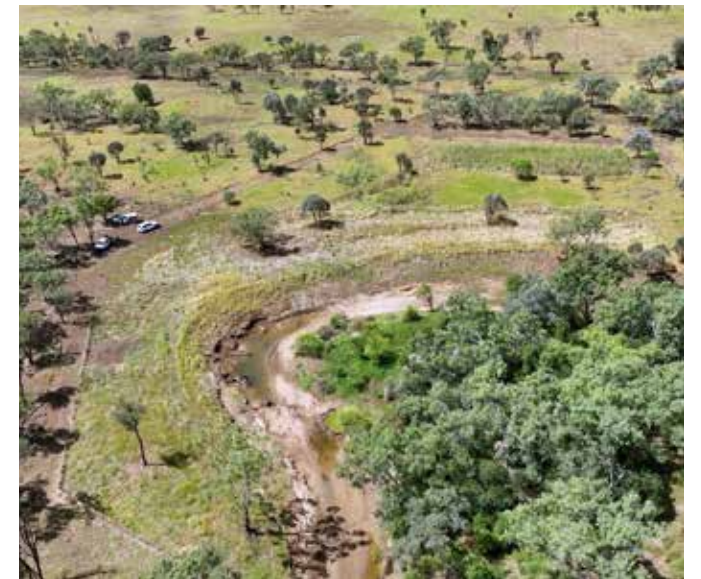
These photos show the transformation at Site 7 following rehabilitation works.

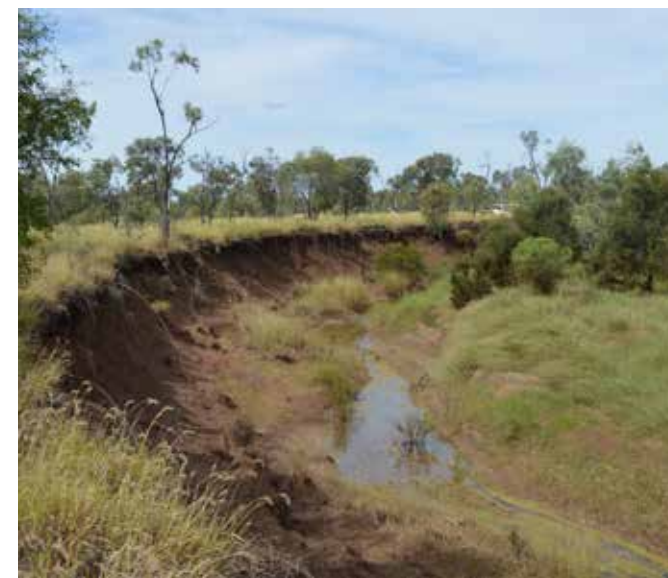
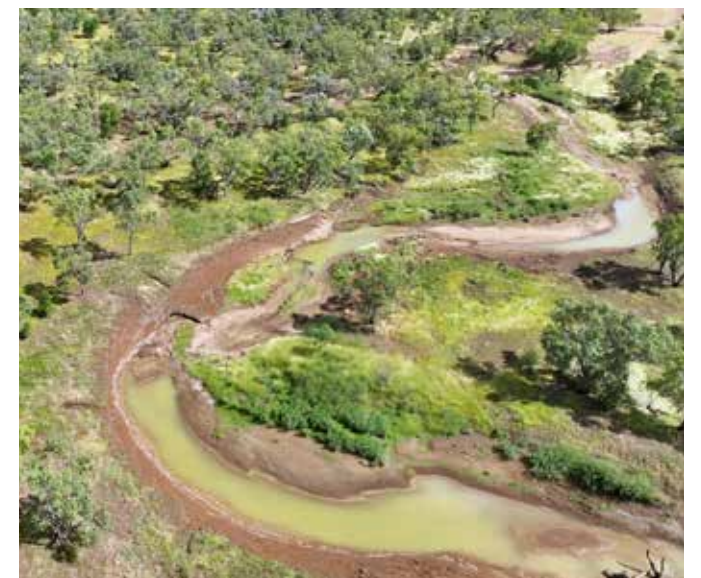
These photos show the transformation at Site 8 following rehabilitation works.
