# Ground Vibration Report

| Location | Phoenix 4030 CYG 6485 F1 |

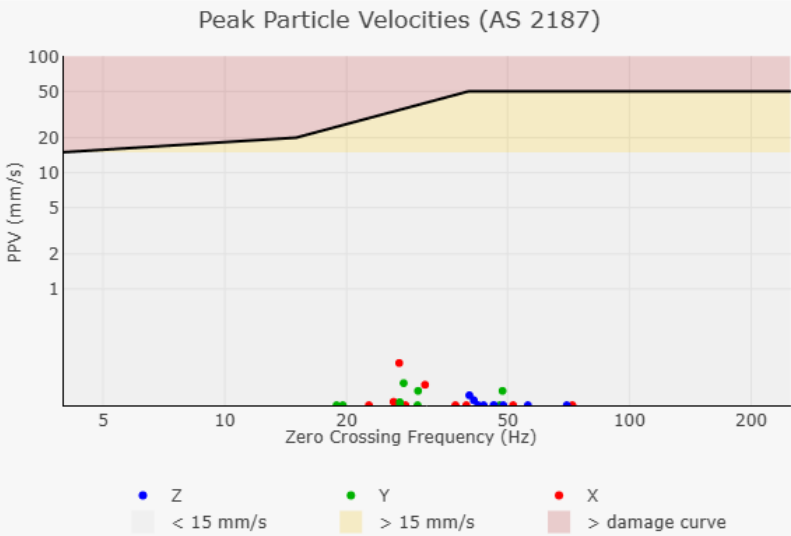
Per-component Peak Particle Velocities (PPV) vs. Zero Crossing Frequencies.  
Line indicates cosmetic damage guidelines  
(residential buildings, Fig. J4.4.2.1, AS 2187.2:2006).
