Ground Vibration Report

| Event Date | 2026/01/05 |
| Location | Phoenix 4030 CYG 6485 |

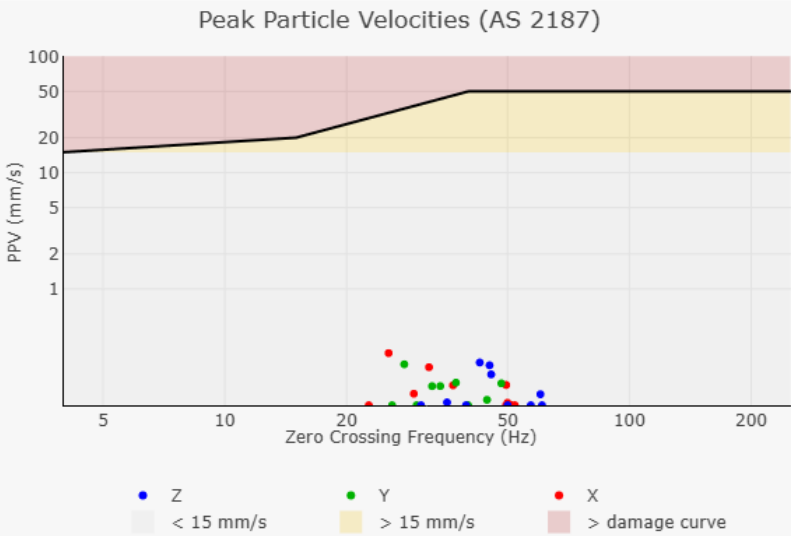
Per-component Peak Particle Velocities (PPV) vs. Zero Crossing Frequencies.  
Line indicates cosmetic damage guidelines  
(residential buildings, Fig. J4.4.2.1, AS 2187.2:2006).
