# Ground Vibration Report

| Event Date | 2026/01/08 |
| Location | Harrier 4290 SHW 4880 F1 |

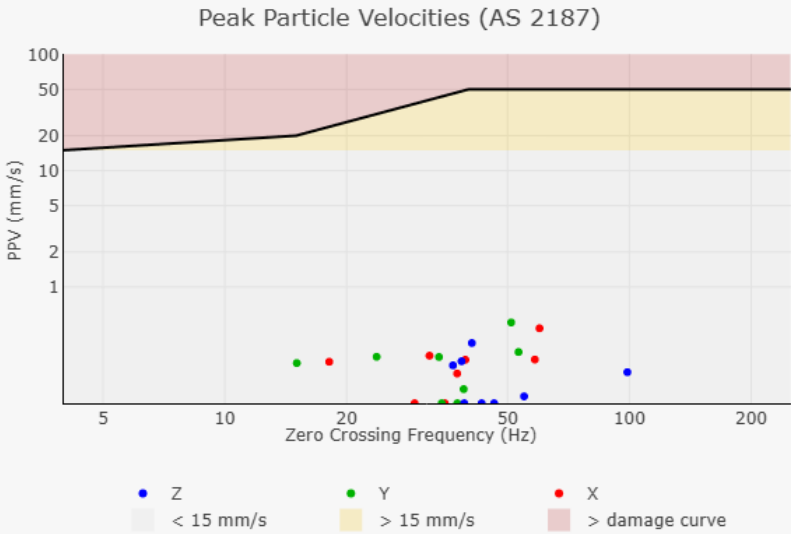
Per-component Peak Particle Velocities (PPV) vs. Zero Crossing Frequencies.  
Line indicates cosmetic damage guidelines  
(residential buildings, Fig. J4.4.2.1, AS 2187.2:2006).
