Ground Vibration Report

| Event Date | 2026/01/10 |
| Location | Phoenix 3865 SWN 6090 F2 |

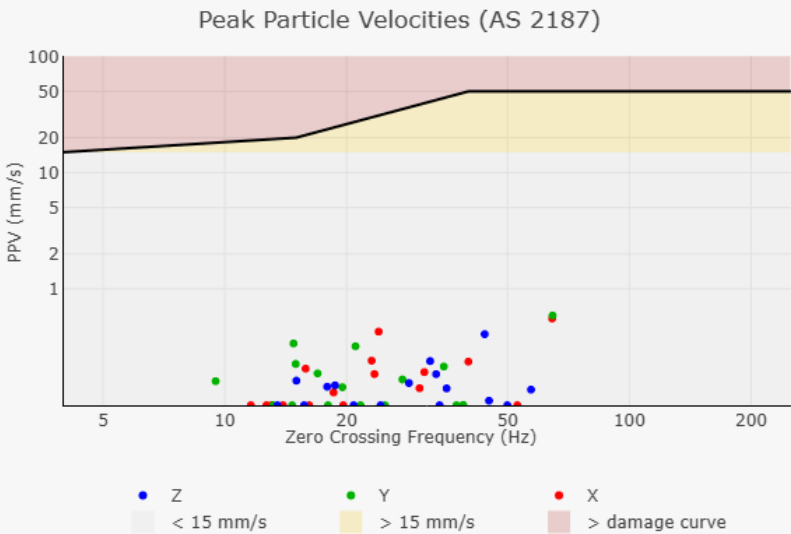
Per-component Peak Particle Velocities (PPV) vs. Zero Crossing Frequencies. Line indicates cosmetic damage guidelines (residential buildings, Fig. J4.4.2.1, AS 2187.2:2006).
