# Ground Vibration Report

| Event Date | 2026/01/14 |
| Location | Phoenix 3750 CRD RAR |

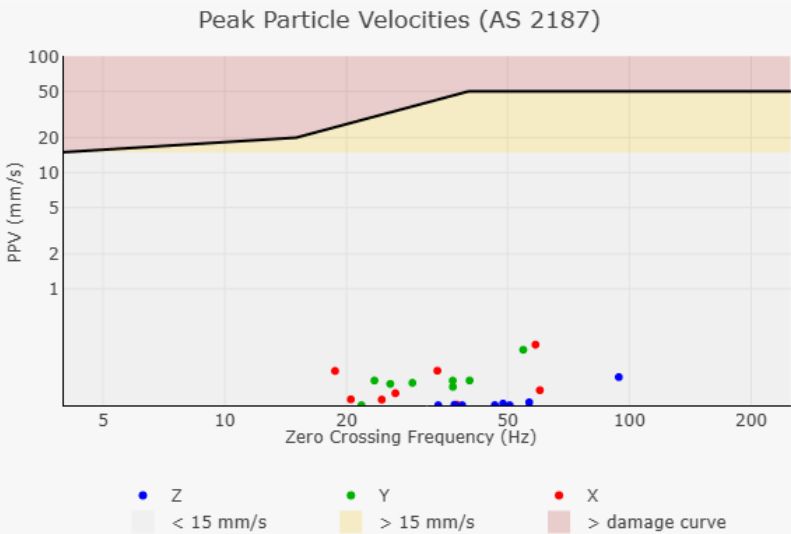
Per-component Peak Particle Velocities (PPV) vs. Zero Crossing Frequencies.  
Line indicates cosmetic damage guidelines  
(residential buildings, Fig. J4.4.2.1, AS 2187.2:2006).
