# Ground Vibration Report

| Event Date | 2026/01/16 |
| Location | Harrier 4290 SHW 4880 |

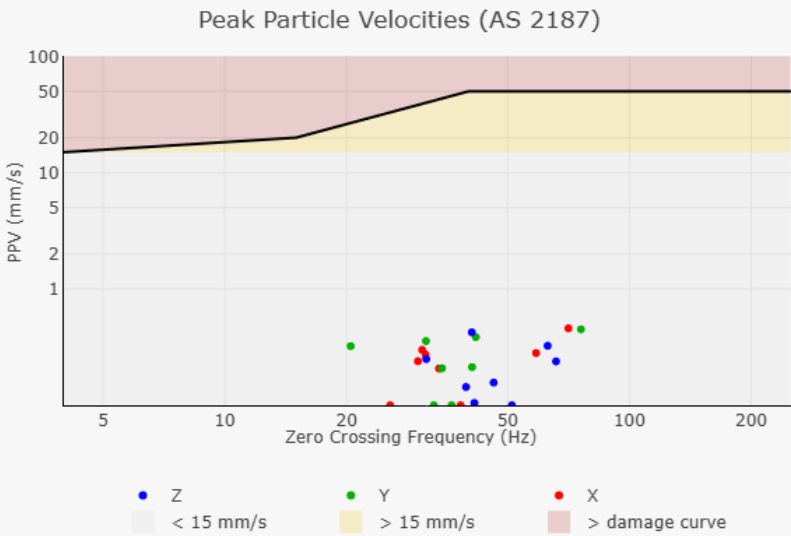
Per-component Peak Particle Velocities (PPV) vs. Zero Crossing Frequencies.  
Line indicates cosmetic damage guidelines  
(residential buildings, Fig. J4.4.2.1, AS 2187.2:2006).
