Ground Vibration Report

| Location | Phoenix 3750 CRD RAR |

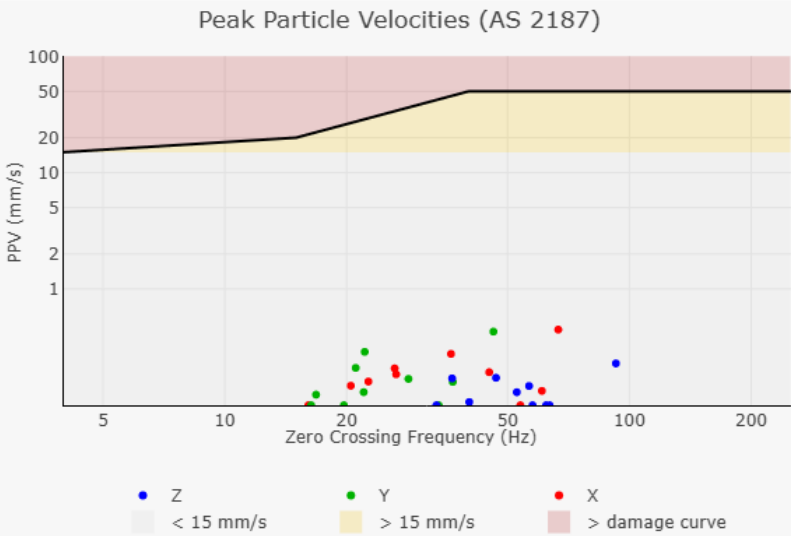
Per-component Peak Particle Velocities (PPV) vs. Zero Crossing Frequencies.  
Line indicates cosmetic damage guidelines  
(residential buildings, Fig. J4.4.2.1, AS 2187.2:2006).
