# Ground Vibration Report

| Event Date | 2026/01/22 |
| Location | Phoenix 3765 LPH 5925 |

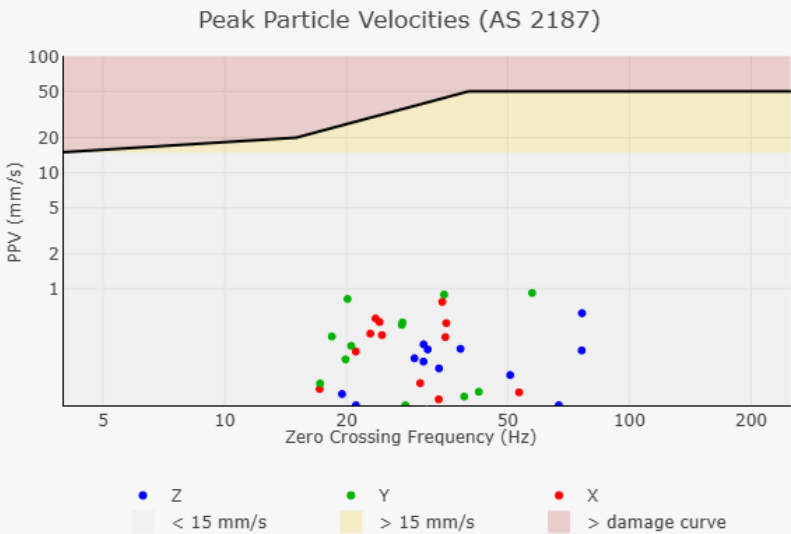
Per-component Peak Particle Velocities (PPV) vs. Zero Crossing Frequencies.  
Line indicates cosmetic damage guidelines  
(residential buildings, Fig. J4.4.2.1, AS 2187.2:2006).
