# Ground Vibration Report

| Event Date | 2026/01/24 |
| Location | Robbins Hill 4580 FWD 2465 |

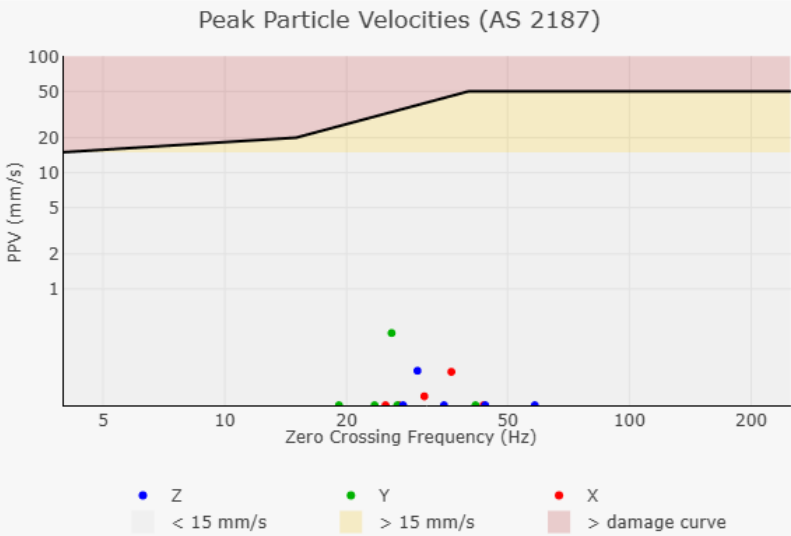
Per-component Peak Particle Velocities (PPV) vs. Zero Crossing Frequencies.  
Line indicates cosmetic damage guidelines  
(residential buildings, Fig. J4.4.2.1, AS 2187.2:2006).
