Ground Vibration Report

| Event Date | 2026/01/27 |
| Location | Phoenix 3765 LPH 5925 |

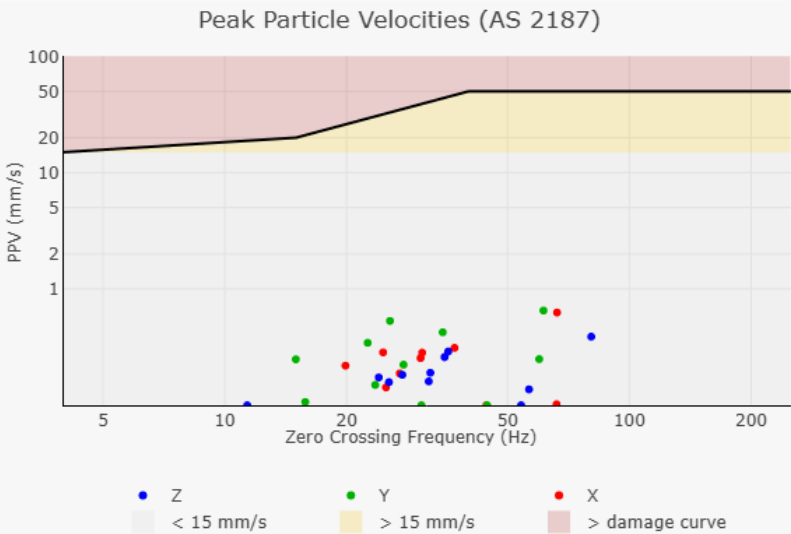
Per-component Peak Particle Velocities (PPV) vs. Zero Crossing Frequencies. Line indicates cosmetic damage guidelines (residential buildings, Fig. J4.4.2.1, AS 2187.2:2006).
