Ground Vibration Report

| Location | Phoenix 4120 RAP 6440 |

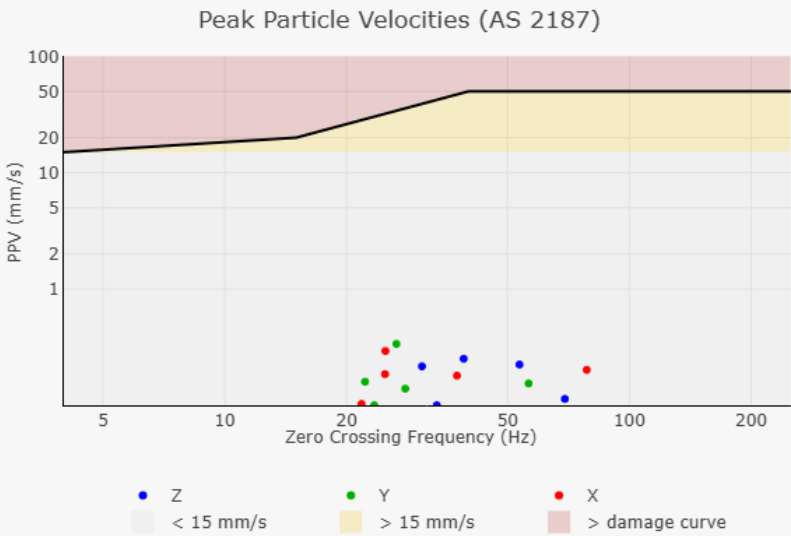
Per-component Peak Particle Velocities (PPV) vs. Zero Crossing Frequencies.  
Line indicates cosmetic damage guidelines  
(residential buildings, Fig. J4.4.2.1, AS 2187.2:2006).
