Ground Vibration Report

| Event Date | 2026/02/02 |
| Location | Phoenix_4030_CYG_6470 |

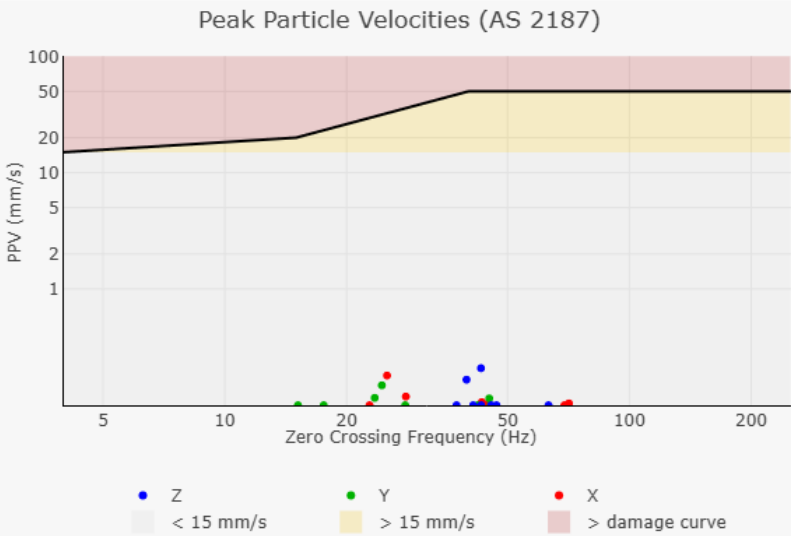
Per-component Peak Particle Velocities (PPV) vs. Zero Crossing Frequencies.  
Line indicates cosmetic damage guidelines  
(residential buildings, Fig. J4.4.2.1, AS 2187.2:2006).
