# Ground Vibration Report

## Summary

| Location | Phoenix_4120_RAP__6440 |

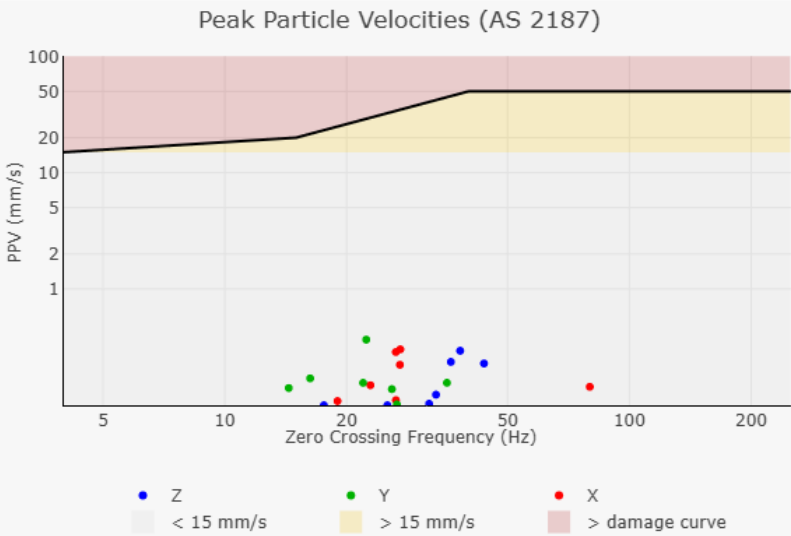
Per-component Peak Particle Velocities (PPV) vs. Zero Crossing Frequencies.  
Line indicates cosmetic damage guidelines  
(residential buildings, Fig. J4.4.2.1, AS 2187.2:2006).
