Ground Vibration Report

Summary

| Location | Phoenix 4030 CYG 6470 |

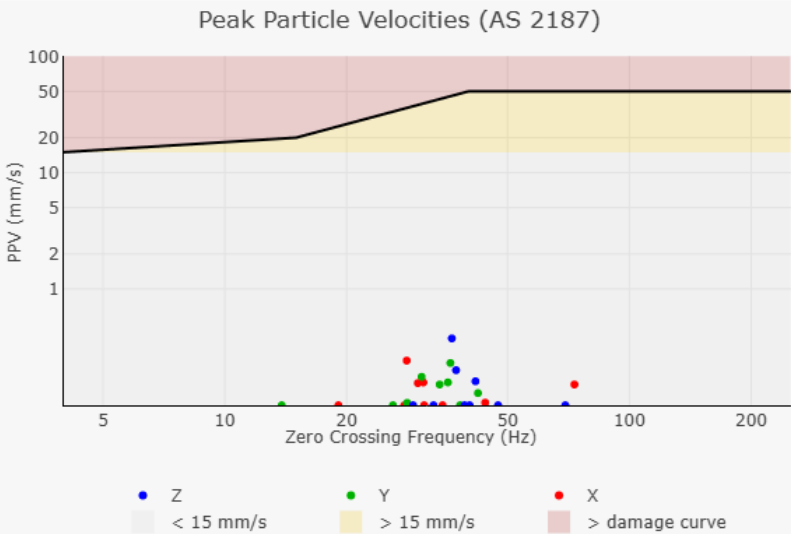
Per-component Peak Particle Velocities (PPV) vs. Zero Crossing Frequencies.  
Line indicates cosmetic damage guidelines  
(residential buildings, Fig. J4.4.2.1, AS 2187.2:2006).
