Ground Vibration Report

| Event Date | 2026/02/12 |
| Location | Phoenix_4695_RAW |

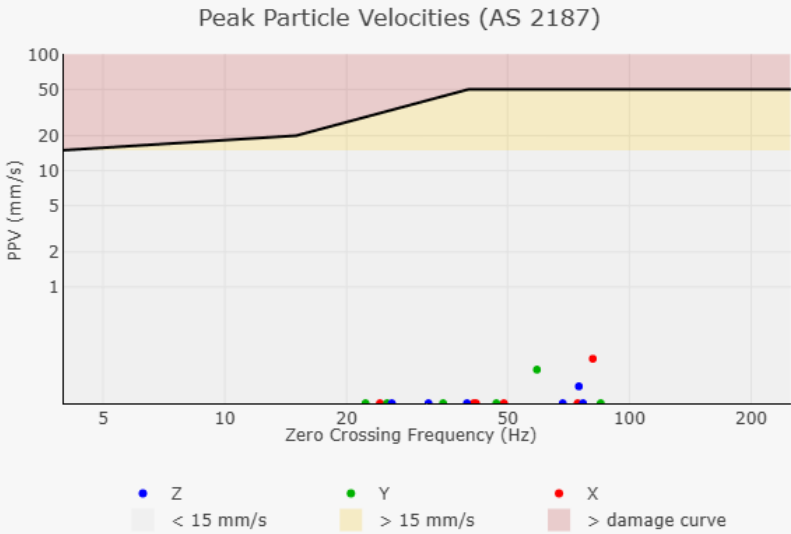
Per-component Peak Particle Velocities (PPV) vs. Zero Crossing Frequencies.  
Line indicates cosmetic damage guidelines  
(residential buildings, Fig. J4.4.2.1, AS 2187.2:2006).
