# Ground Vibration Report

| Event Date | 2026/02/14 |
| Location | Phoenix 3790 LPH 6010 |

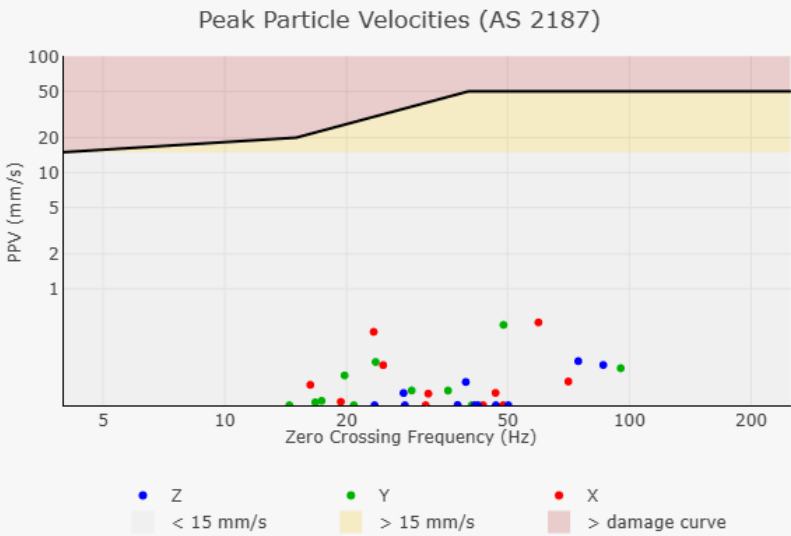
Per-component Peak Particle Velocities (PPV) vs. Zero Crossing Frequencies.  
Line indicates cosmetic damage guidelines  
(residential buildings, Fig. J4.4.2.1, AS 2187.2:2006).
