Ground Vibration Report

| Event Type | Development Blast |
| Location | Harrier 4625 |

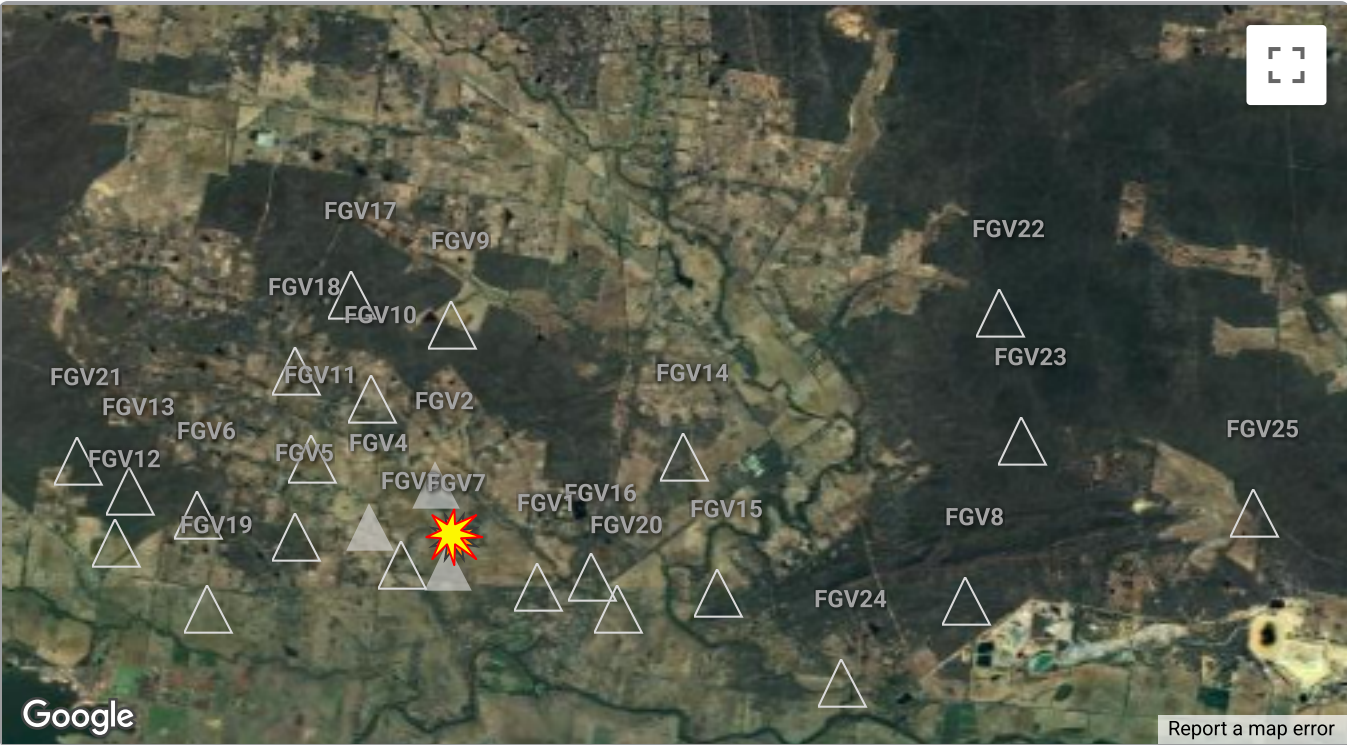
| Notes | Located near Harrier 4625 DD SP1 Floor bench. |

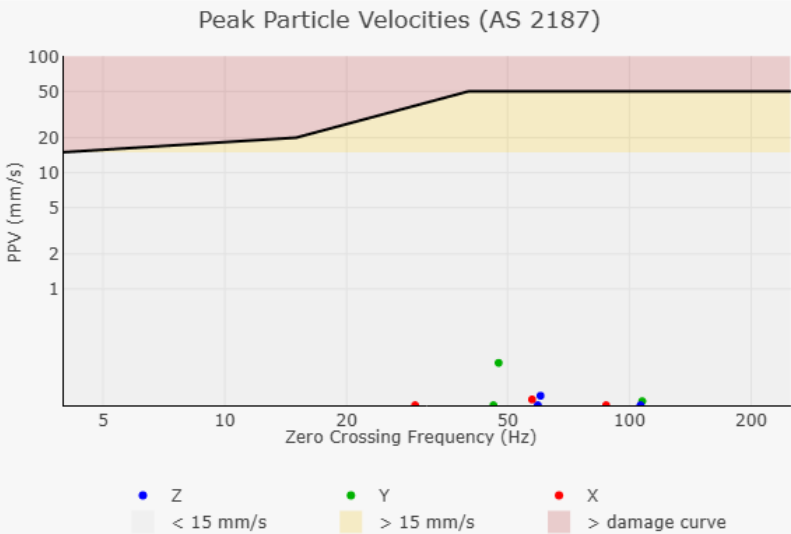
Per-component Peak Particle Velocities (PPV) vs. Zero Crossing Frequencies.  
Line indicates cosmetic damage guidelines  
(residential buildings, Fig. J4.4.2.1, AS 2187.2:2006).
