Ground Vibration Report

| Event Date | 2026/02/20 |
| Location | Phoenix 3890 SWN 6110 |

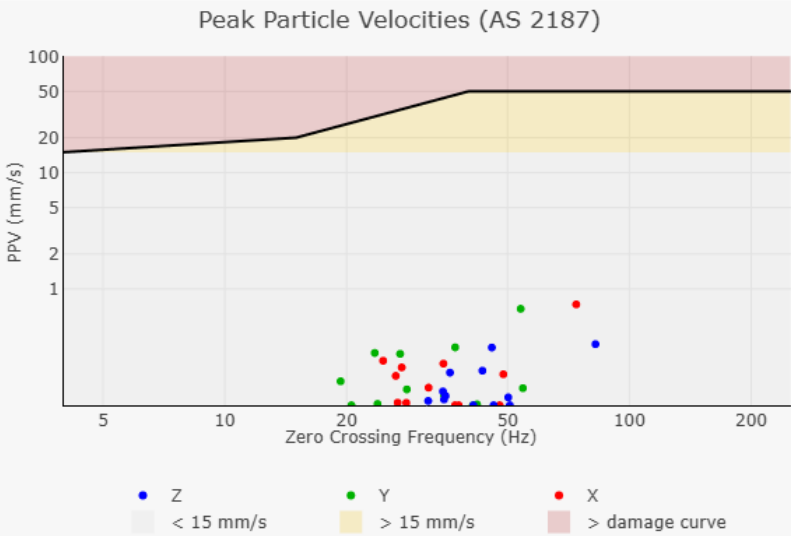
Per-component Peak Particle Velocities (PPV) vs. Zero Crossing Frequencies.  
Line indicates cosmetic damage guidelines  
(residential buildings, Fig. J4.4.2.1, AS 2187.2:2006).
