Ground Vibration Report

Summary

| Location | Phoenix 3740 LPH 5830 |

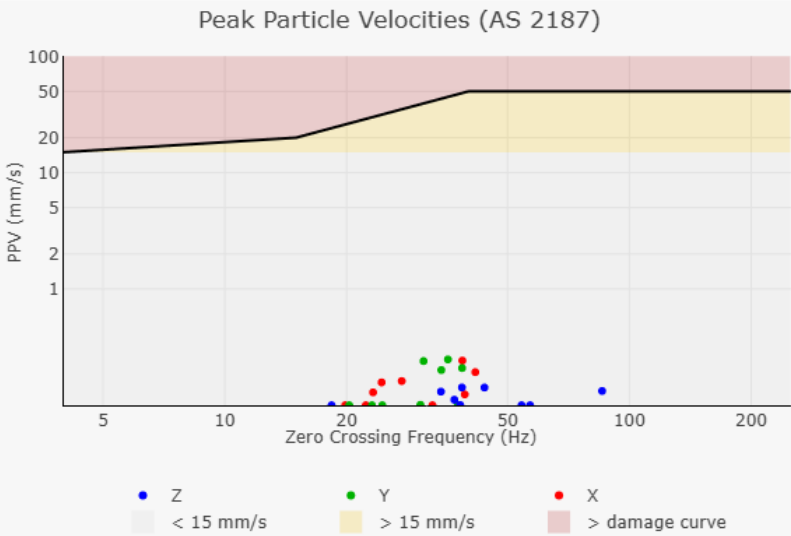
Per-component Peak Particle Velocities (PPV) vs. Zero Crossing Frequencies.  
Line indicates cosmetic damage guidelines  
(residential buildings, Fig. J4.4.2.1, AS 2187.2:2006).
