Ground Vibration Report

| Location | Phoenix 3780 - Phoenix 3825 FAR |

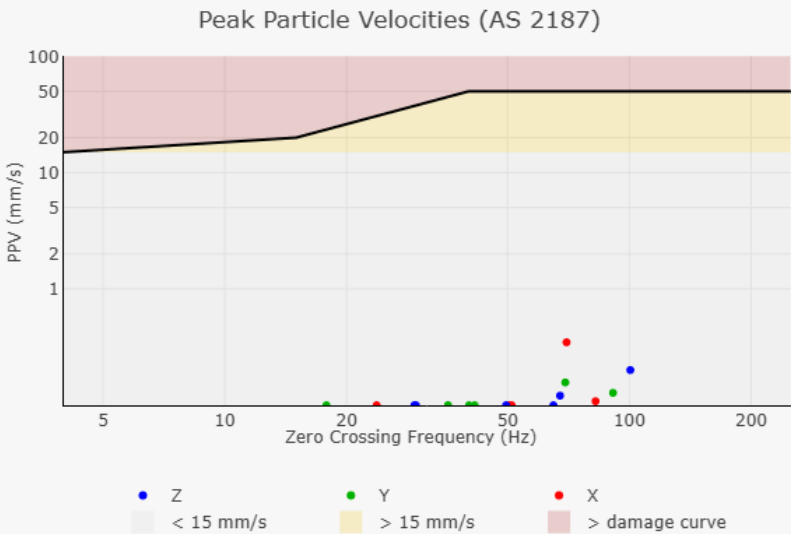
Per-component Peak Particle Velocities (PPV) vs. Zero Crossing Frequencies.  
Line indicates cosmetic damage guidelines  
(residential buildings, Fig. J4.4.2.1, AS 2187.2:2006).
