# Ground Vibration Report

| Event Type | Development Blast |
| Event Date | 2026/02/23 |
| Location | Phoenix 3695 RAW |

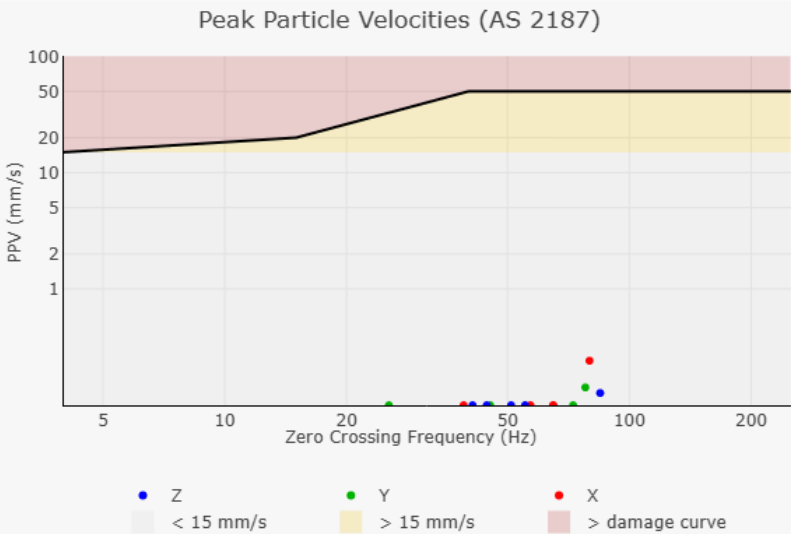
Per-component Peak Particle Velocities (PPV) vs. Zero Crossing Frequencies.  
Line indicates cosmetic damage guidelines  
(residential buildings, Fig. J4.4.2.1, AS 2187.2:2006).
