Ground Vibration Report

| Event Date | 2026/02/24 |
| Location | Harrier 4310 NFW 4970 |

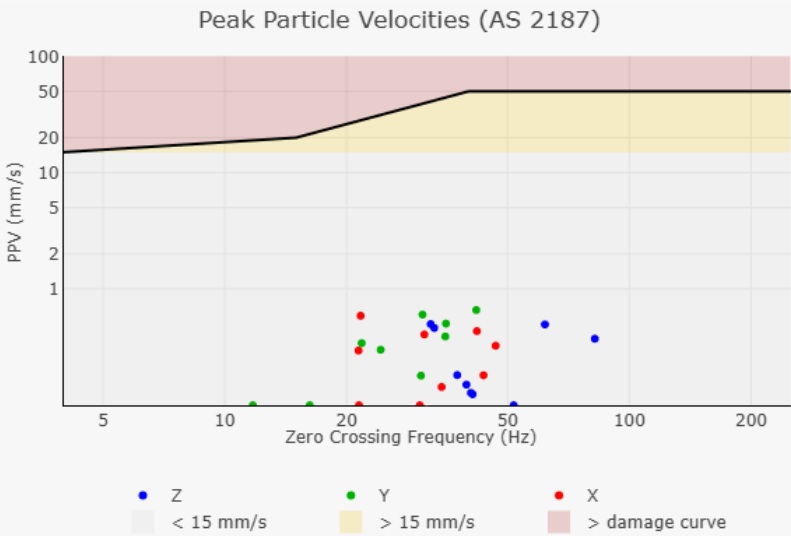
Per-component Peak Particle Velocities (PPV) vs. Zero Crossing Frequencies.  
Line indicates cosmetic damage guidelines  
(residential buildings, Fig. J4.4.2.1, AS 2187.2:2006).
