# Ground Vibration Report

| Event Date | 2026/02/24 |
| Location | Phoenix 3740 LPH 5830 F2 |

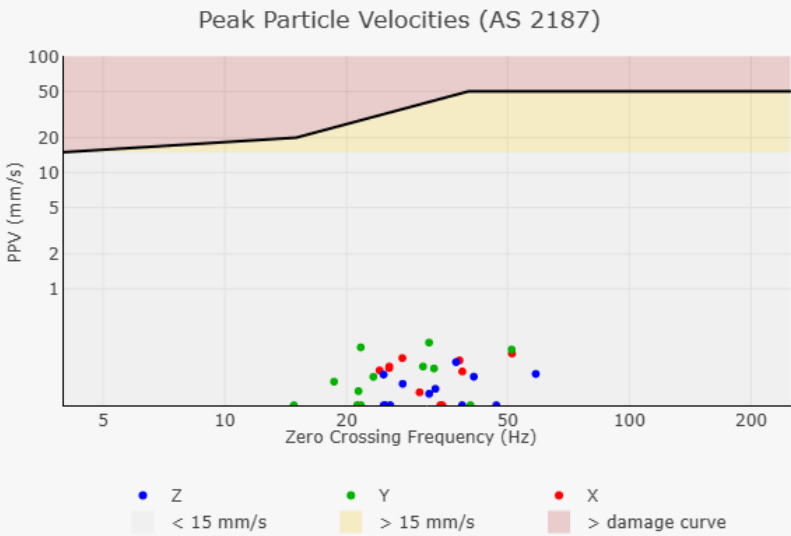
Per-component Peak Particle Velocities (PPV) vs. Zero Crossing Frequencies.  
Line indicates cosmetic damage guidelines  
(residential buildings, Fig. J4.4.2.1, AS 2187.2:2006).
