# Ground Vibration Report

| Event Type | Production Blast |
| Event Date | 2026/03/04 |
| Location | Harrier 4310 NFW 4970 |

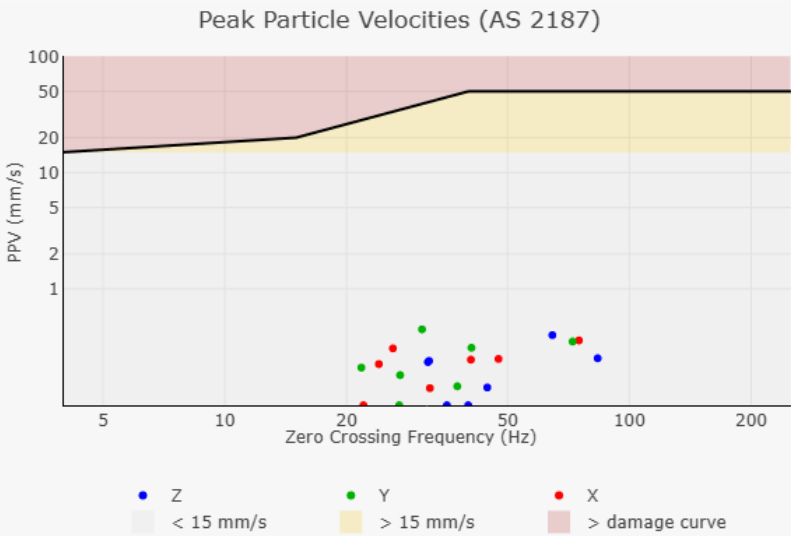
Per-component Peak Particle Velocities (PPV) vs. Zero Crossing Frequencies.  
Line indicates cosmetic damage guidelines  
(residential buildings, Fig. J4.4.2.1, AS 2187.2:2006).
